Advancements in Low Z Materials: Comprehensive Characterization and Applications by the Mechanical and Materials Engineering Group at CERN

A. T. Perez Fontenla, S. Atieh, S. Sgobba, G. Arnau Izquierdo, A. Cherif, M. Celuch, J-P. Rigaud, S. Pfeiffer, M. Guinchard, O. Sacristan de Frutos, CERN, Geneva, Switzerland

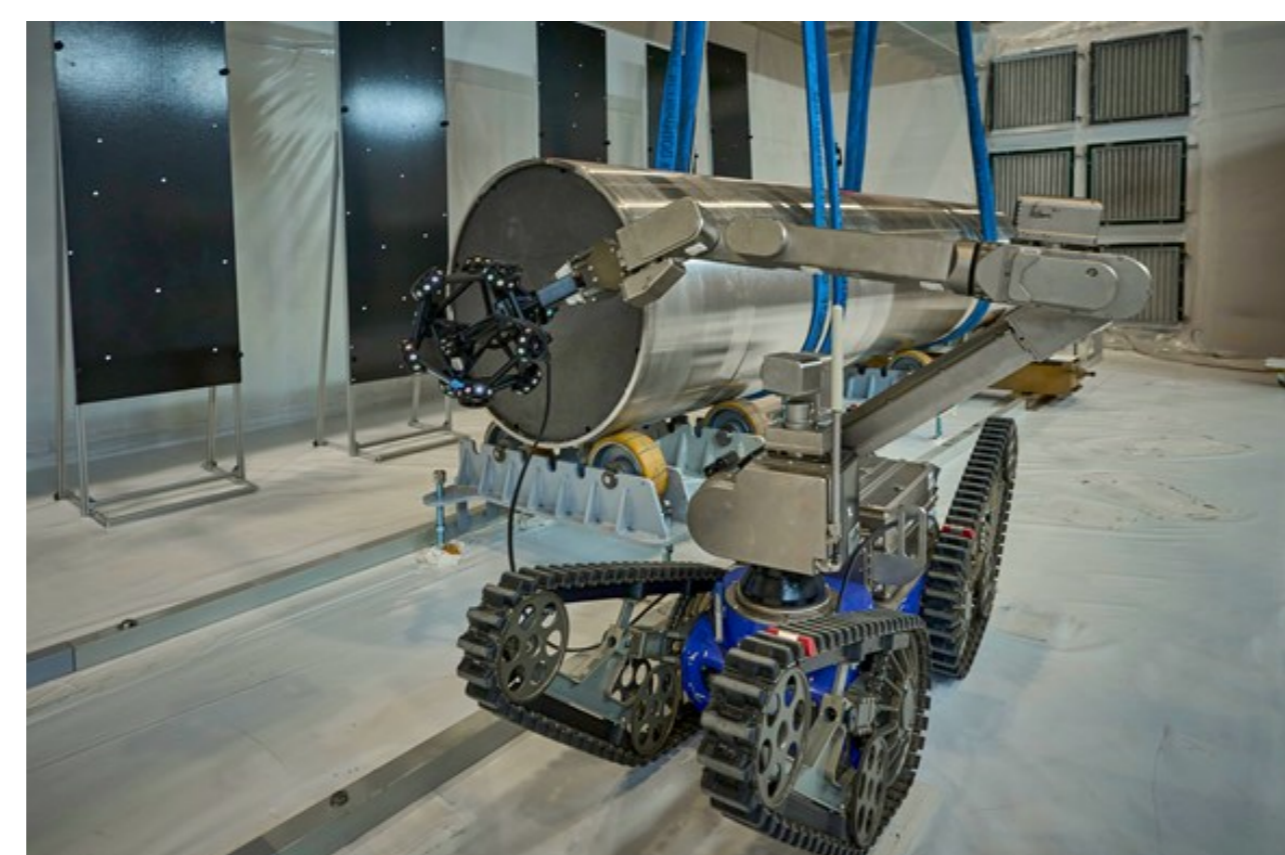
Figure 2: Portable 3D laser scanner mounted in a robot when the 318LN vessel was still on (images N. Solieri)

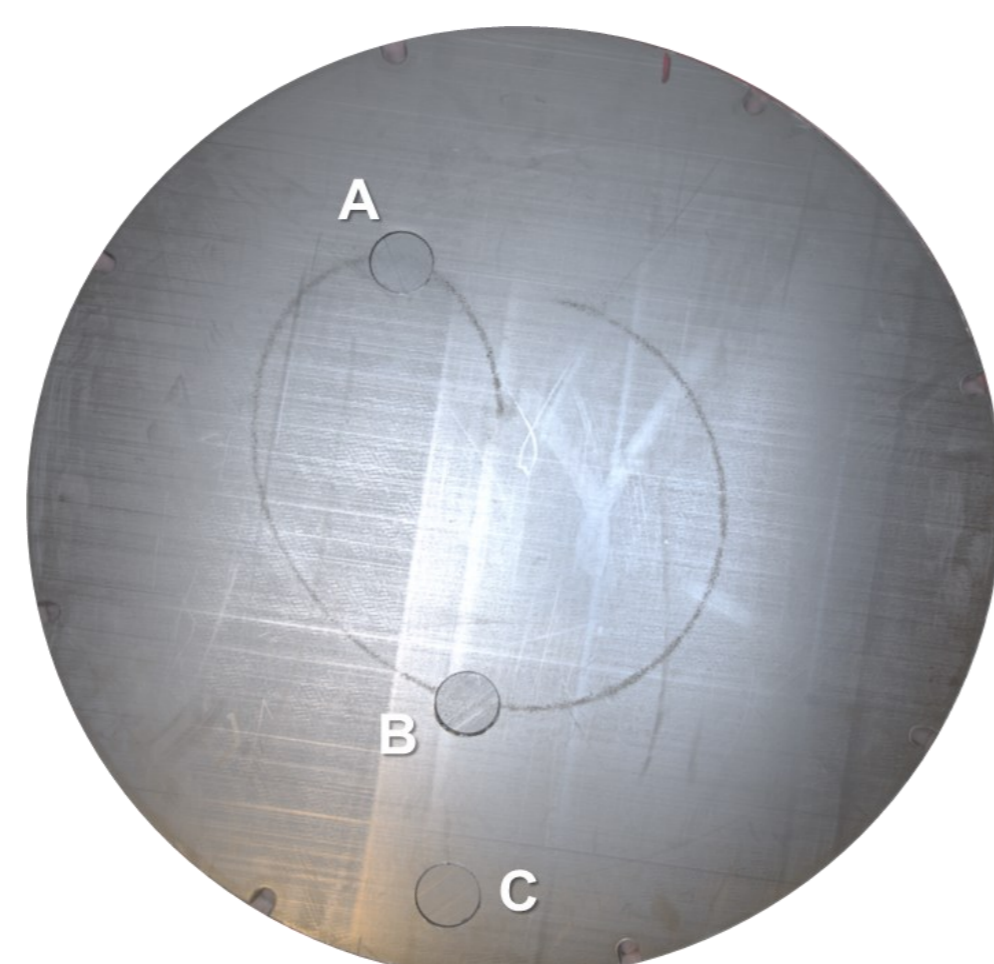
Figure 3: Upstream of graphite sheet with visible beam sweep. Different samples were investigated (A: Area of energy deposition peak; B: Control area; C: Reference)

The aspect of the beam impacted zones was rougher and the chemical analysis showed that systematically there was a higher amount of O content on the spots indicating leaks presence. This was confirmed by FIB-SEM cross sectional view and surface-sensitive spectroscopic techniques (XPS) that pointed out also N incorporation.

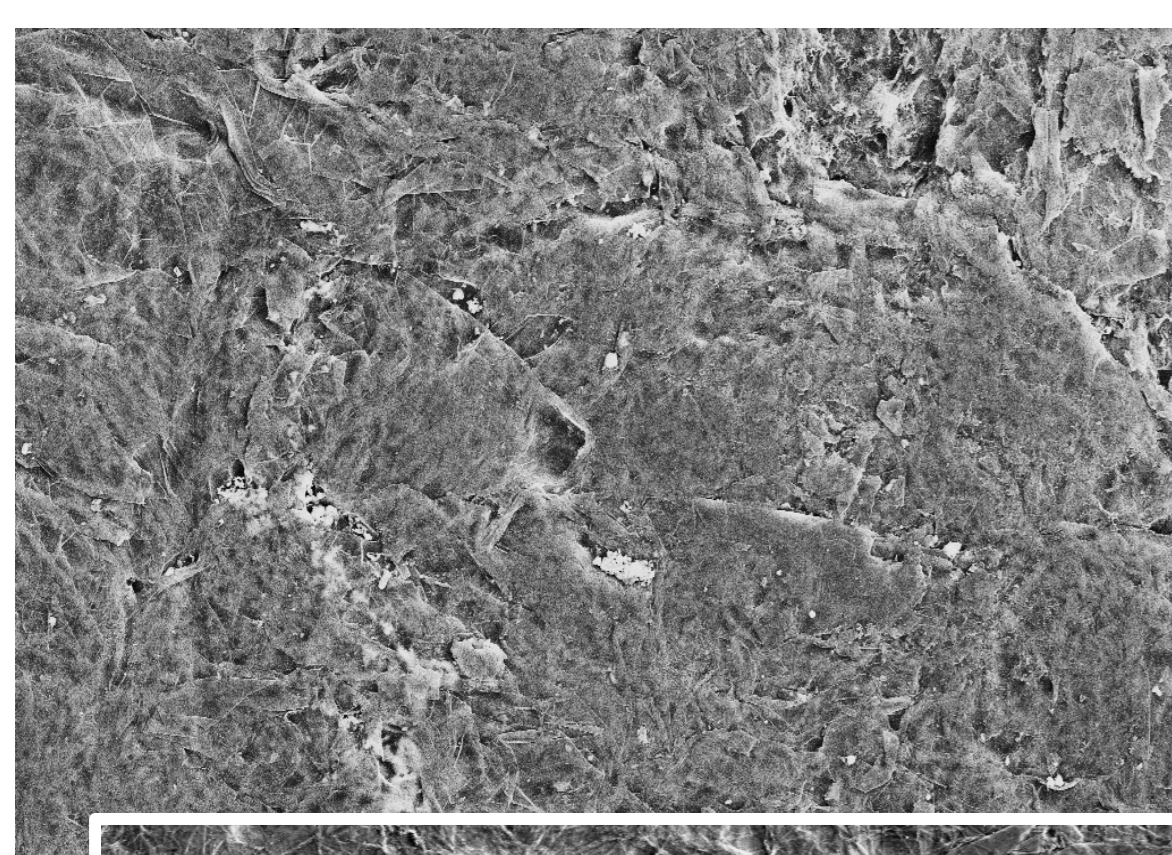
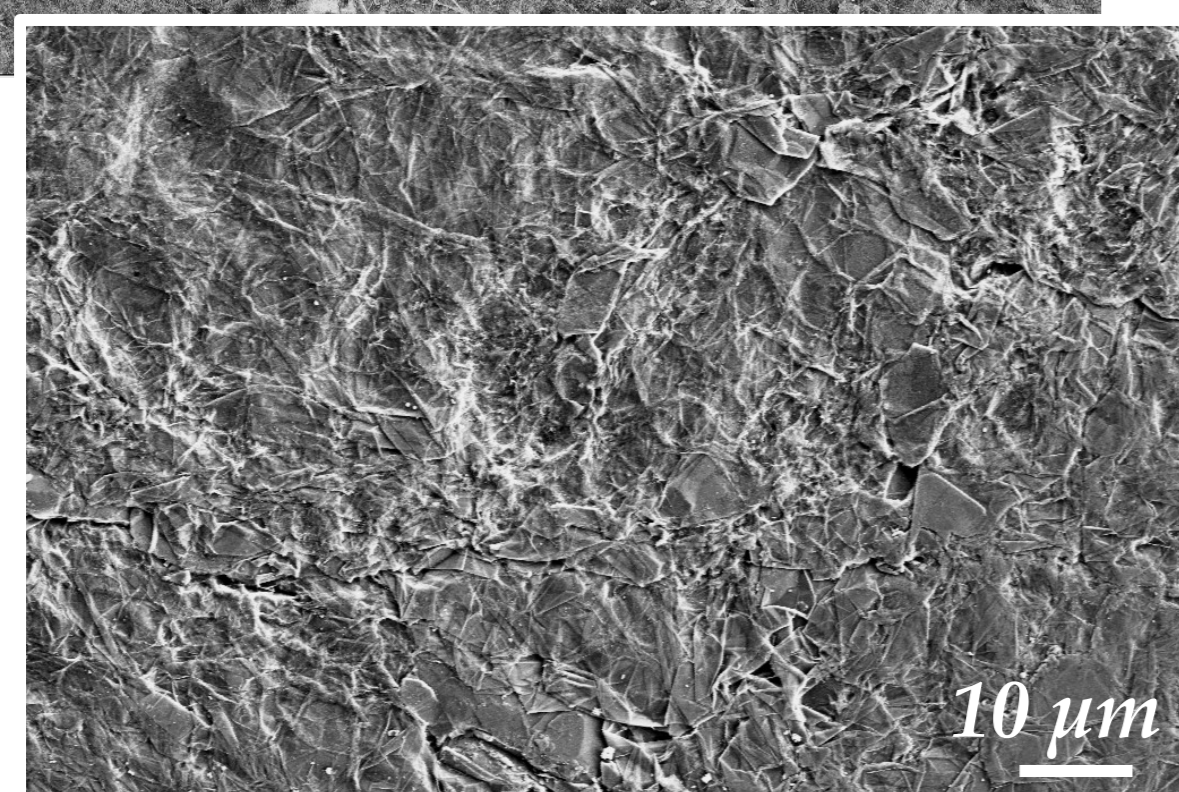
Figure 4: FIB-SEM on reference sample (up) and sample A (down)

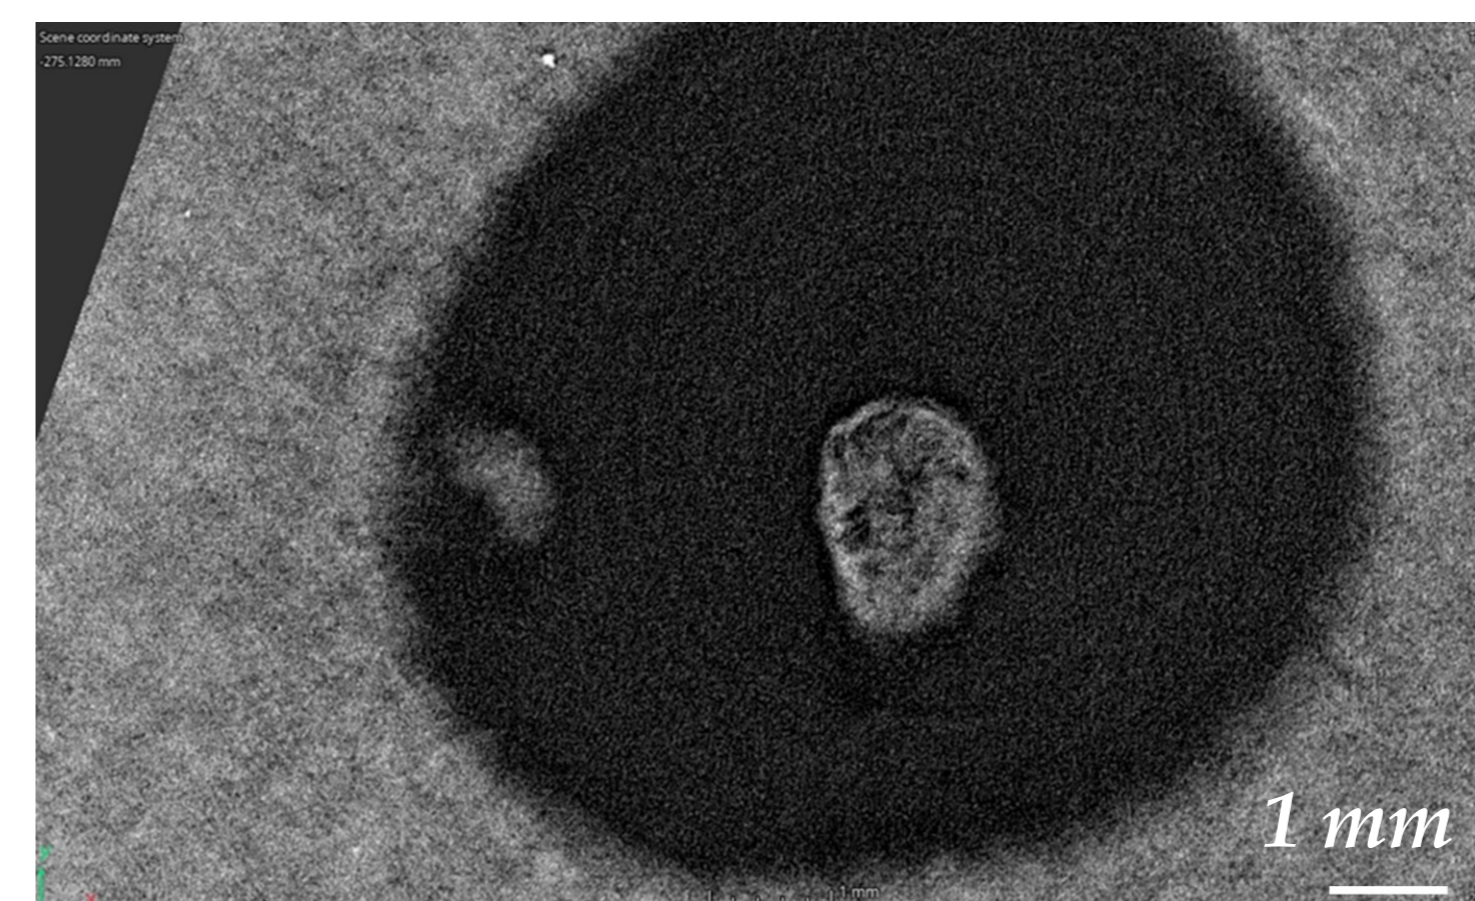
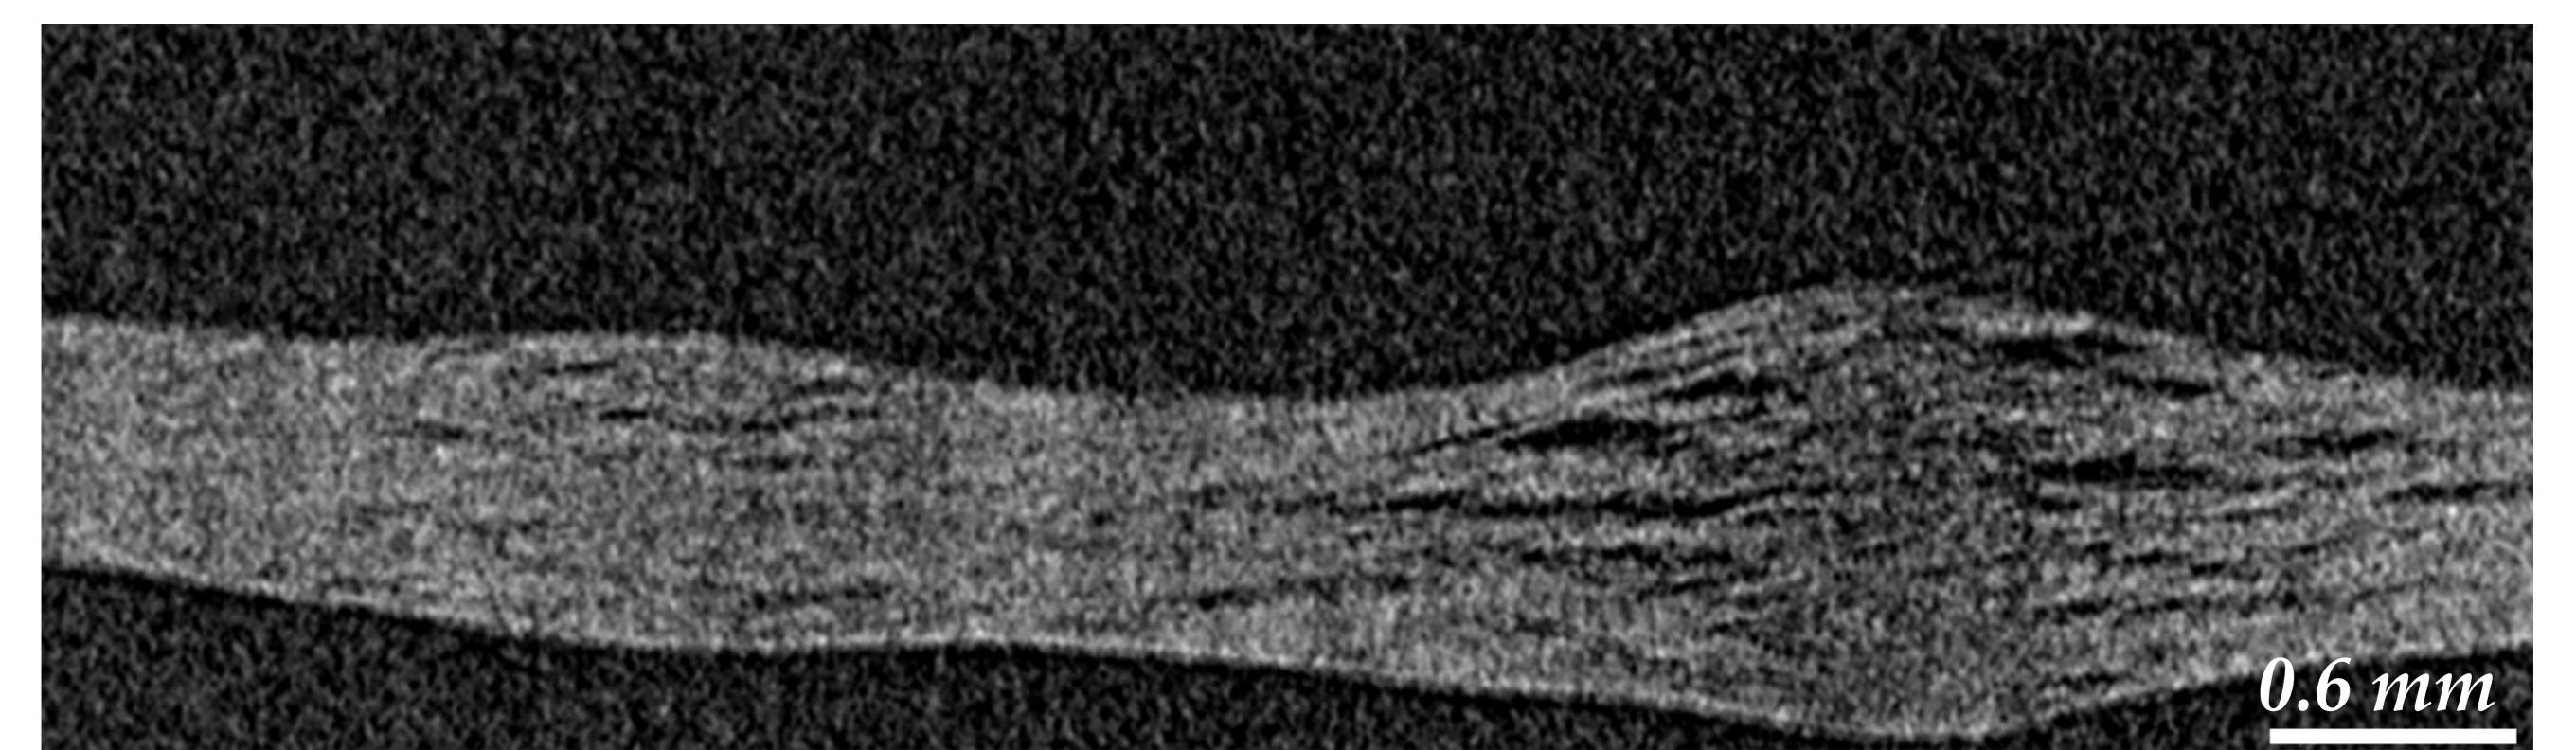
In the shown example the material was impacted three times at the centre and one time 3 mm from it with a beam spot size of 0.34 mm (in a N₂ atmosphere of 1.05 bar).

CT revealed a local swelling of the material and an important delamination through the full thickness.

Figure 5: CT images of Sigraflex specimen after HiRadMat56 (top view and cross-sectional view)

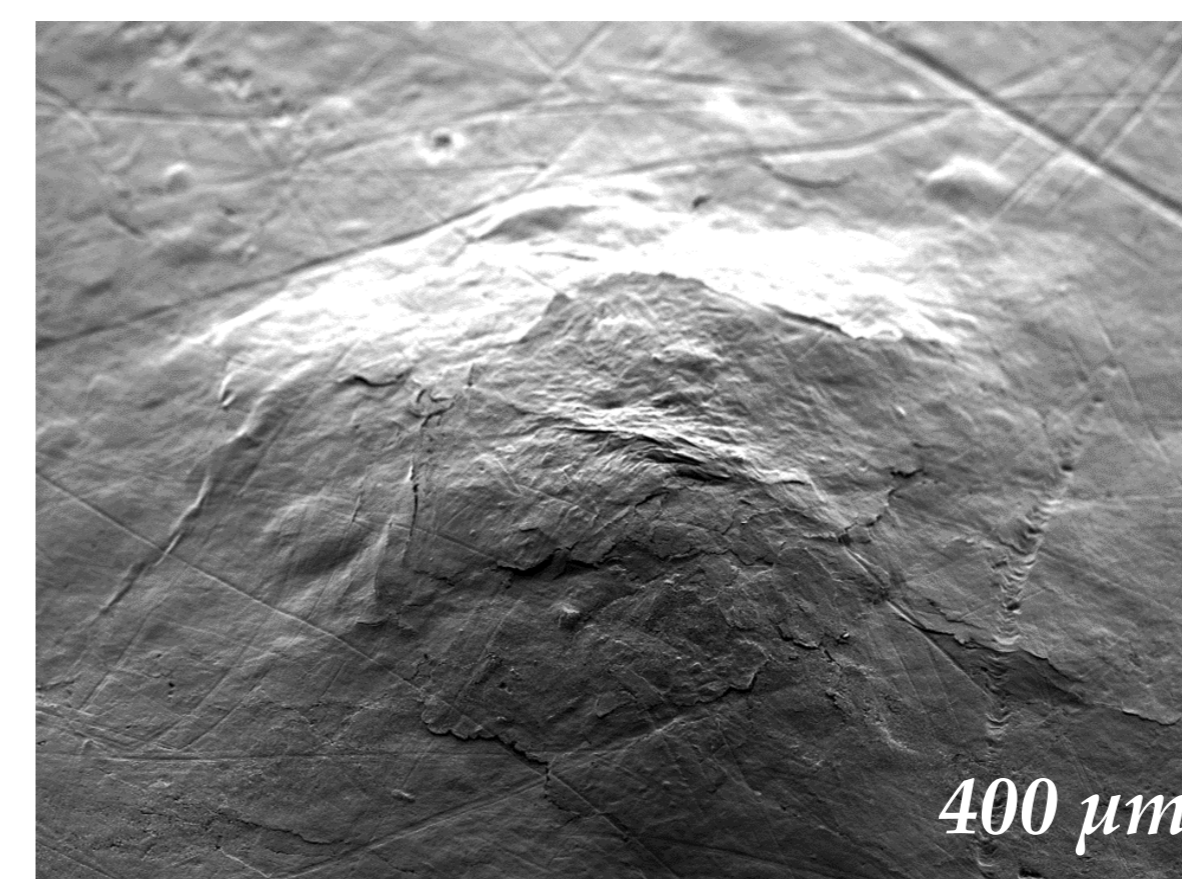
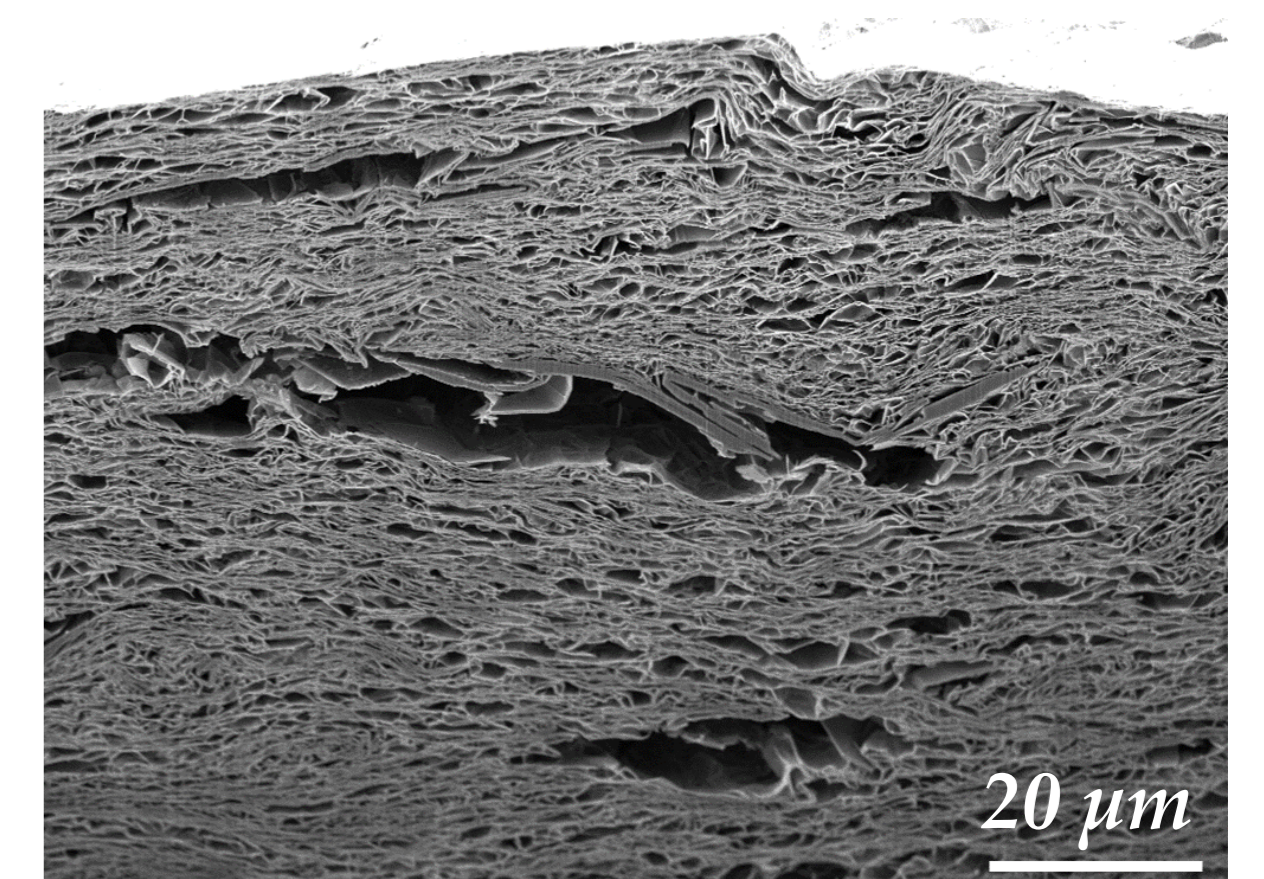
When observed at low magnification both cross sections present the typical graphitic structure in layers and the main difference is the separation between them (delamination) and a larger pore size in the irradiation spot region than in the reference.

Figure 6: SEM images of Sigraflex specimen after HiRadMat56 (top view and FIB-SEM cross-sectional view)

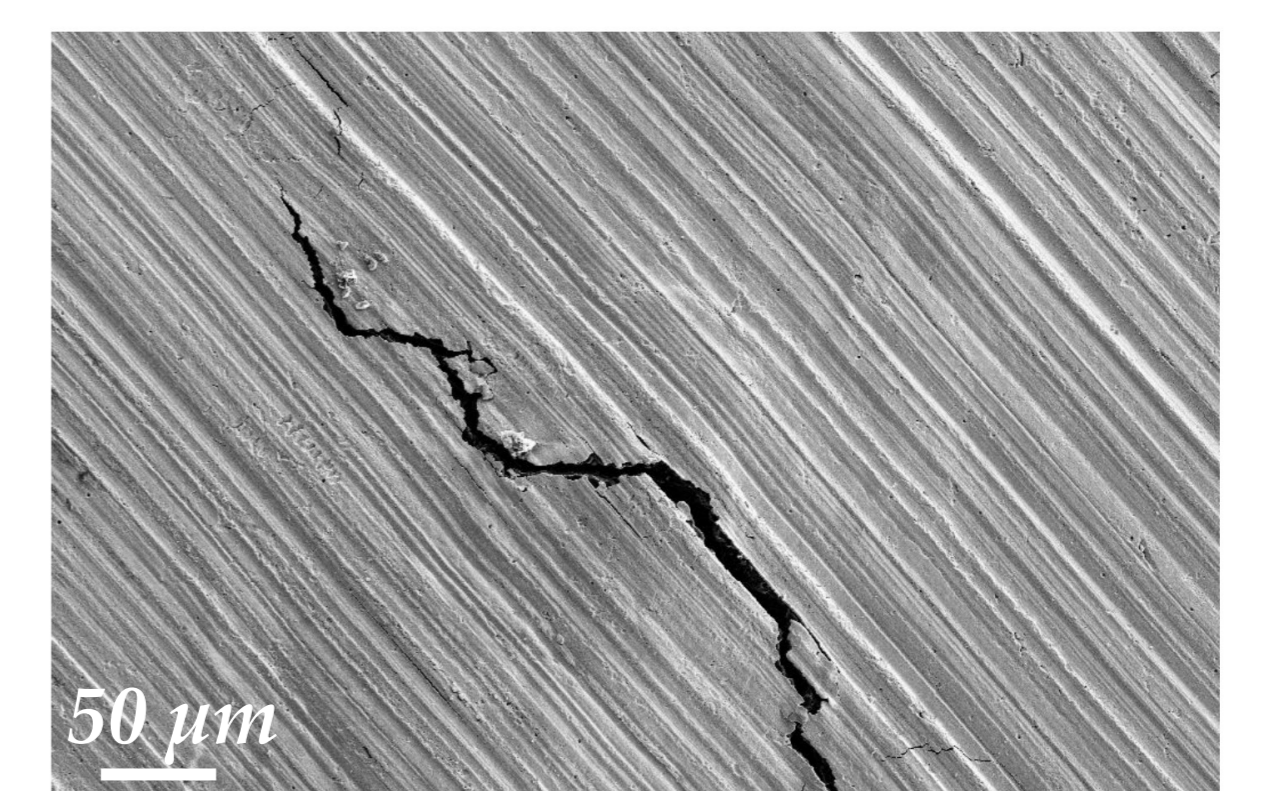
The SMAUG study alternated vacuum and air chambers (windows experimented pressure gradient) and included pressure sensors in vacuum to detect window leaks to identify failures like the one on a Be window on the SEM image (right)

Figure 7: SEM image of Be window after failure at the area of beam imprint. The fracture progressively propagated from air to vacuum side (cyclic phenomenon that appeared in both occurrences only after ~50 high-brightness shots)
