Problem with FRS dipole magnets

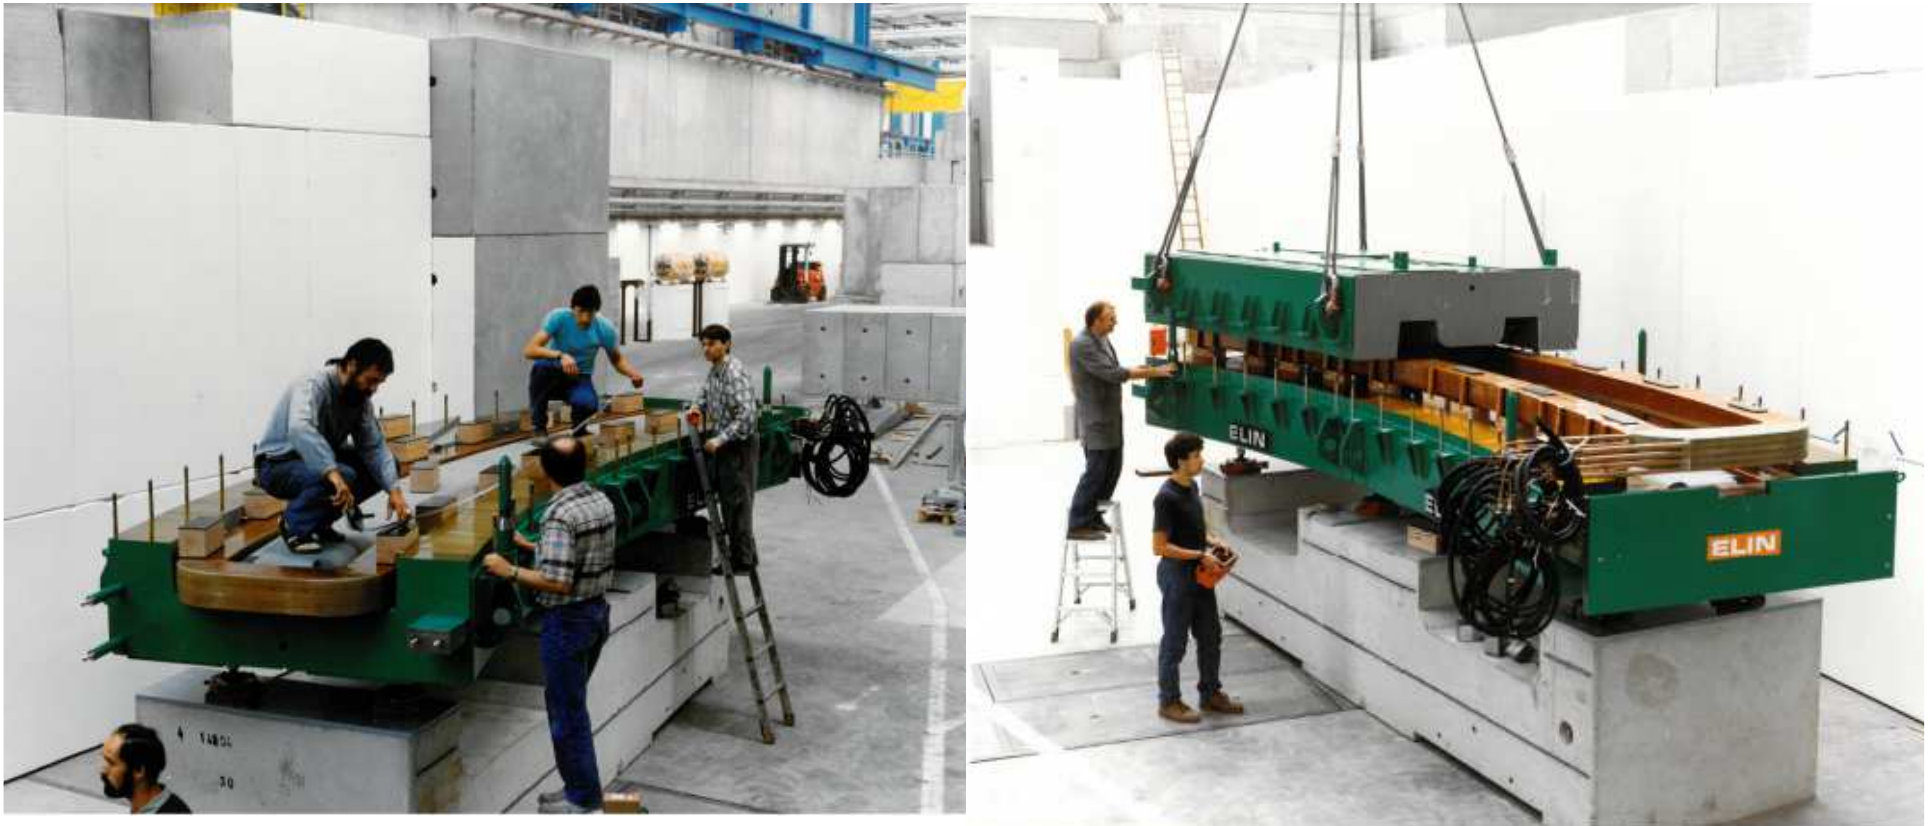
During the Hall-probe calibration procedure, it was noticed that the upper coil of a dipole is lifted by $\sim 1\text{cm}$

First result of scrutiny: the damping material ($\sim 2 \times 5 \text{ mm}$ rubber-type plastic) between the coils, which keeps the coils in position, has „disappeared“; it was found to lie between the yokes
