INFN - Milano
University of Milano
Department of Physics

Status of the AGATA preamplifiers

12th AGATA Week
June 11-13, 2012, GSI, Germany

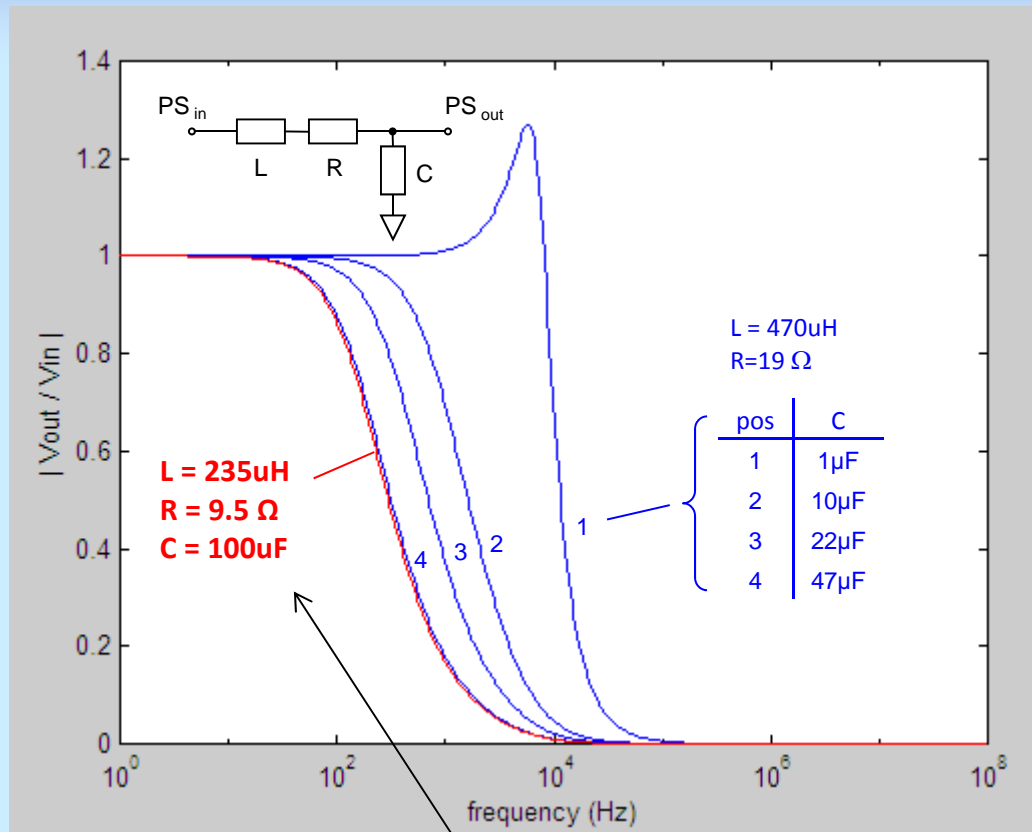
Sizing the LC filter of the +6V PS

Among the four used power supplies the +6V is the most power eager @ ~50mA per triple → I firstly and mostly worked on the filter for the +6V PS

✓ Oscillations removed after adding LC filter on +6V

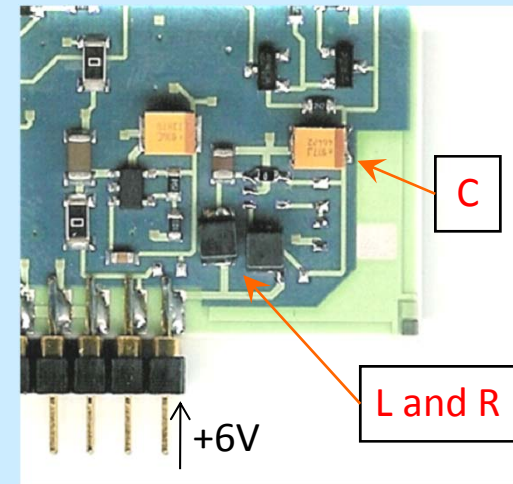
Chip inductors non-idealities:

- coil resistance
- maximum DC current

Two 470uH inductors in parallel:

- $L_{eq} = 470\mu\text{H} / 2 = 235\mu\text{H}$
- $R = 19\ \Omega / 2 = 9.5\ \Omega$
- $I_{MAX} = 2 \times 60\ \text{mA} = 120\ \text{mA}$
