AGATA Ge-Detectors at GSI

Status Report

I. Kojouharov

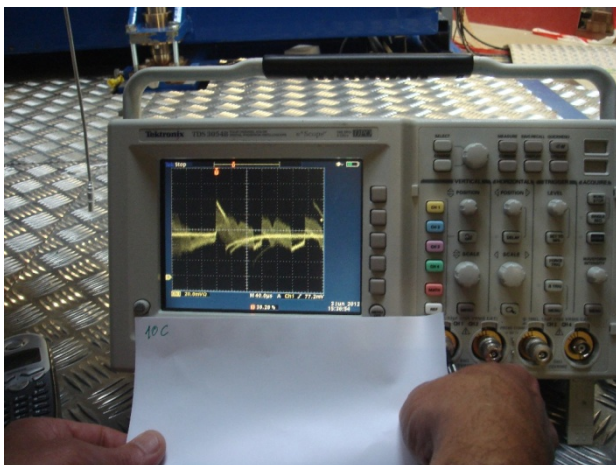
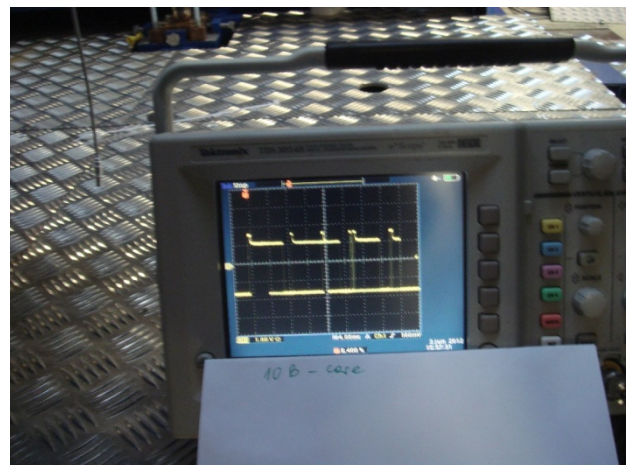
ADC2:

oddly signals from the core channels of the both crystals, developed the problem within several weeks.

lately not confirmed – "... the detector ADC2 is working nicely with analog electronics out of the frame. The energy resolution is reproduced the detector shows no sign of damage...."

To be inspected reinstalled again.

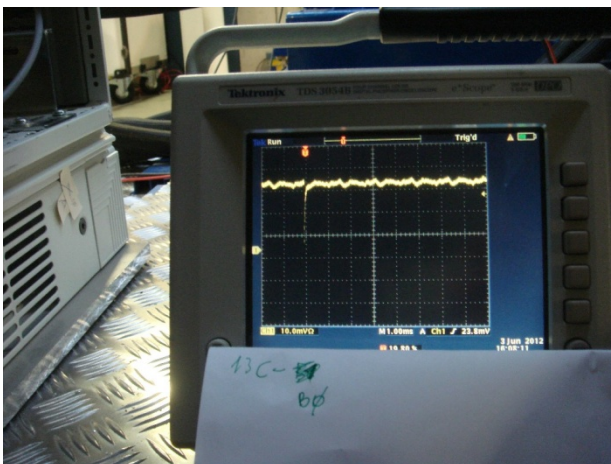
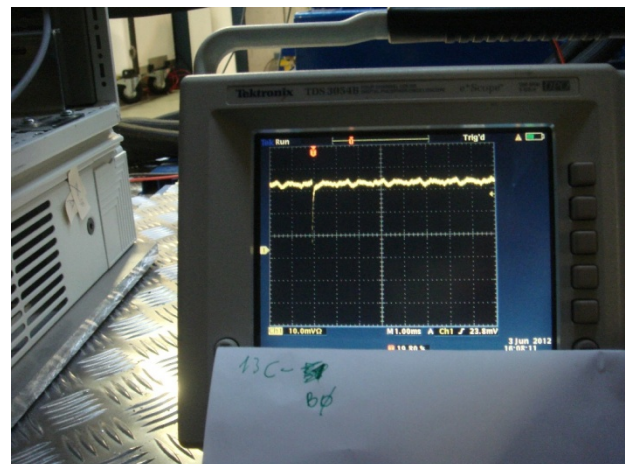
ATC3:

supposed ground loop which caused poor resolution of crystal C. The ground loop most likely comes from the signal cables. When detached a clear baseline was observed. Good chance for Nabil to demonstrate the power of the EMC compatibility diagnostics.

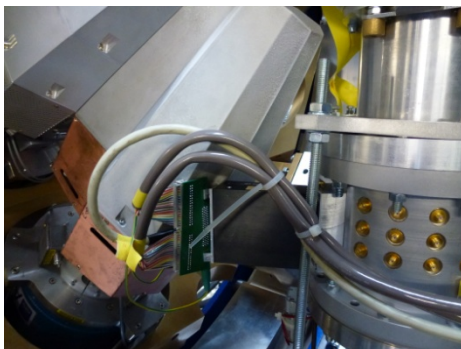
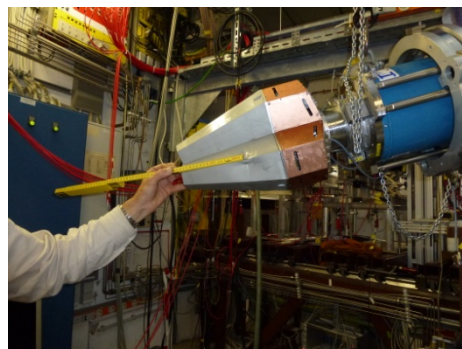
ATC1 accident:

- rotation was ongoing in order to find out the reason for strong vibrations and sudden jumps of the mechanics
- as a rule any work on the frame is being carried out by at least two persons, at this time these were IK and PB

- poor observation field, many items are hidden or difficult to assess their conflict with the detectors, especially by rotation
- the target chamber was not fully implemented and many components have been replaced by provisional (or even makeshift) solutions, some of them conflicting with the detector rotation cone. Principally, any device which may cause conflict must be deinstalled immediately after the experiment. One preamplifier was not.

- The rotation in counterclockwise direction was done without accidents.
- The rotation in clockwise direction caused the accident. The rotation was stopped immediately when the sound of the conflicting objects was heard. Unfortunately, removing the detector from the dangerous position was already not possible before deinstallation of the conflicting preamplifier and the ATC1.

- the vacuum was not lost immediately but after some 1-2 minutes. Nevertheless, the time was too short to shut down the HV.
- the impact point was too far from the capsule lid, lately was confirmed that the capsules are operational.
