When we thought summer service was over

Breakdown of the RF feedthrough on the Gustaf Werner cyclotron

The Svedberg Laboratory, Uppsala University, Sweden

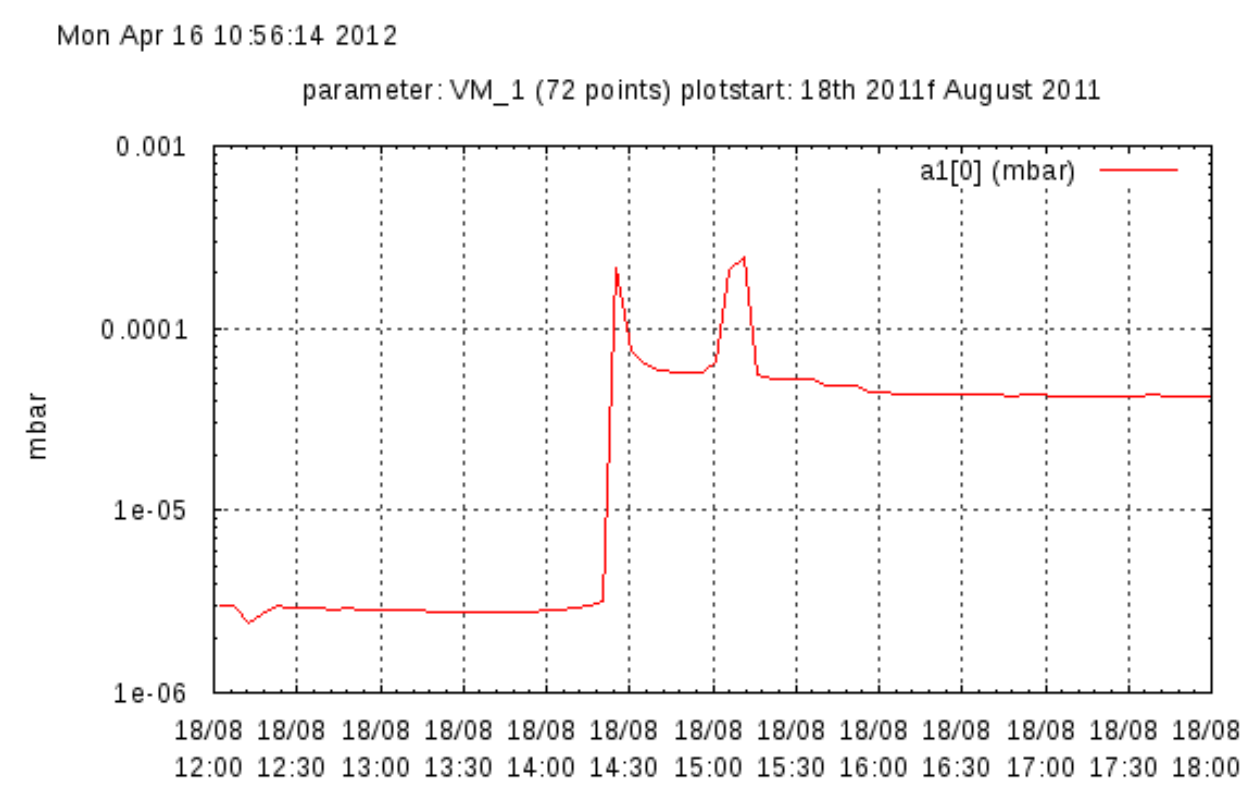
2011-08-18 Breakdown moment

It happened during the last trial to accelerate an Argon 9+ beam from the external ECR and through the cyclotron. We had beam on the inflector but not further. The RF systems were tuned to run 17.467MHz but we still had some mismatch somewhere and retuned once more. Then suddenly we had a big change in vacuum and we started the work to find out why.

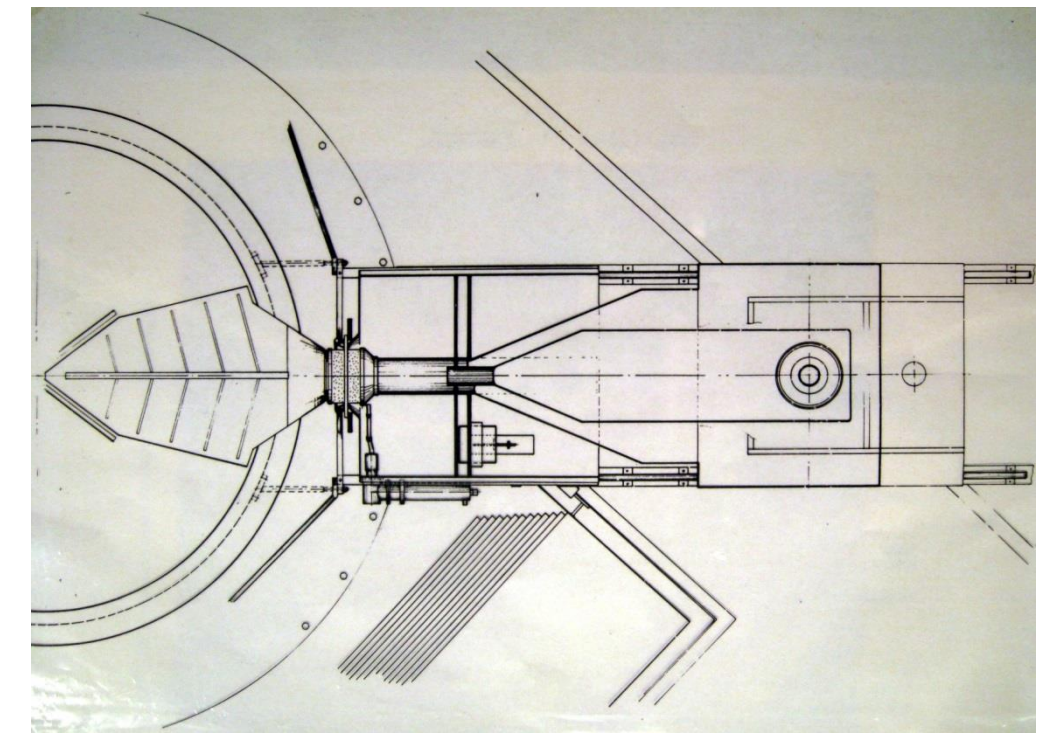
We found pictures that gave us an idea of fault

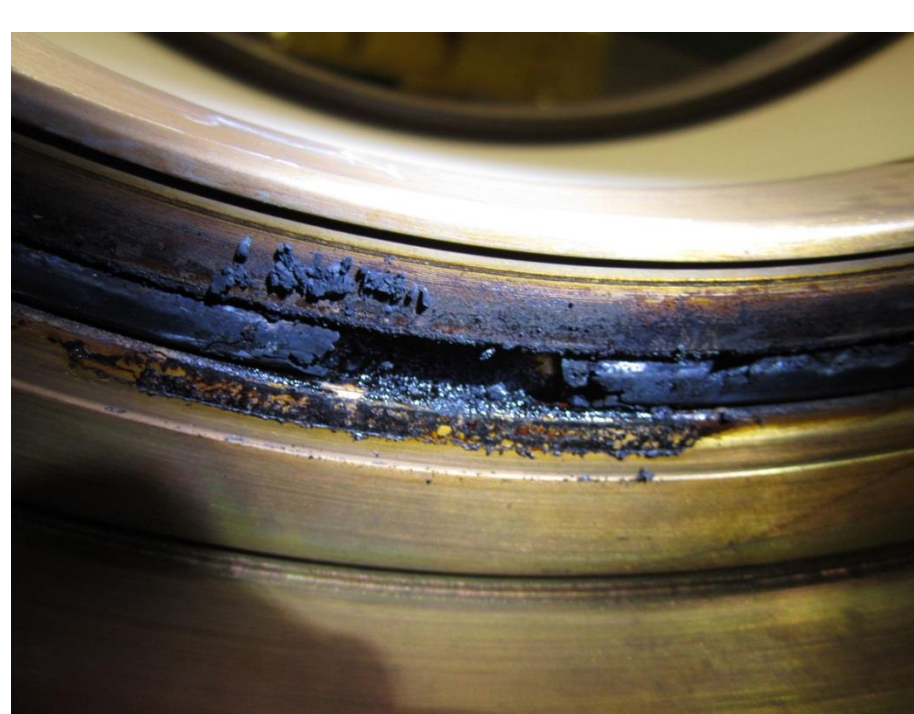
We found the main cause of the leak, a broken O-ring

Most probable cause of failure: The O-ring had aged due to radiation, mechanical stress, heat changes, arcing and ozone. The Nitrogen in the feedthrough leaked through the damaged O-ring into the tank. The nitrogen was shut off as in standard run cases low effect. During this odd run case we had high power in the feedthrough and arcing caused the O-ring to disintegrate and the ceramics to crack.

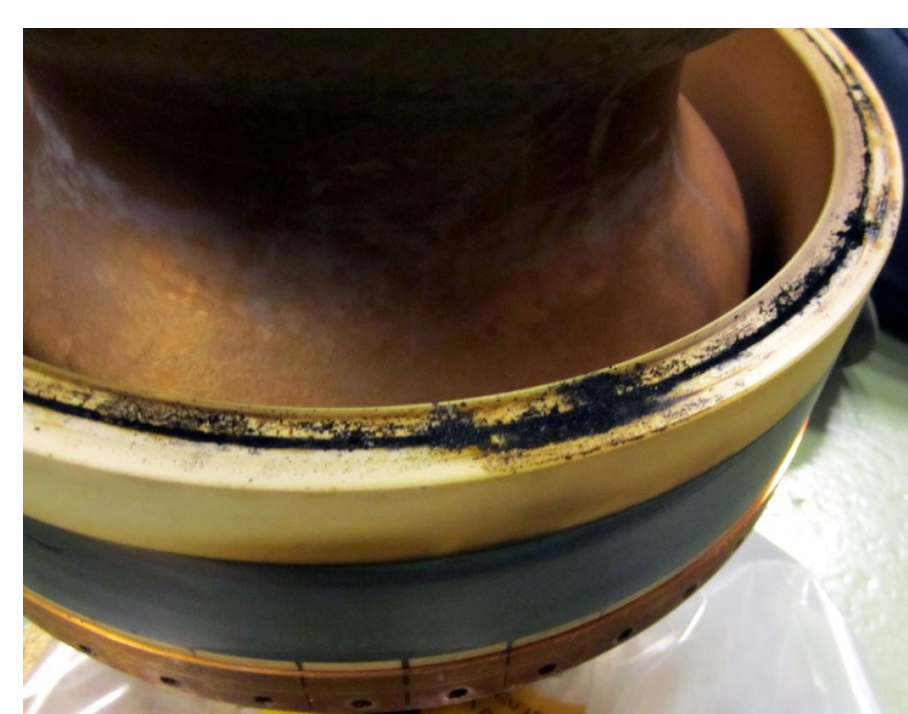
Remains of the O-ring on the cracked ceramics

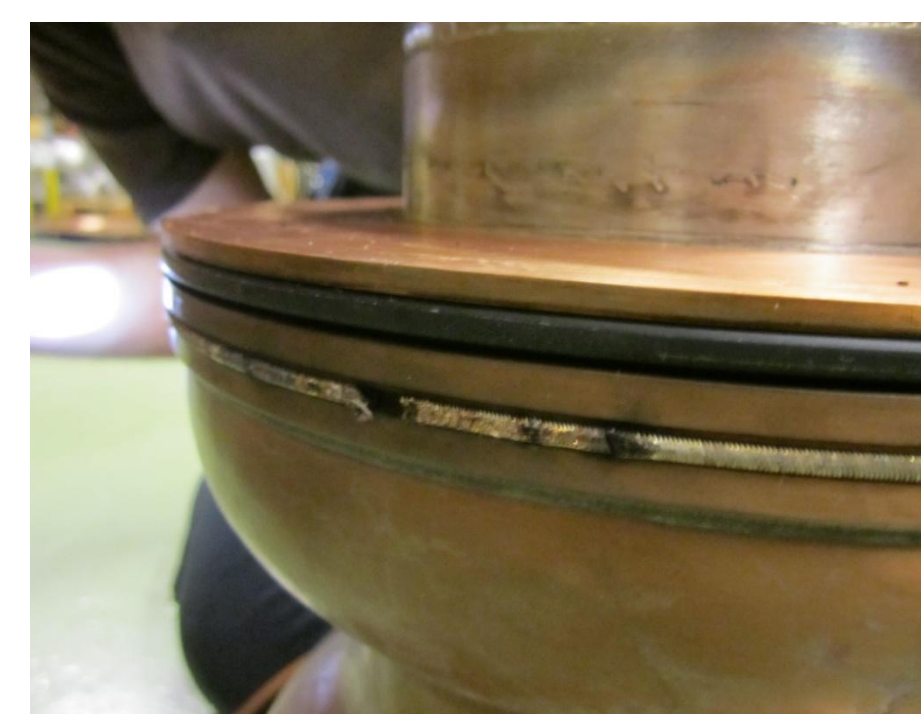
The colonial spring made of CuBe was damaged
