# KOrea Multi-Purpose Accelerator Complex

- About KOMAC
- Operation Status
- Trouble-shooting
- > Plan
- Summary

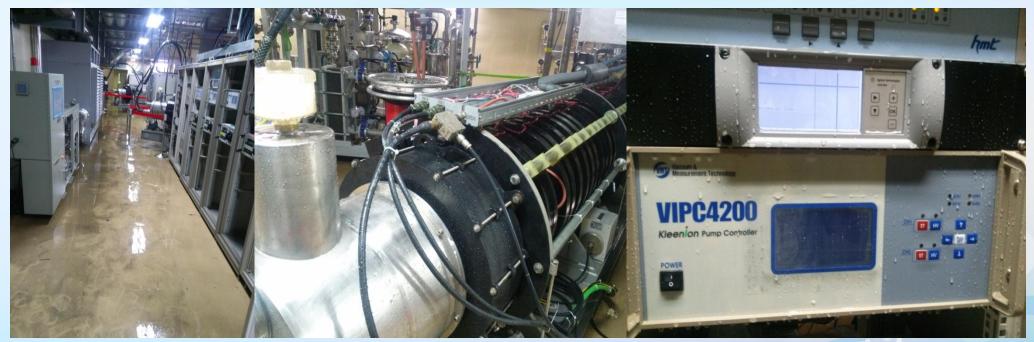
Klystron gallery

- Although completed commissioning of the utility, several troubles
- Long-term
  - Watered electronics in klystron gallery
  - : Due to unexpected triggering the fire extinguisher
  - : Shut down vacuum, RF and control system

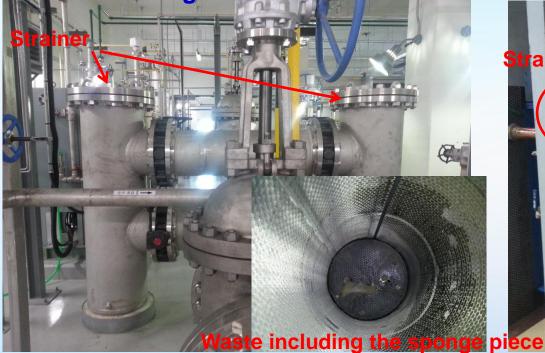
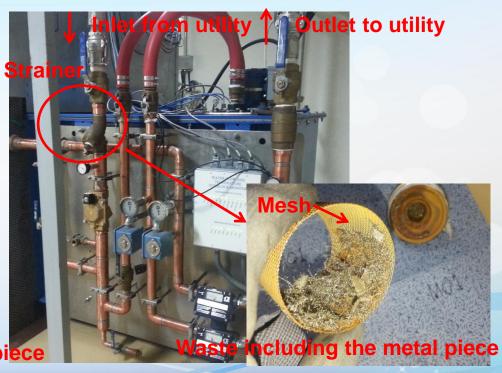
- Abnormal stopping cooling pump caused by momentary electrical power failure
- Tripped off vacuum system due to improper grounding
- Burned LEBT solenoid magnet by malfunction of cooling skid
- Waste in the strainer

: cooling system keeping the temperature of utility

: cooling unit of modulator

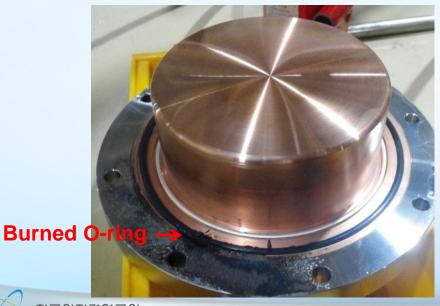
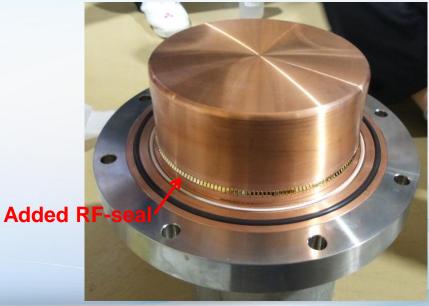
- RF arcing at a slug tuner of DTL tank
  - : when is increasing the pulse width and repetition
    - (1.2ms, 10Hz @ ~ 1 MW of forward power)
  - : broken vacuum due to burn the O-ring and then added the RF seal
- Short-term
  - RCCS control and klystrons failure
  - Flow-meter failure for DT 's electro-magnet

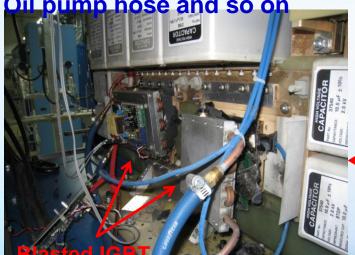
Oil pump hose and so on

- IGBT blasting at low duty 500us, 2Hz
  - : acted the fire detector and actuated CO2 gas
  - : cleaned the blasting debris on switching plate of A phase
  - : replaced IGBT's, IGBT drive boards
- Controller failure
- SCR firing circuit failure
- Short-term
  - IGBT over-current set value
  - SCR control circuit jumper

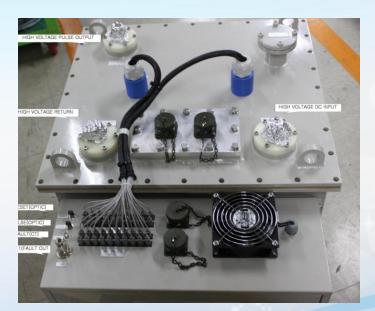
HV switch: 60kV, Dong-A Hitech., Korea

- HV switch malfunction by HV arcing
  - : It cannot be repaired due to molded type
  - : long delivery and lead time
  - : changed the HV switch made in domestic company
  - : Although faults in twice, repair time reduced

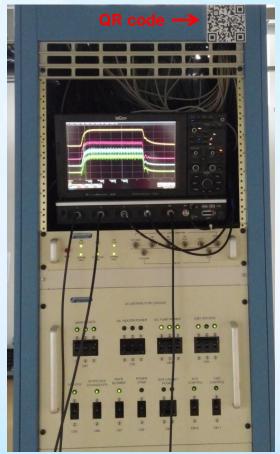
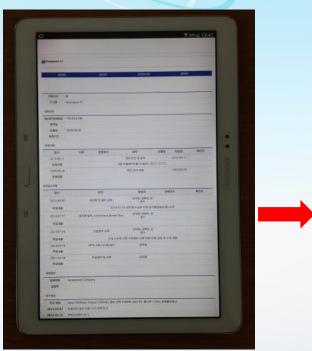
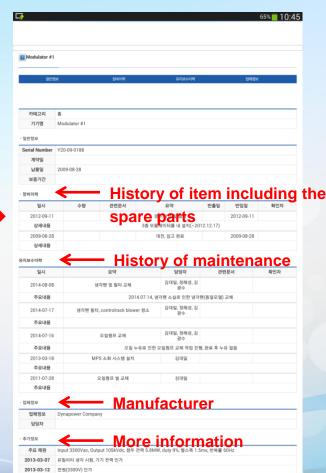
: set up MIS (Management Information System) which can be known the details of item as check the QR code on machine
