Catastrophic Equipment Failure During an Extended Outage

**T. Spickermann, LANL/LANSCE Accelerator
Operations Group**

WAO 2014

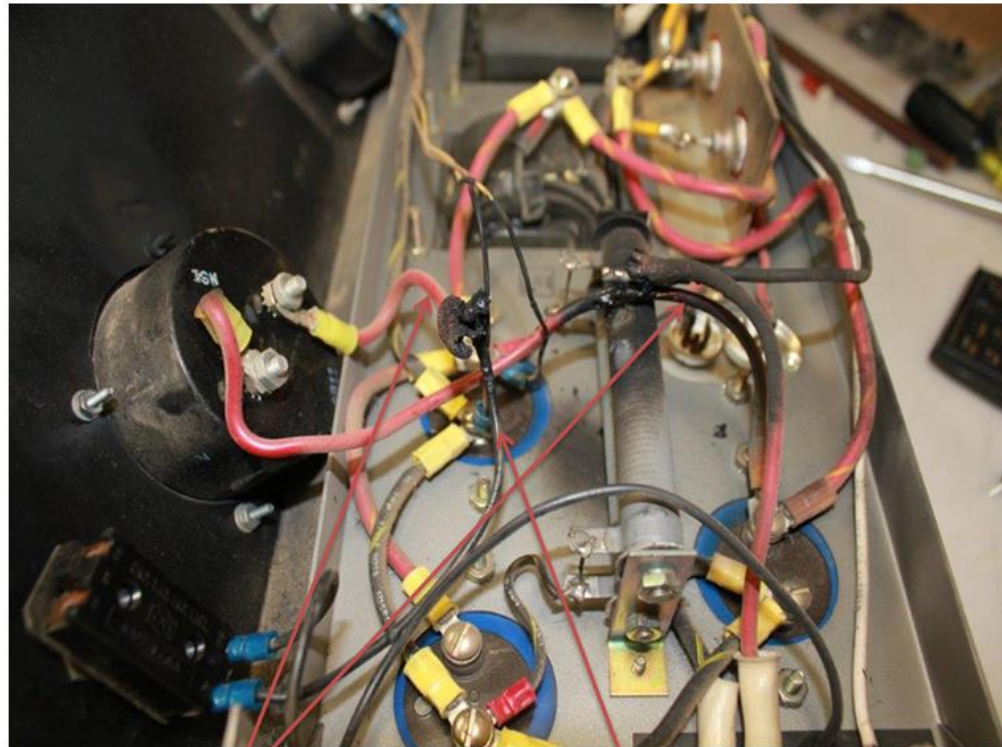
- One night, during the 2014 extended maintenance outage: In a “Sola” 24 V power supply, installed around 1970, 120 VAC conductor wires shorted to both positive and negative 24 VDC buses.

Melted Red Wires 24v DC

Melted Black Wire 120v AC

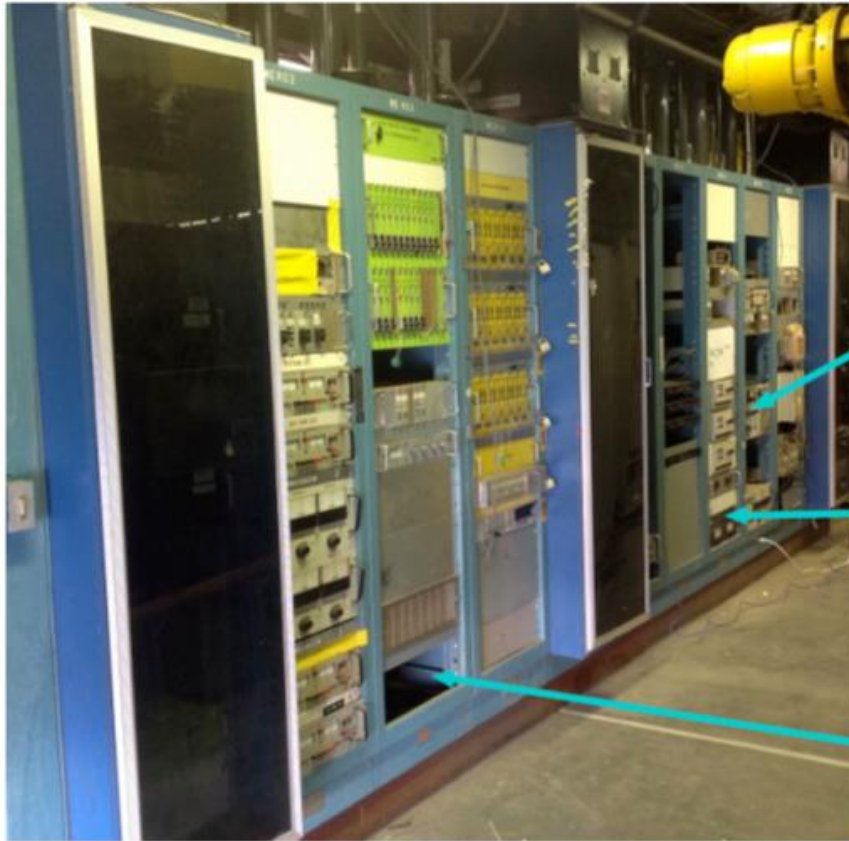
Configuration of Equipment Racks: WER01-WER11

- As a result, there were 0 V between the two DC buses, and 120 VAC on both buses w.r.t. rack ground.
- This power supply served one group of racks.
- Another group of racks was served by another, functional Sola supply.
- The negative 24 VDC buses for these two groups of racks were interconnected. This was done some time in the past, for reasons not entirely clear.
- One rack in the second group contained the Control & Monitor chassis and regulation NIM bin for Magnet Power Supply 1RMP01 (PS for magnet 1RBM01).

1RMP001 Power Supply
C&M Chassis and
Regulation NIM bin
in Rack WER09

Functional "Sola" 24VDC
Control Power Supply
in Rack WER08

Failed "Sola" 24VDC
Control Power Supply
in Rack WER03

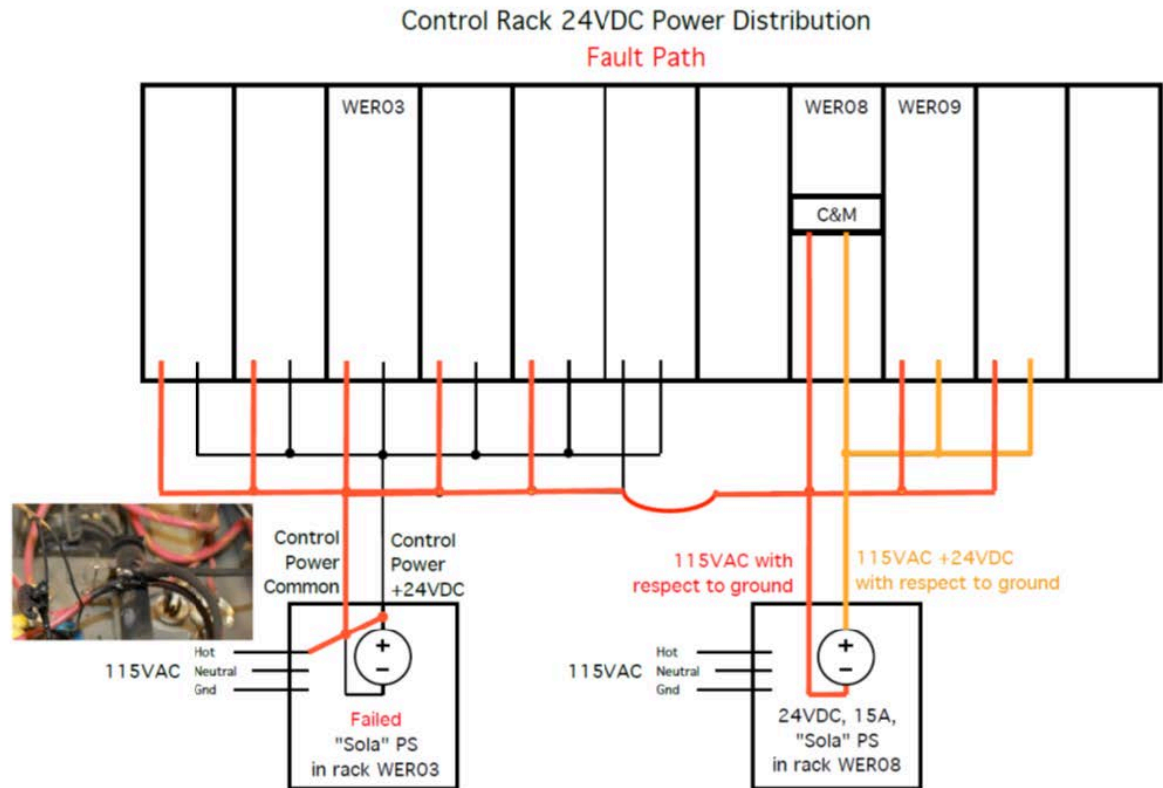
- DC buses are insulated, so no current flow to case or ground, but several components were exposed to potential difference greater than what they were designed for.

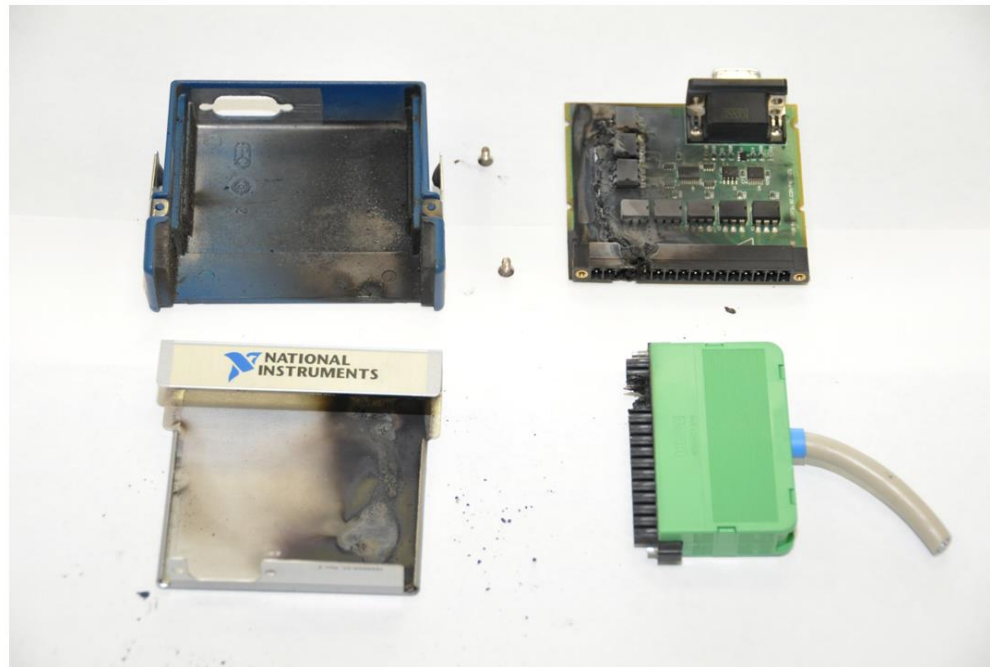
Photo of Damaged Computer I/O Module

- **Insulation in the computer I/O module for 1RMP01 failed, allowing current through a relay, bypassing interlocks and turning power supply on.**

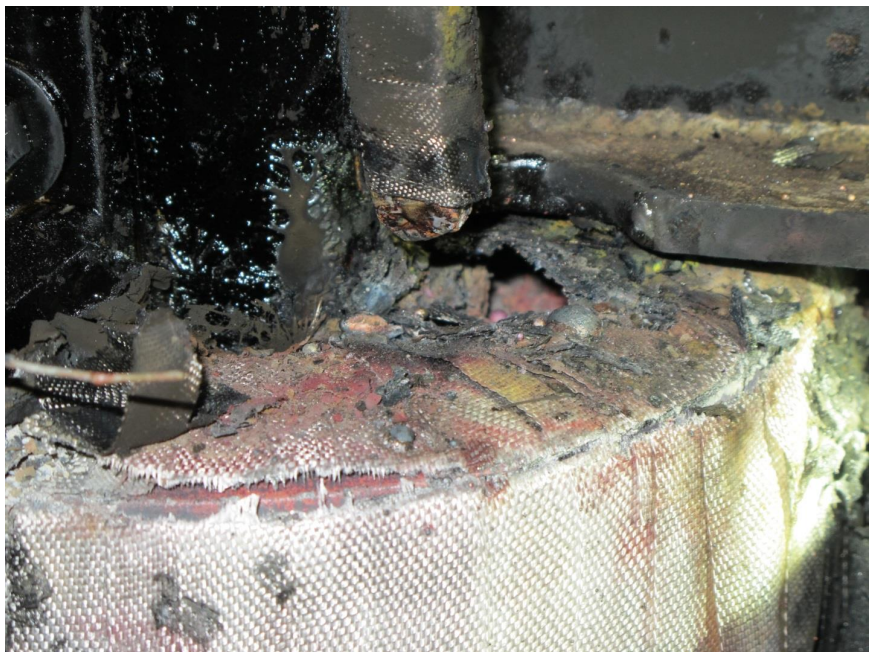
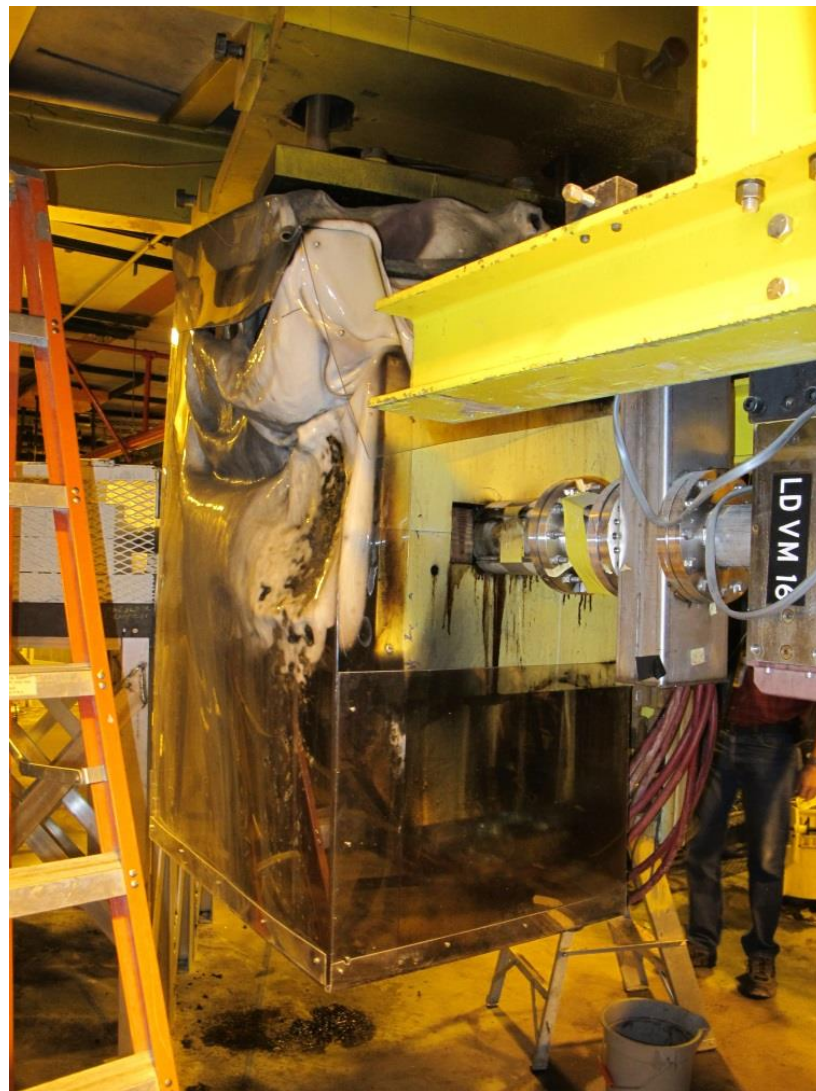
- When magnet power supply 1RMP01 came on (**breaker feeding supply was closed**), it ramped the current through 1RBM01 up to the **set point stored in the computer control system** (~1800 Amps).
- The **cooling water system** for this and other magnets in the beam line **had been off**, as is normal during extended outages.
- Coils overheated, melting insulation and Plexiglas enclosure and activated sprinkler head.
- Arcing caused localized temperatures in excess of 1000 °C, as evident from copper beads.

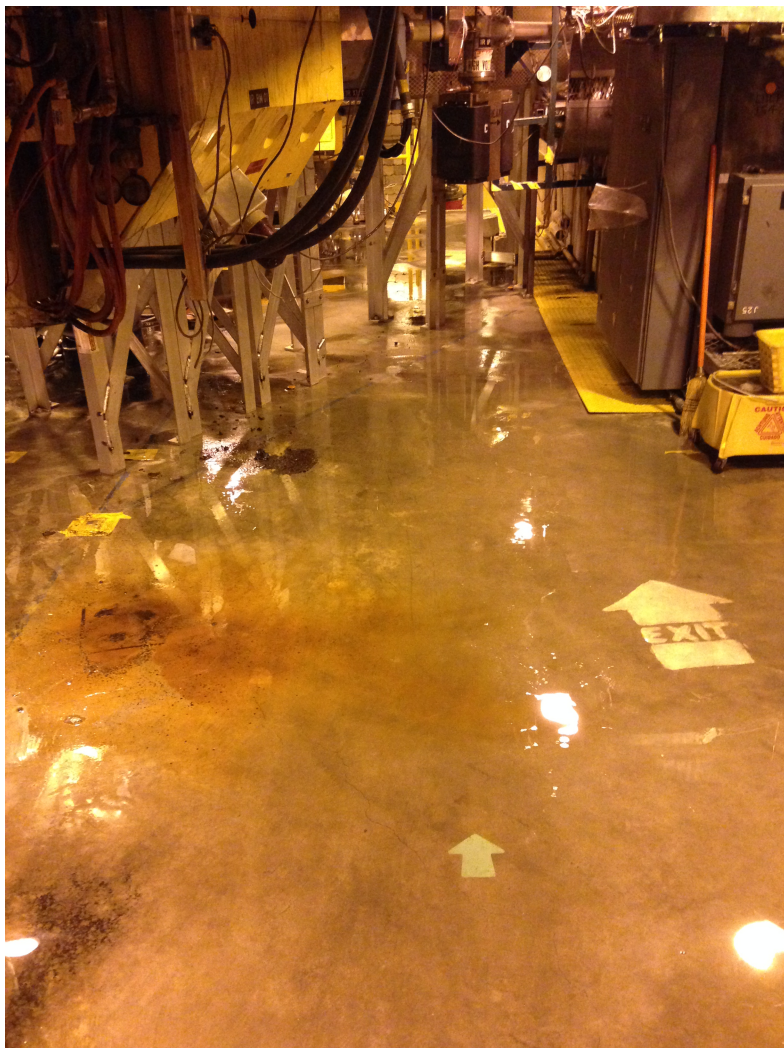
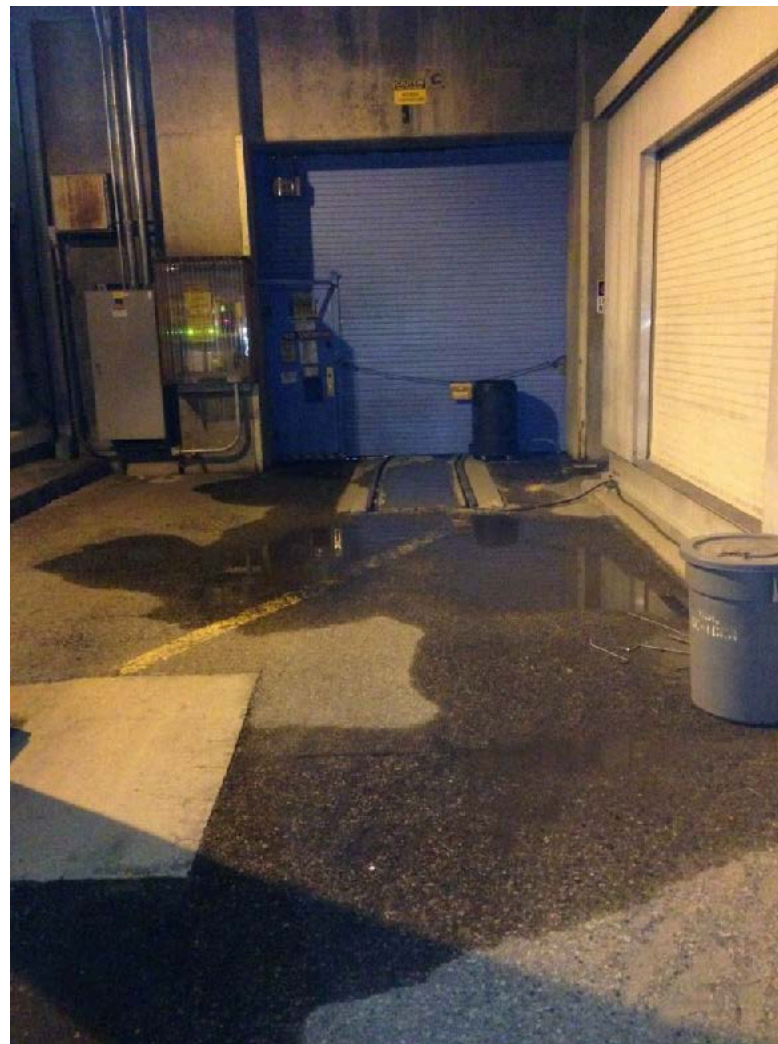
- Rising levels in Radioactive Liquid Waste (RLW) tanks caused LANSCE *Facility* personnel to isolate fire suppression water.
- By then more than 41,000 liters of water had been discharged by sprinkler system, leading to flooding of large area, requiring tremendous subsequent cleanup effort, and initially preventing safe access to the magnet.
- For a while it was thought that a failure of the sprinkler itself had caused the flooding.

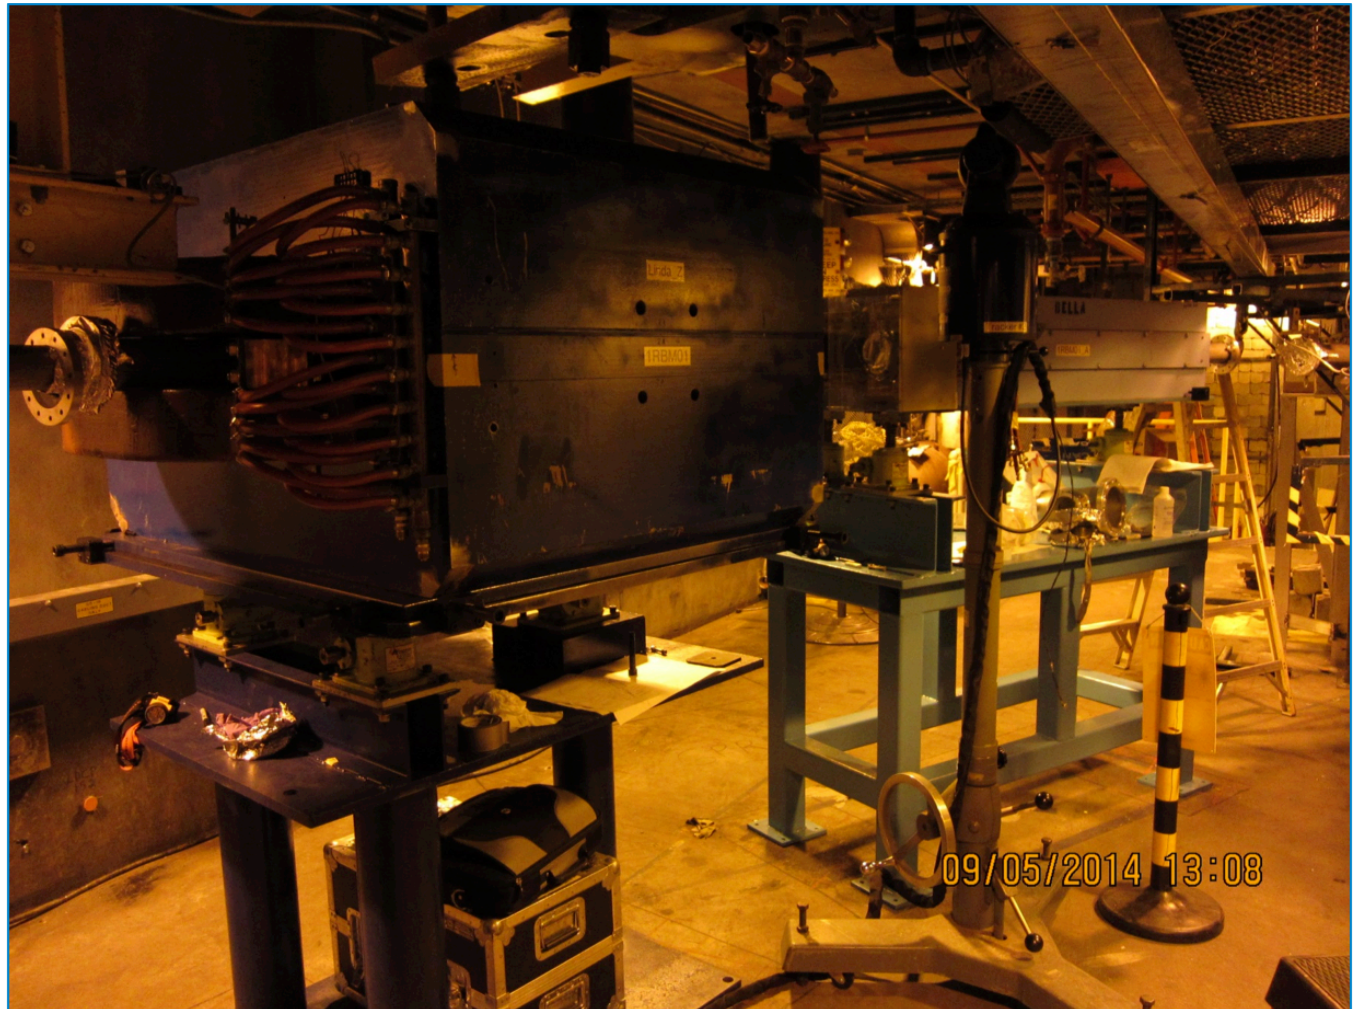
- Burnt magnet had to be replaced with two magnets:

- **This was a tremendous effort, requiring**
 - ❑ **Moving heavy magnets in and out of beam line**
 - ❑ **Moving other equipment around (quads, diagnostics, etc.)**
 - ❑ **Un-stacking and restacking shielding**
 - ❑ **Revising cooling water, controls, interlocks, etc.**
 - ❑ **Re-aligning, re-tuning, revising procedures, etc.**
- **Another Lesson Learned: Keep track of your (Legacy-) spare equipment, unless you're really, really sure you won't ever need it again!**
