# Update on MCP-PMT investigations

Klaus Föhl

PID session - PANDA meeting at GSI

6 March 2018

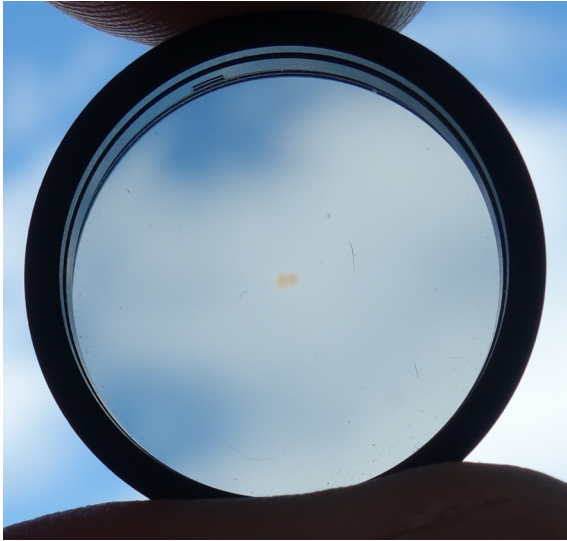
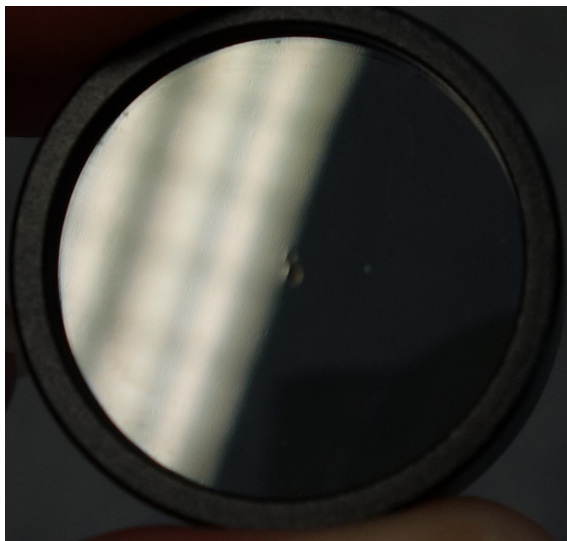
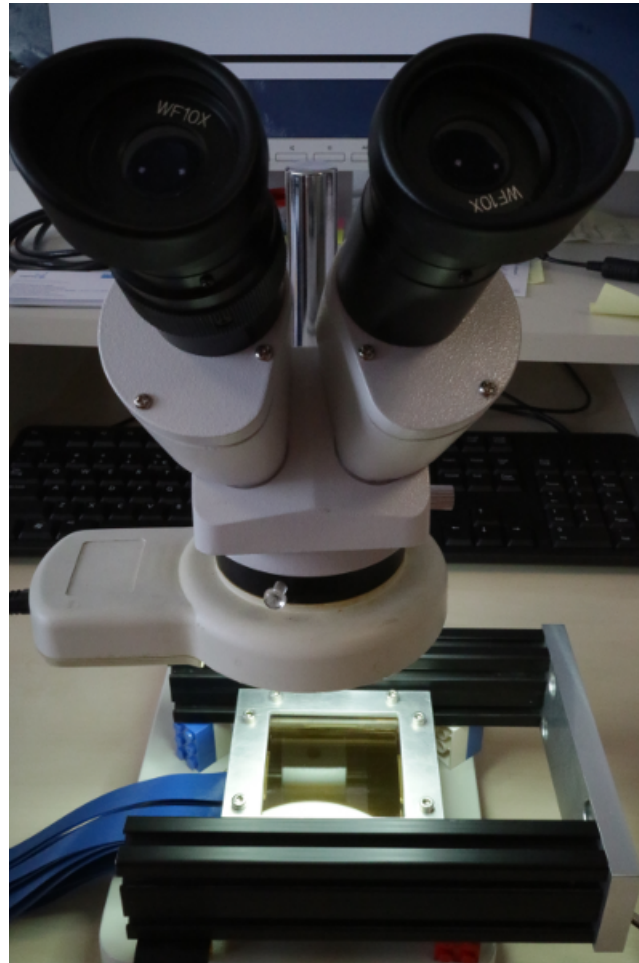
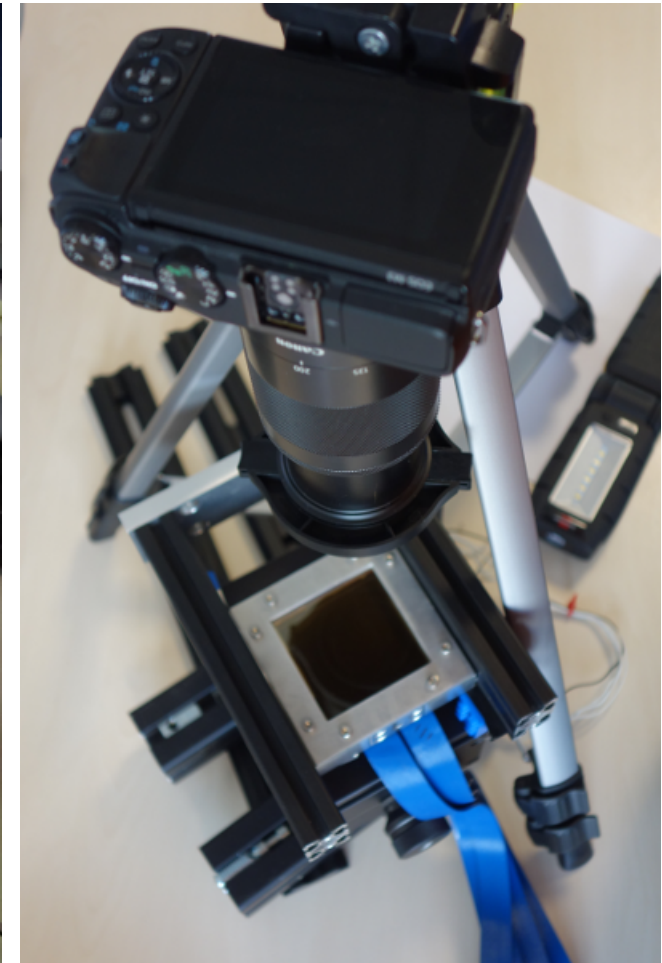
# Excess power of few mW – localised deposition?

~5 mW extra power – deposited into the sensor, unfortunately not only into the resistors

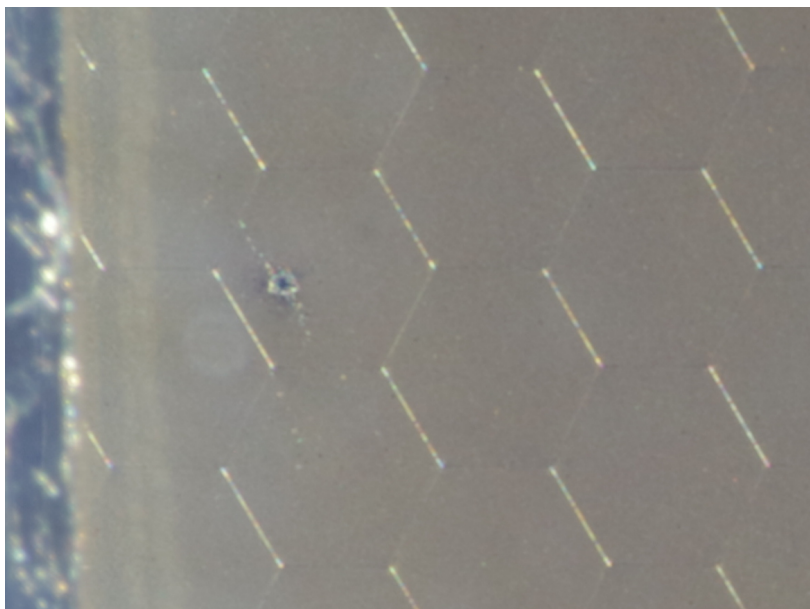
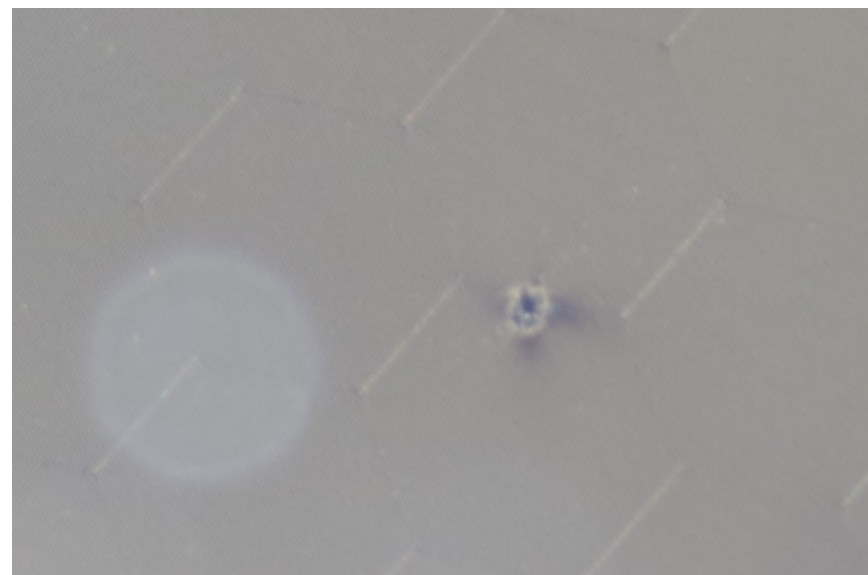
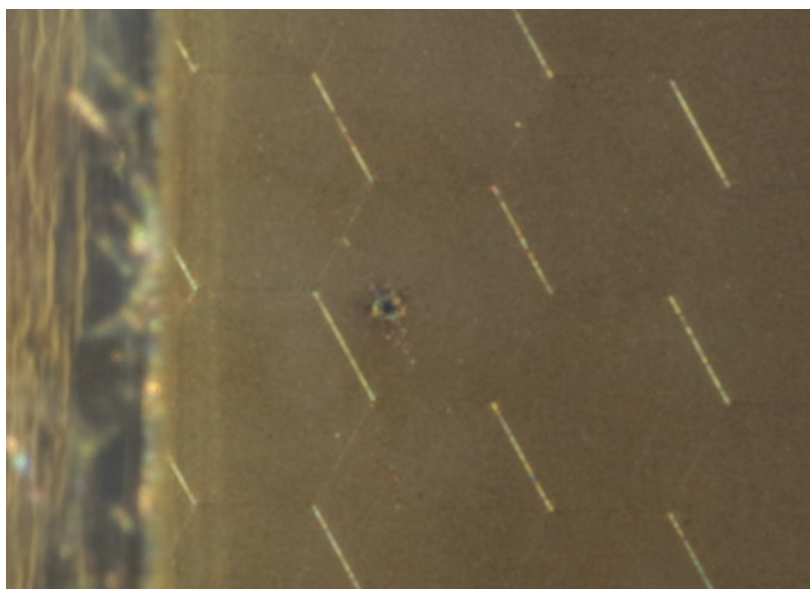
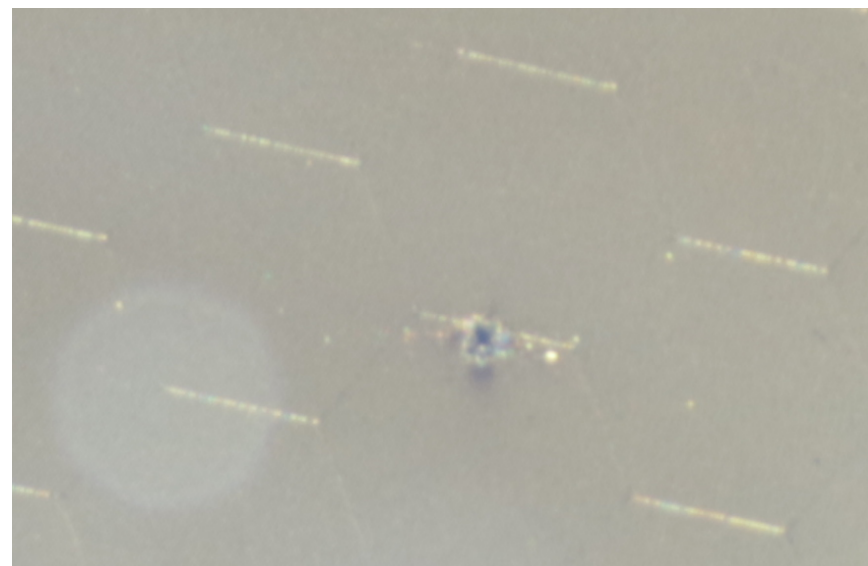
# Two surface damages on 1<sup>st</sup> MCP front

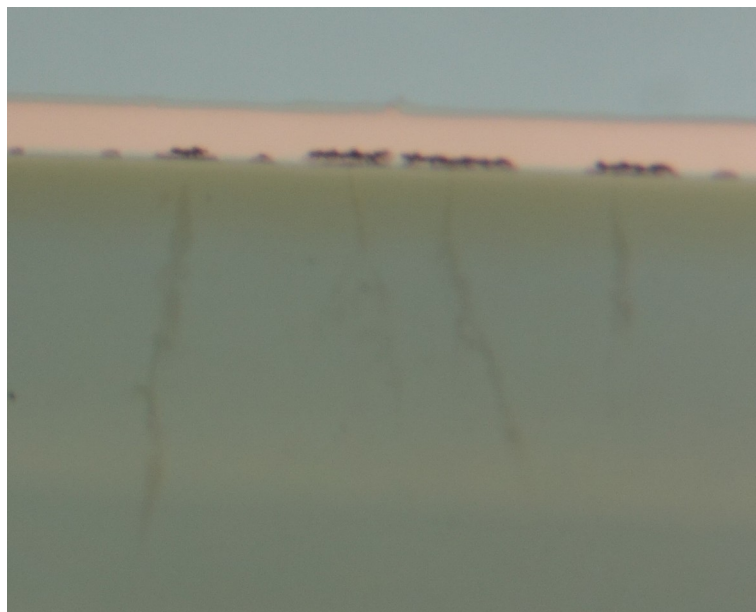
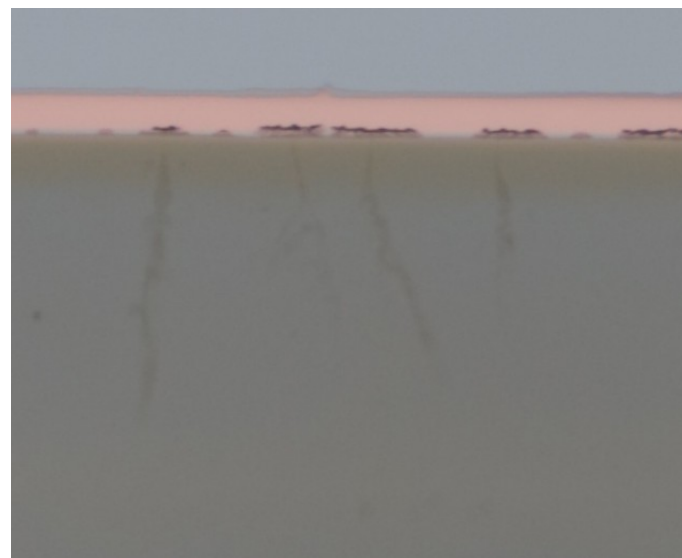
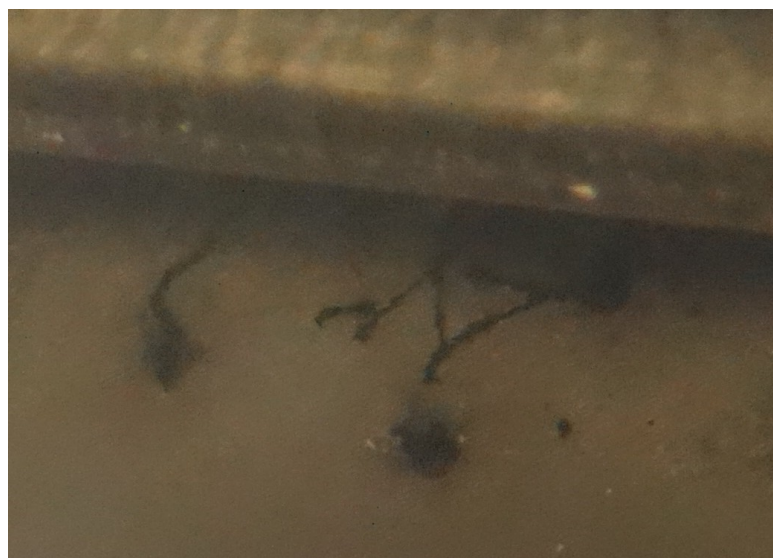
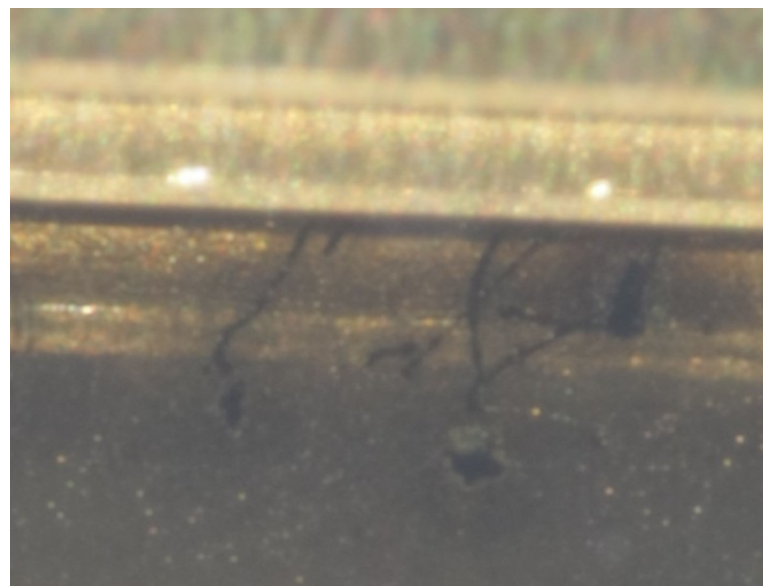
# Filaments in photocathode and 1<sup>st</sup> MCP front

- White granular cover on 1<sup>st</sup> MCP front
  - one big grain casting a shadow
- Patch ~ 5x3 mm<sup>2</sup>
  - thickness fractions of  $\mu\text{m}$
  - dielectric layer – presumed metal, source unknown
  - black filaments on 1<sup>st</sup> MCP leading to rim
  - matching filaments on photo cathode
- Some minor black mark in corner
