# Radioactive Material Leak at the Hadron Experimental Facility of J-PARC

Tadashi Koseki and Fujio Naito for J-PARC Accelerator group  
Accelerator Laboratory, KEK & J-PARC Center (KEK&JAEA)

**ABSTRACT:**  
In J-PARC, a radioactive material leak accident occurred at the Hadron Experimental Facility (HD facility) on May 23, 2013. The accident was triggered by a malfunction of the slow extraction system of the Main Ring synchrotron (MR). A beam of  $2 \times 10^{13}$  protons was extracted within a very short time of 5 ms and delivered to the gold target in the HD facility, whereas normally a total of  $3 \times 10^{13}$  protons were extracted for 2 s. The gold target was instantaneously heated up to an extraordinarily high temperature due to the short-pulse beam and partially damaged. As a result, the radioactive material dispersed from the gold target and leaked into the primary beamline room, because the target container was not hermetically sealed. Since airtightness of the primary beamline room was not sufficient, the radioactive material leaked into the hadron experimental hall (HD hall) and workers were exposed to radiation. Additionally, due to operation of ventilation fan

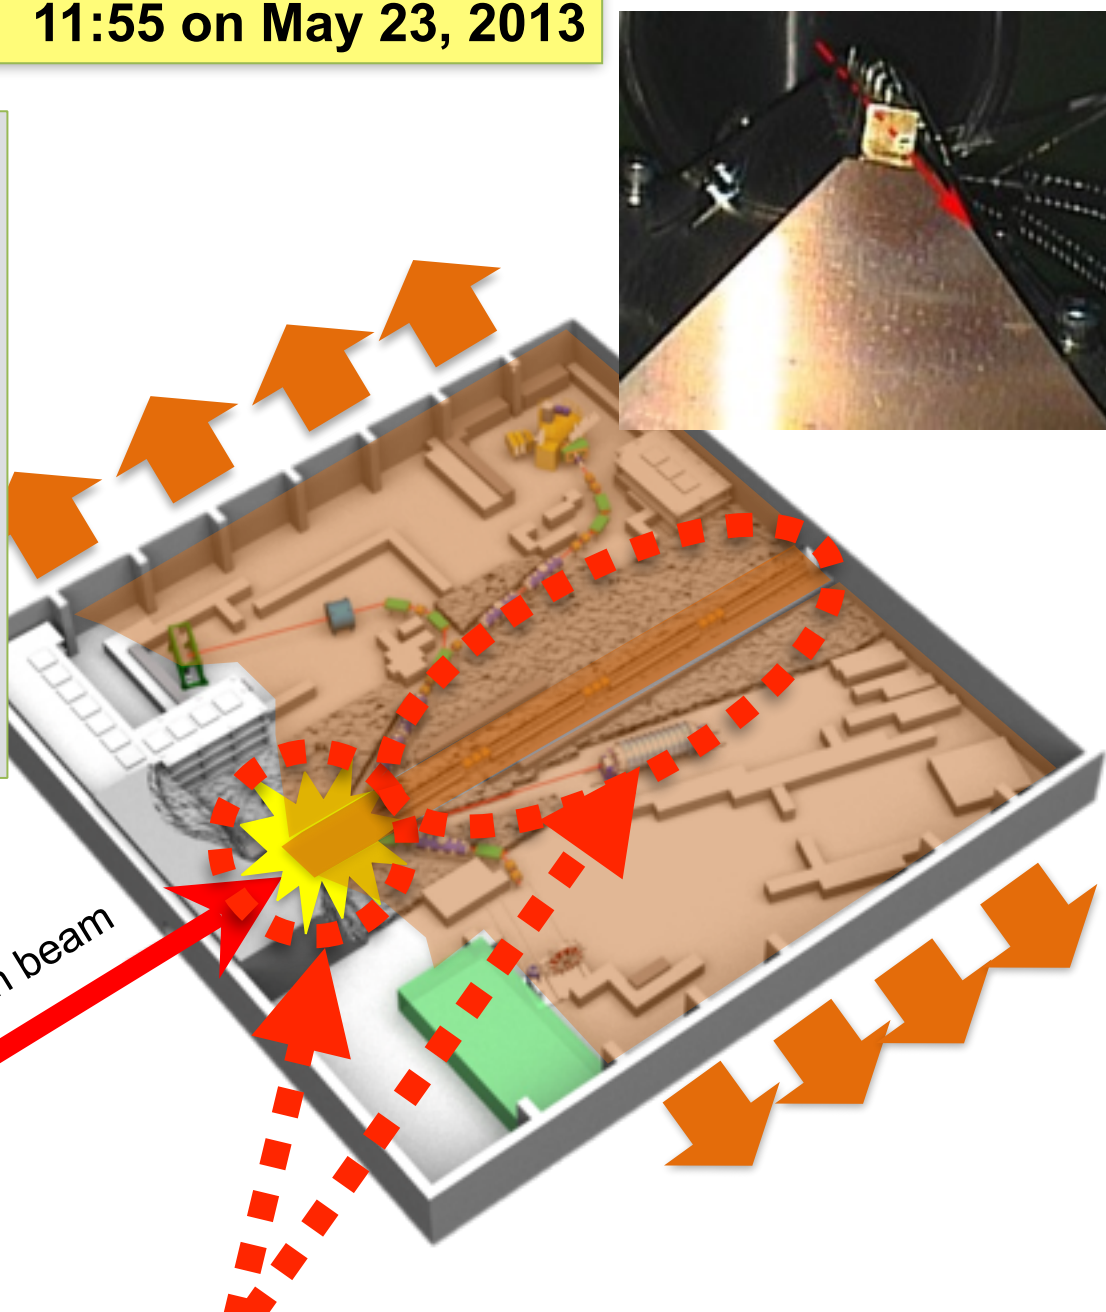
1. A short-pulse beam to the target accidentally
2. Heating of the target to melting
3. Release of radioactive material from the target.
4. Leak of the radioactive material into the HD hall, because the target container did not have air-tightness.
5. Release of the radioactive material into the environment outside of the controlled area, because ventilation fans in the HD hall was operated.

Target chamber & the beam-line had no air-tightness
