Lessons learned from building and testing

24% of ALICE-TRDs and 50% of ALICE-OROCs

**Mariana Petris for Hadron Physics Department (HPD) team
National Institute for Physics and Nuclear Engineering (IFIN-HH),
Bucharest, Romania**

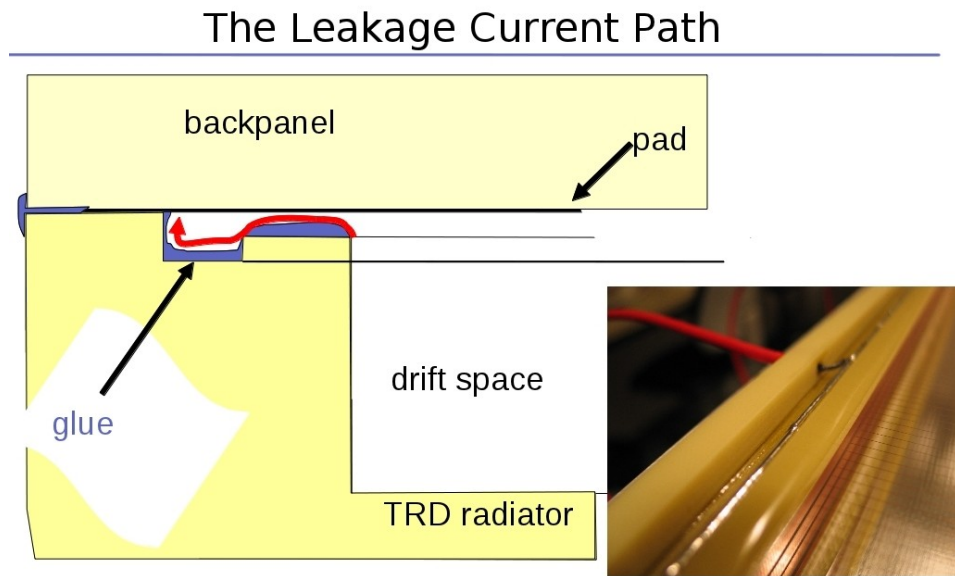
More Glue issues?

- Recent dark current problems at Bucharest:
 - μA dark currents at 1300-1500 V in 2 chambers
 - Disappeared after some time.

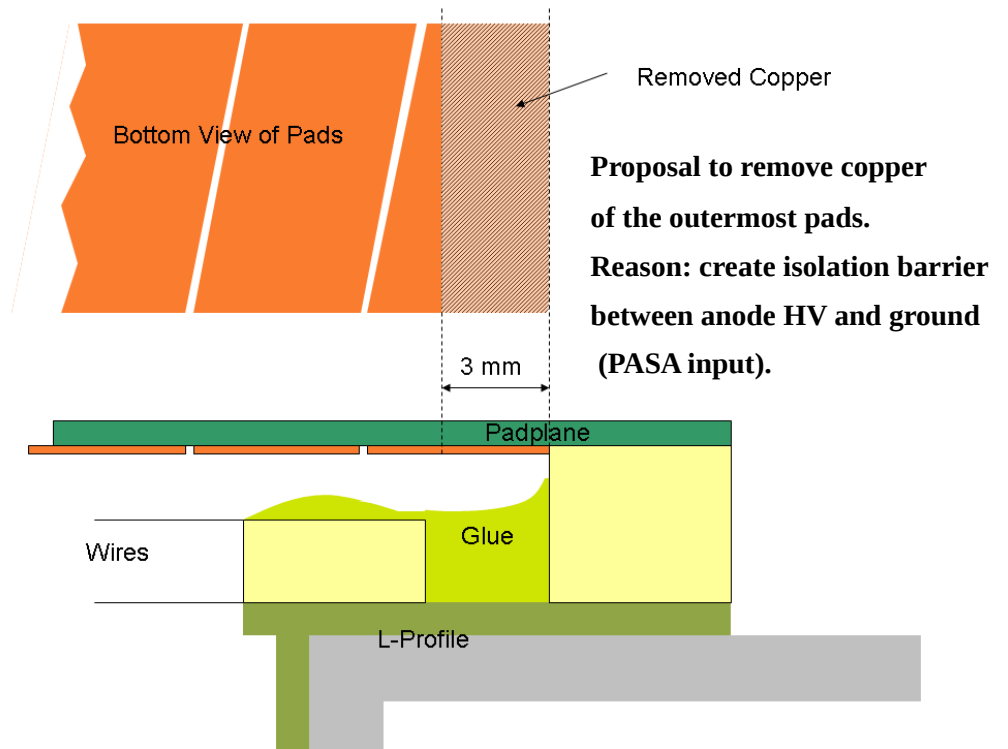
Leakage current appeared after final gluing;
They were localized to pads that touch the frame;
“Sticky” surface of the glue.

The resin and hardener were bought with quality certificate (mechanical and electrical properties)

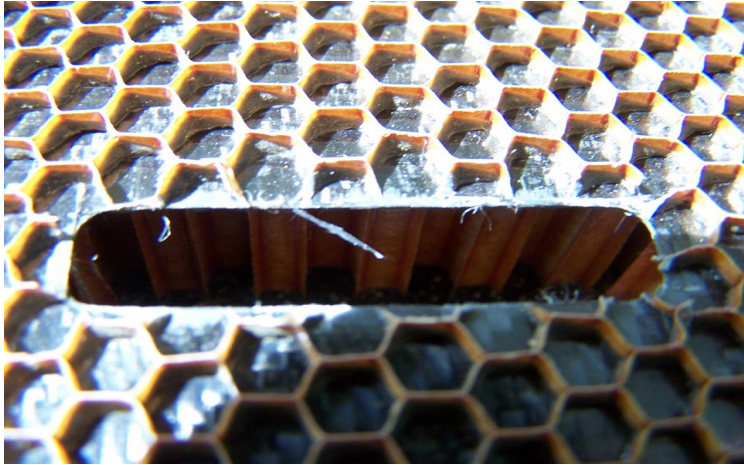
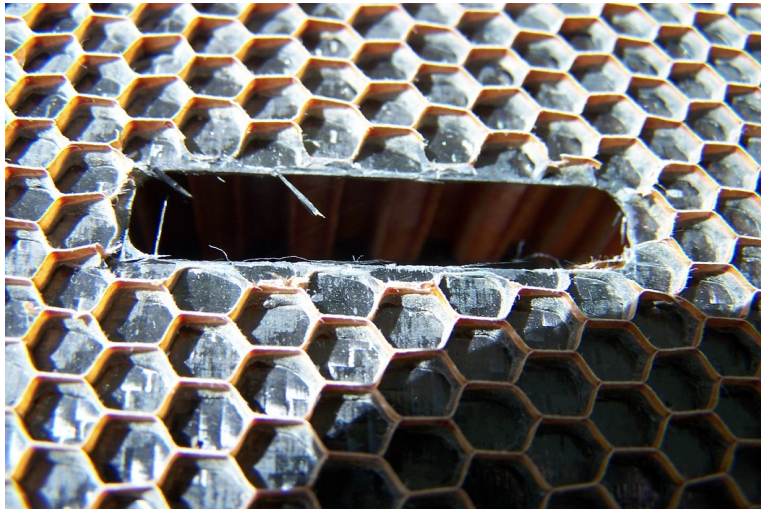
'Grounded Pads'

Cut-out of the back panel with fibers

- 3 Pad panels in Bucharest:
1 pad is connected to carbon of panel-> connected to PASA ground.
- 2 cases of connected pads discovered (only checked in Bucharest).
