Operation Experience with SNS RFQs

Sang-ho Kim, SNS/ORNL On behalf of the SNS team

Presented at: 'High Intensity RFQ meets Reality' Workshop Heidelberg, Germany

April 15-16, 2019

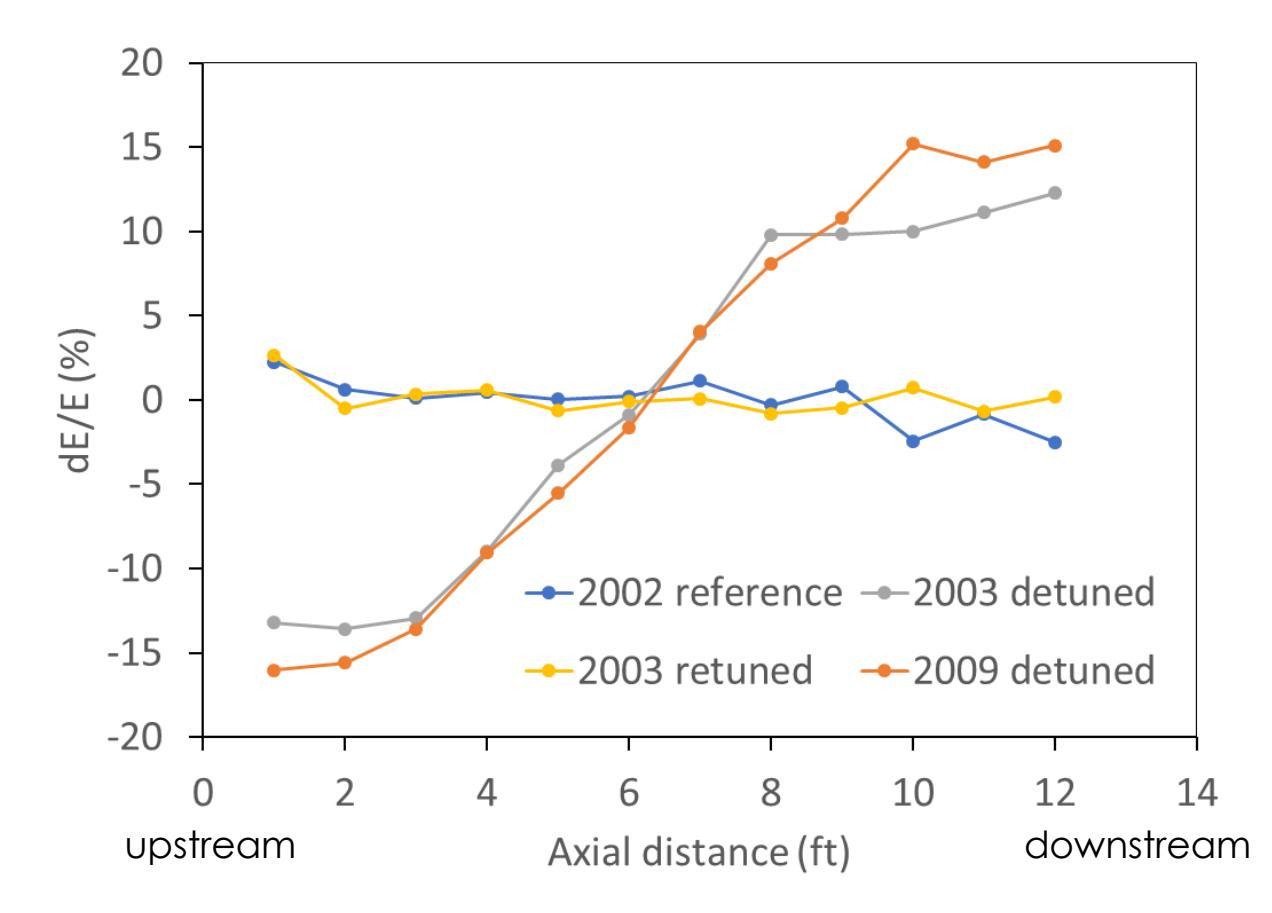
Issue (1) with the original SNS RFQ – Sudden detuning

- First detuning event in 2003
 - About -450 kHz detuning
 - Suspect Glidcop/OFC brazing joint but inconclusive
 - Happened when cooling water system control was down
 - Retuned and back to service
- Second detuning event in 2009
 - About -230 kHz detuning

- Suspect Glidcop/OFC brazing joint but inconclusive
 - Happened when cooling channel was over-pressurized by accident
- Retuned and back to service

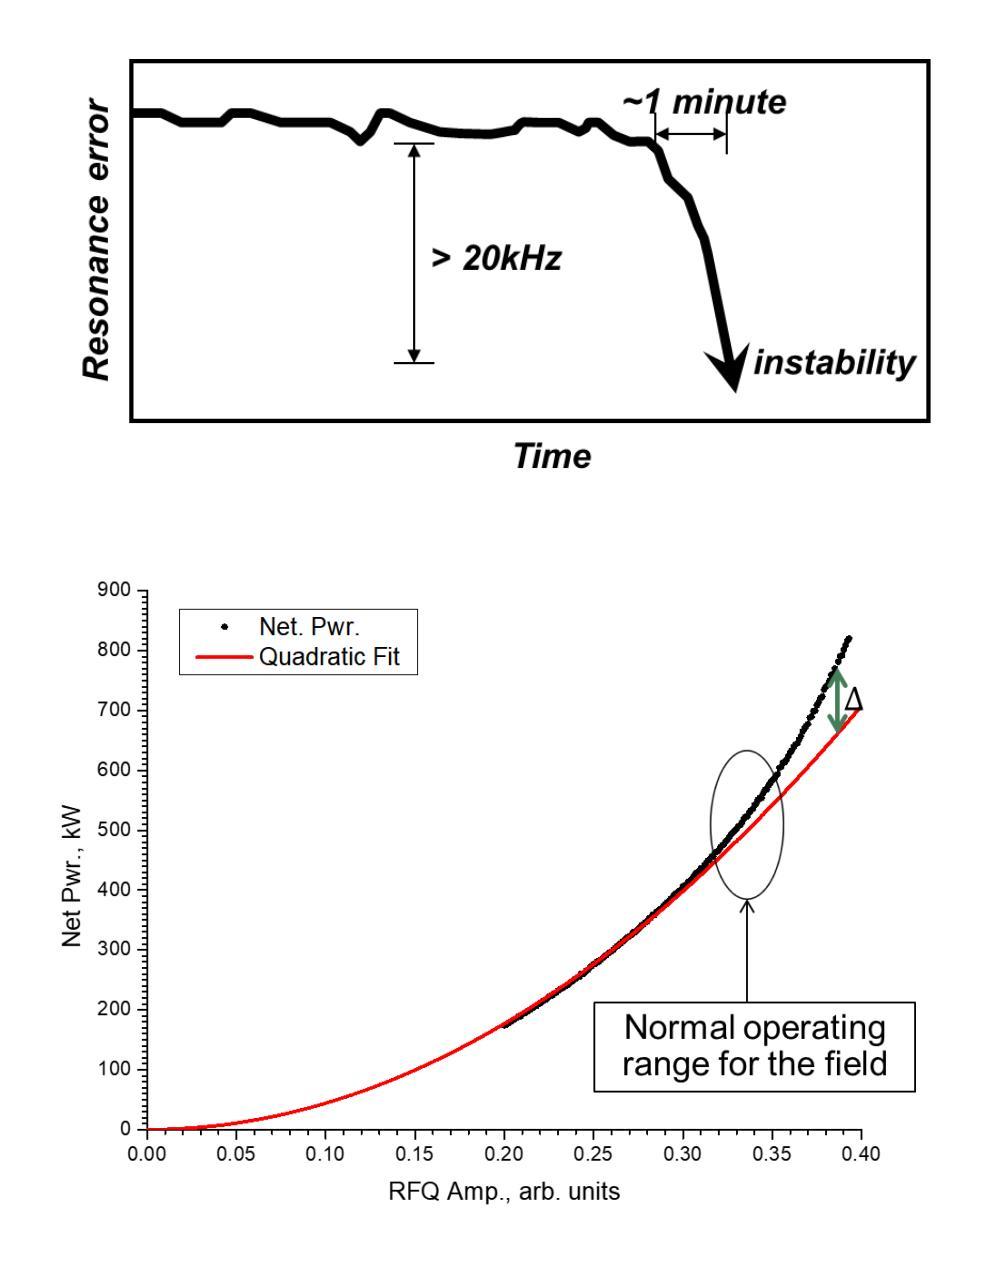
Issue (2) with the original SNS RFQ – Operational instability

- Difficult to keep RFQ in closed-loop as we increased duty factor (2009)
- Findings
 - Changes in net RF power while running at constant setpoints (field setpoint, cooling, etc.)
 - Net RF power=Forward pwr reflected pwr
 - Non-quadratic relation between net RF power and RFQ field amplitude
 - Correlation with Ion source/beam
- The root cause is not fully understood
 - Additional load (discharge somewhere in the structure?)

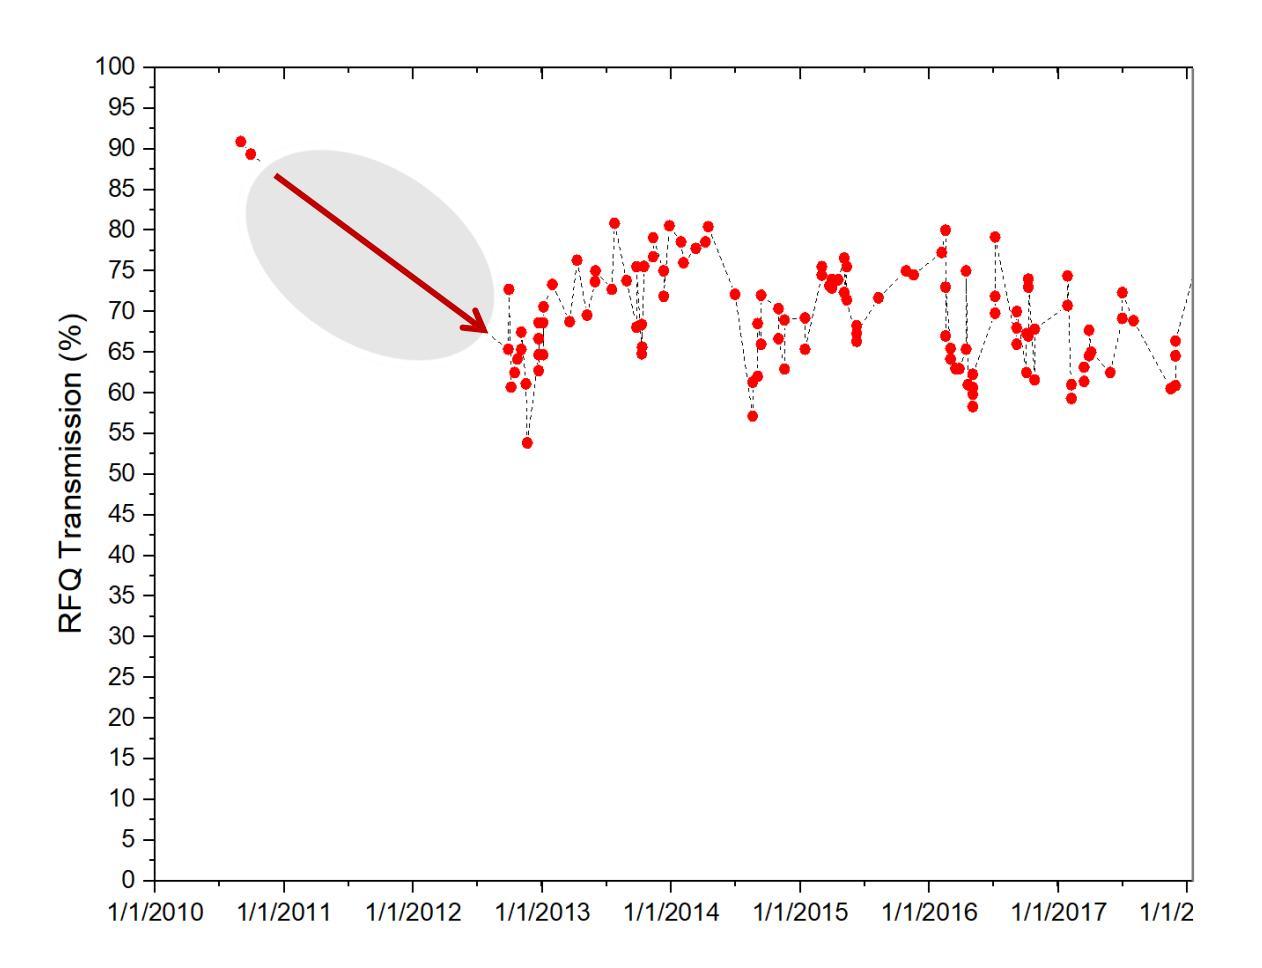
Issue (3) with the original SNS RFQ – Beam transmission

- Gradual field profile changes
 - Happened over 2 years
 - Gradual (?) reduction of beam transmission by 20-30%
- No significant detuning
- Measured field flatness in 2013: -15/+5% (upstream/downstream)
 - Retuned in 2013

- But beam transmission did not recover. Root cause unknown
 - Retuning is only for overall field balancing
 - If damages are around vanes, irreversible

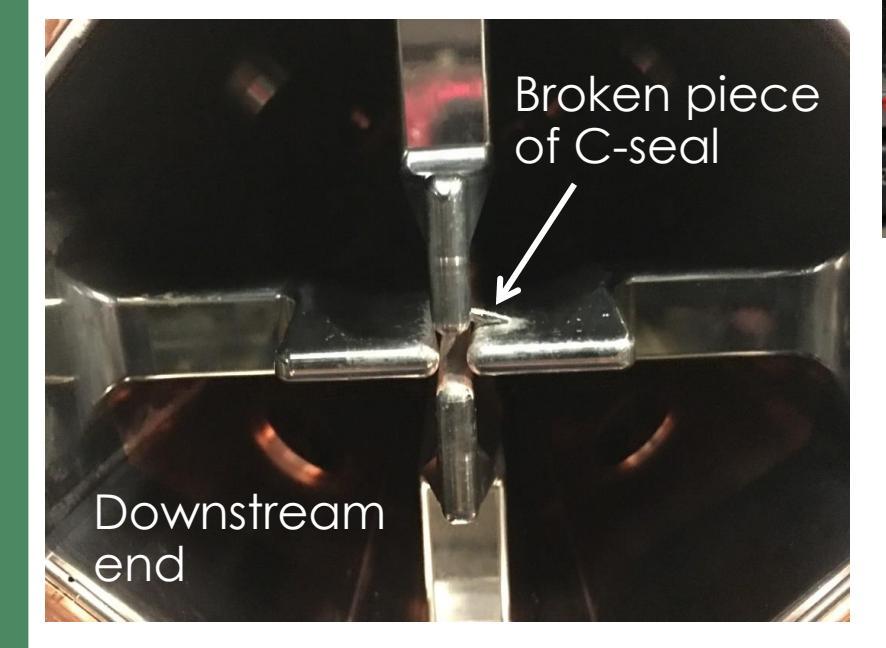
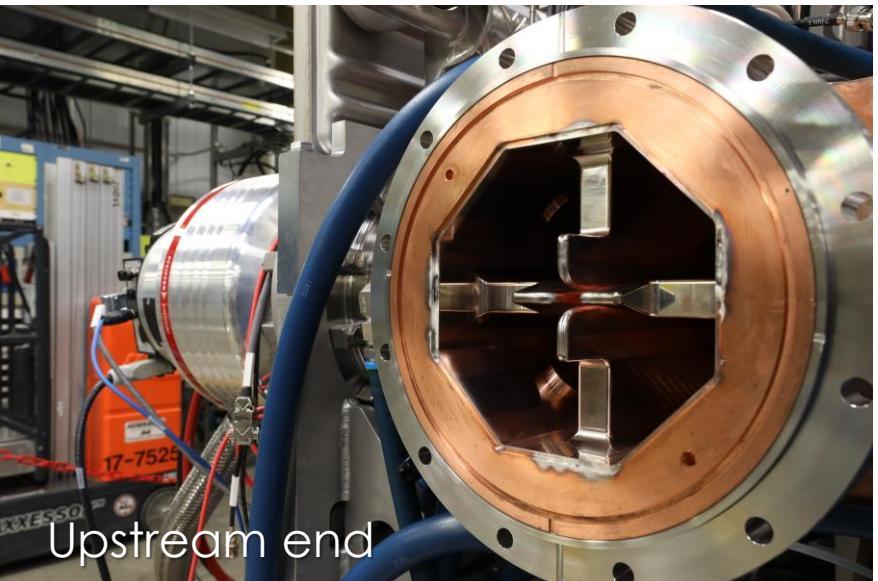
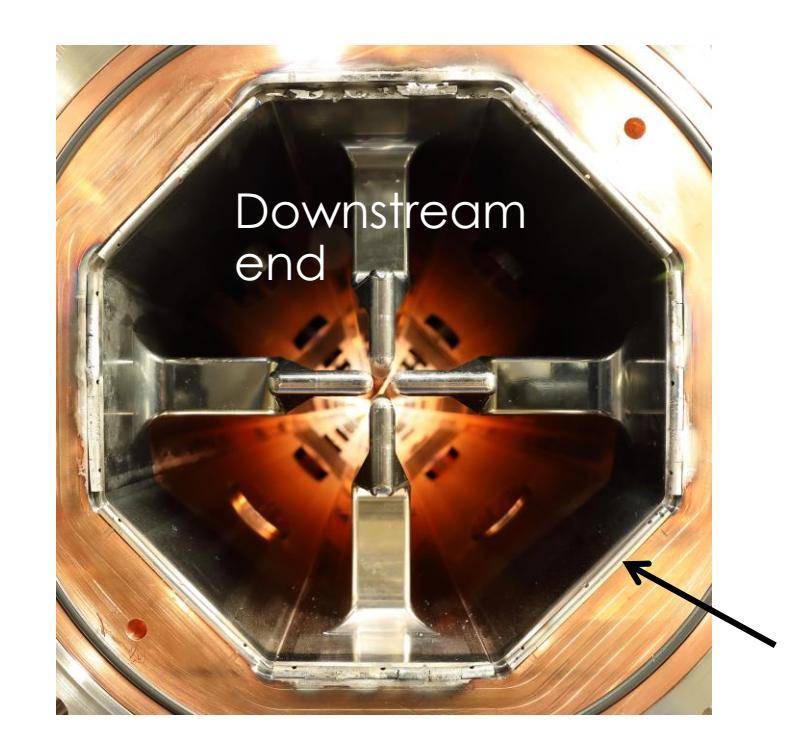
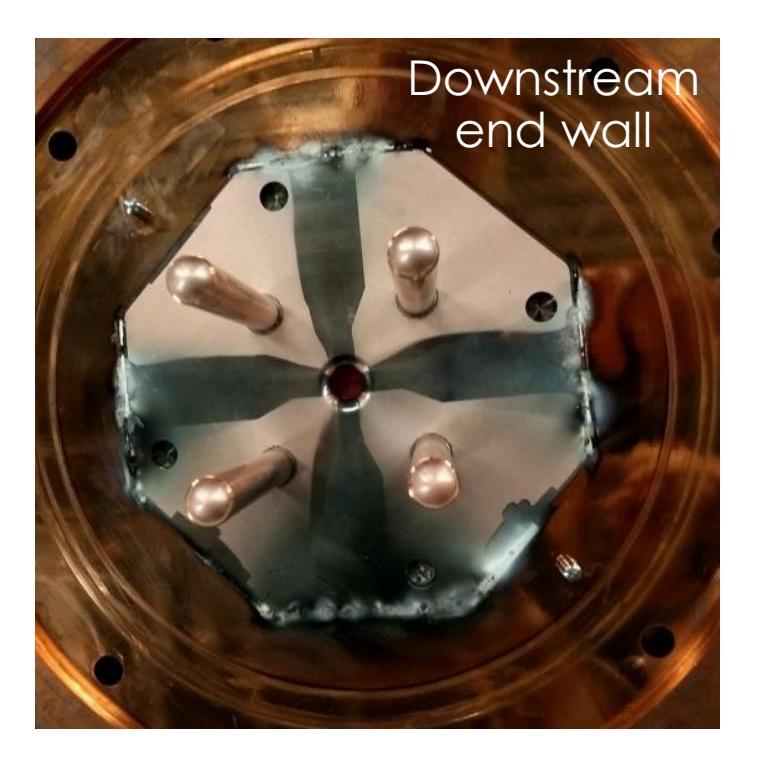
Damages

Issue with the new SNS RFQ – RF seal (C-seal)

- RFQ tripped and required investigating
 - Happened at the end of the first period of FY19 machine run (Nov. 2018)
 - The new SNS RFQ had been operated at high power and high duty factor (>5%) for 4900 hours until this trip
- Findings
 - No quadrupole mode near the operating frequency, 402.5 MHz
 - A broken piece of the C-seal shorten two vanes at the downstream side
 - Damage of C-seal at both ends (more severe damage at the down stream side)

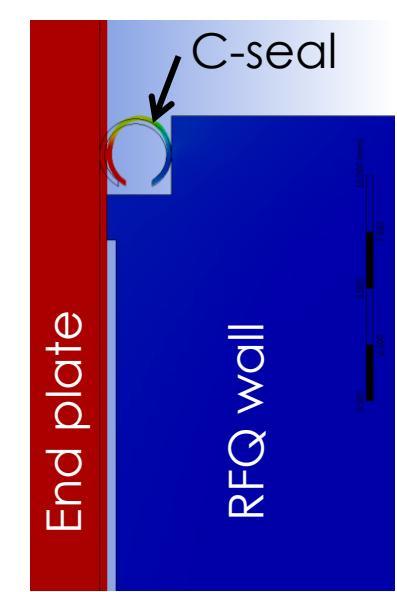
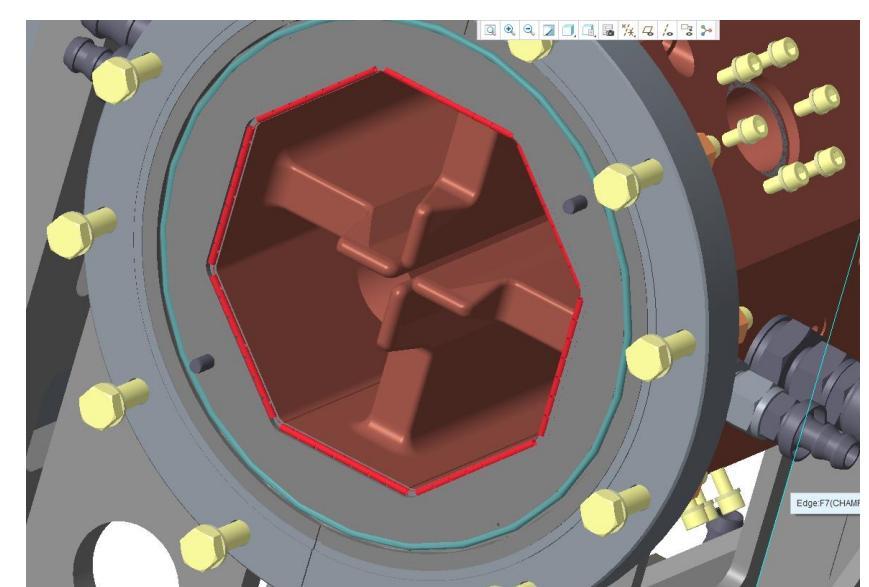
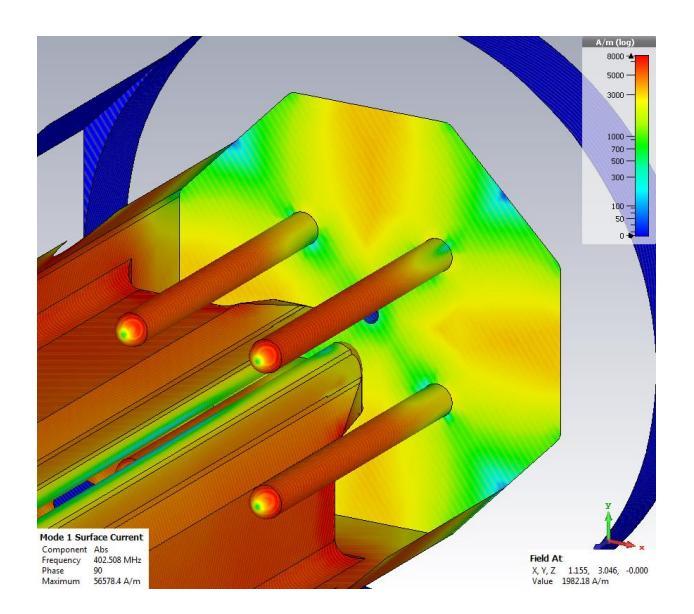
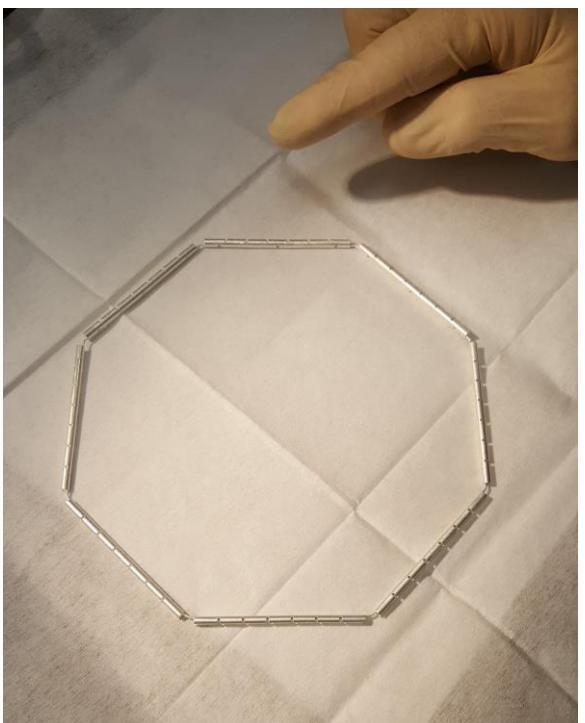
C-seal failure

- Pure thermal load from surface RF field can not explain the RF seal failure
 - Total RF power loss on C-seal < 0.2 W (silver, copper)
- Investigation is ongoing for root cause
 - Bad contact?
 - Discharge? Multipacting?

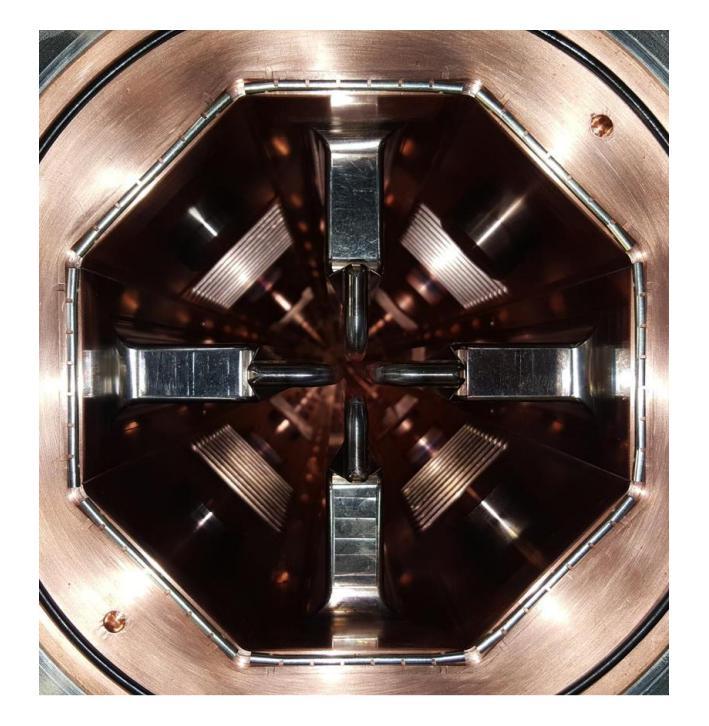
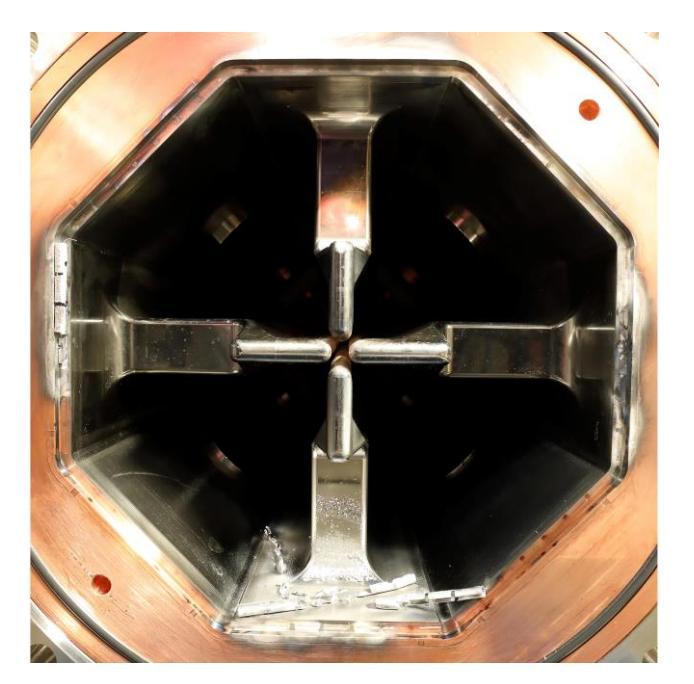
- No fundamental fix yet
 - Removed the broken C-seal piece
 - Cleaned damaged areas
 - Chemical cleaning for Ag and mild mechanical polishing
- RFQ back to service in Jan. 2019 and supported 1.4-MW operation for 2.5 months until planned machine outage
- Opened both ends of RFQ for inspection and repair
 - Severe damages of C-seal at the downstream end

Temporary repair and back to operation
