# Aging studies and resulting design change considerations for MRPC2

Tsinghua University

**CBM-TOF Design Change Reveiw**

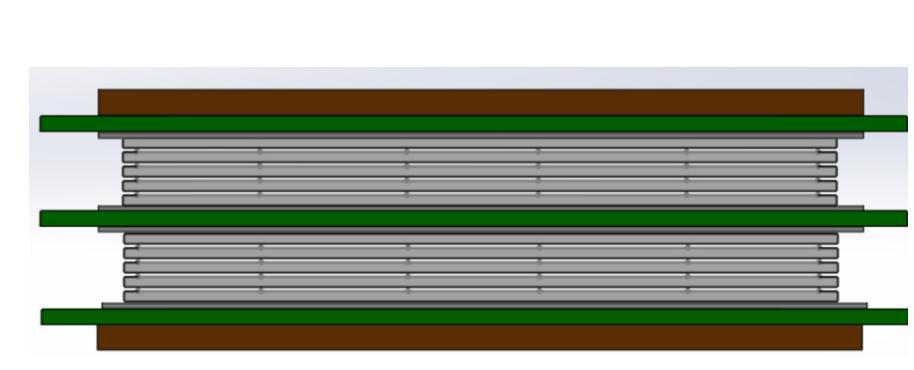
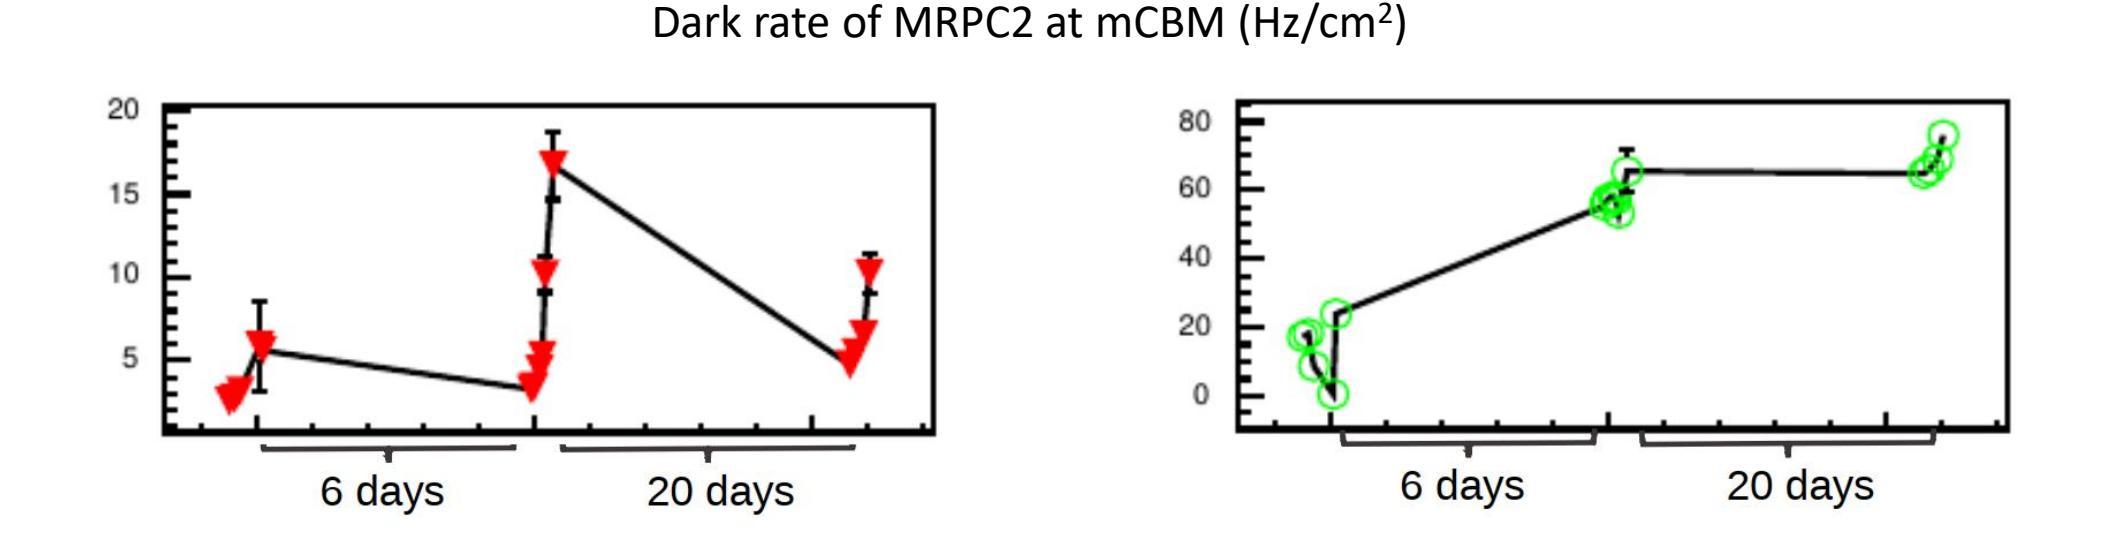
Potential radiation response: increased dark rate(off-spill) compared to cosmic tests(~ 1Hz/cm<sub>2</sub>). Big difference among counters.

$\rightarrow$ Insights into aging effects: gas pollution, glass aging.

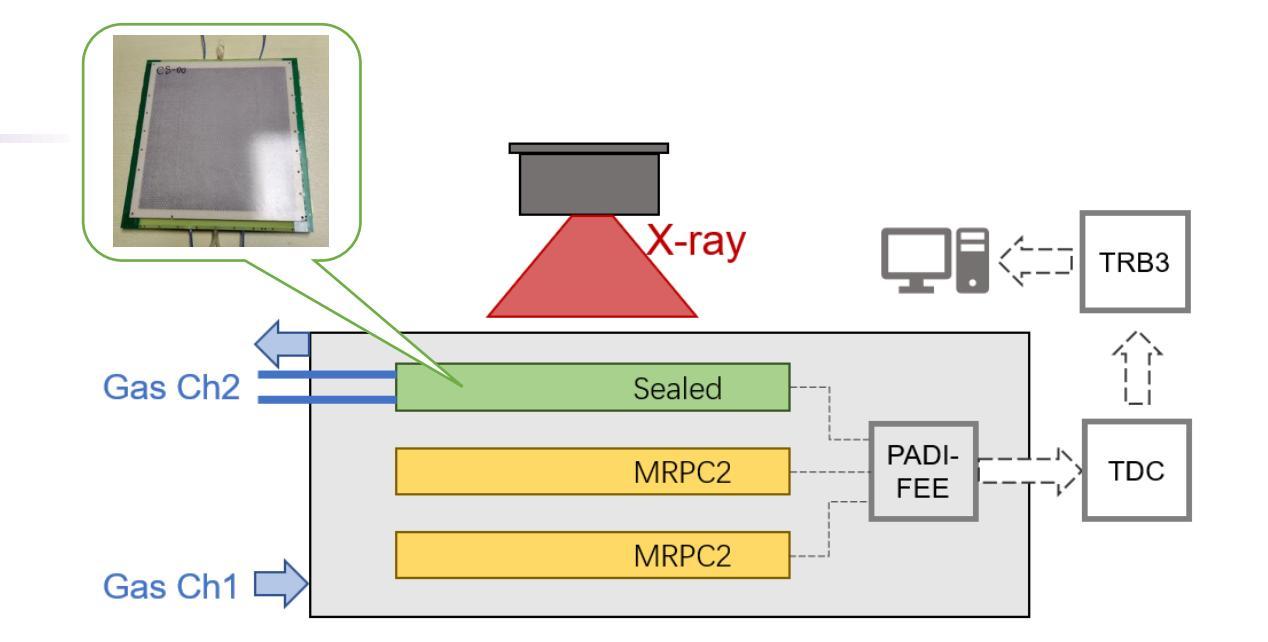
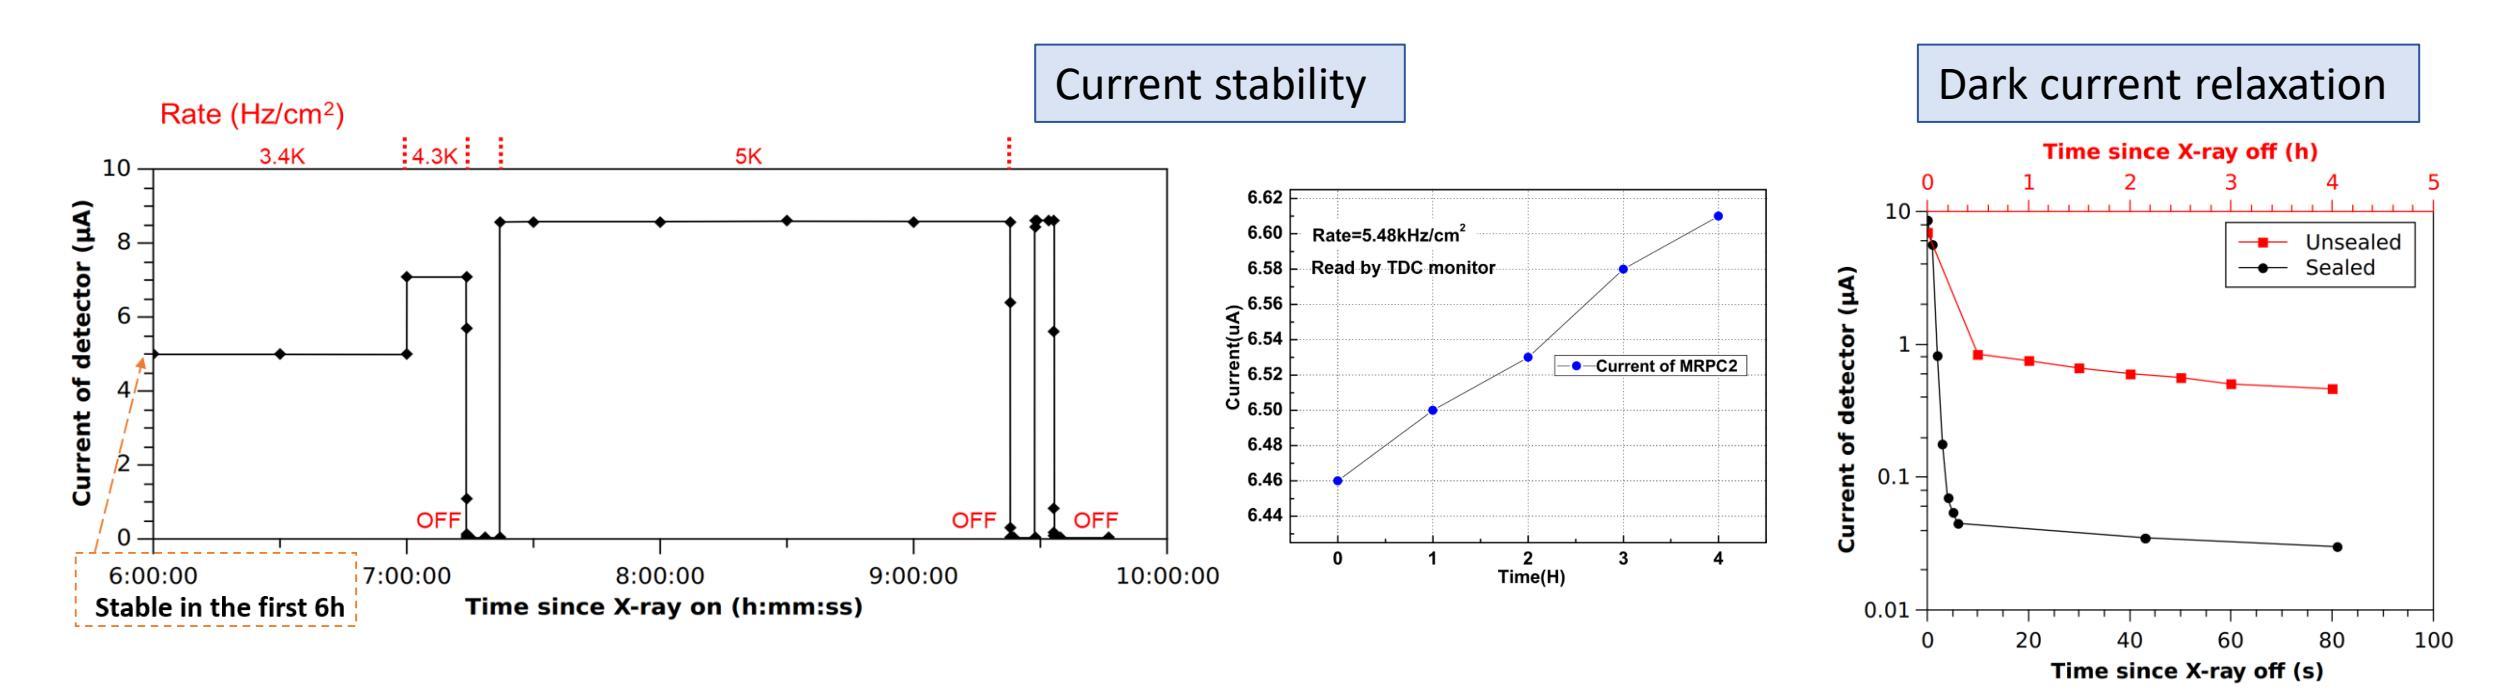
X-ray test finds the gas pollution effect:

- Current rise in constant flux rate
- Slow exchange of pollutant.

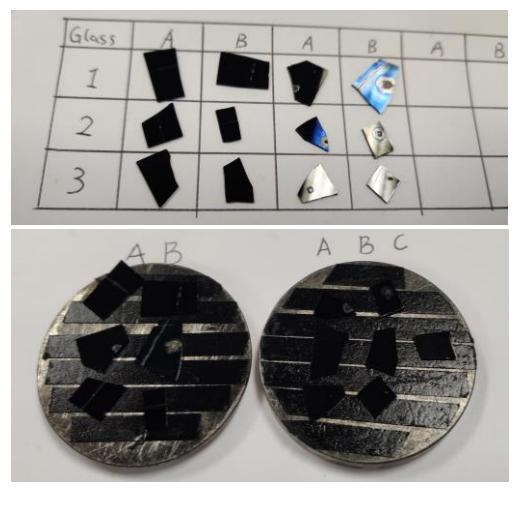
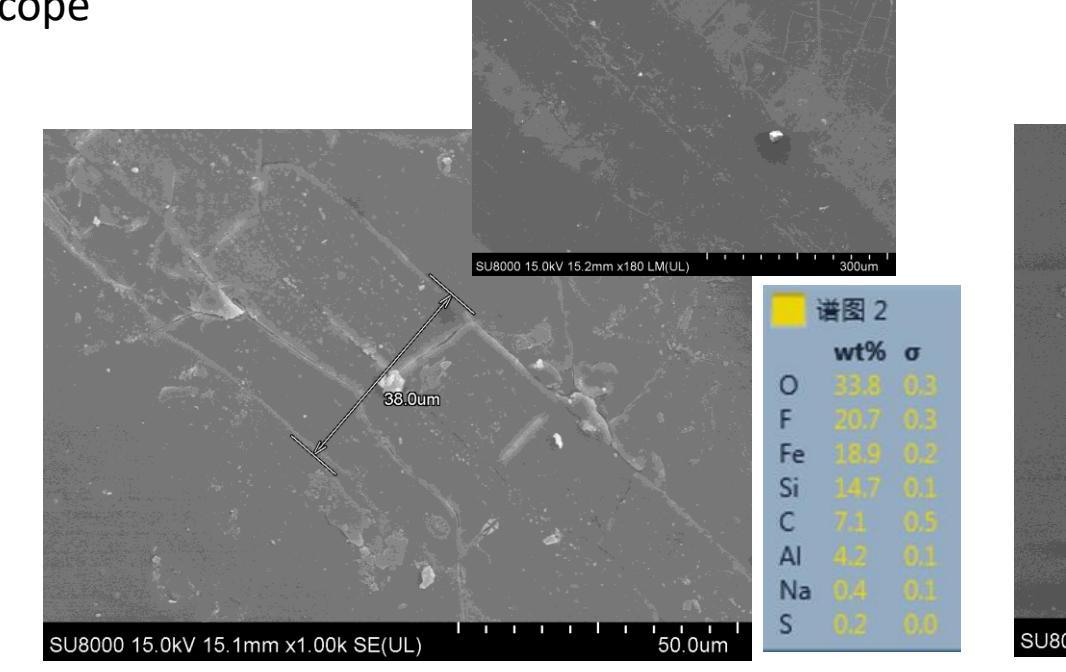
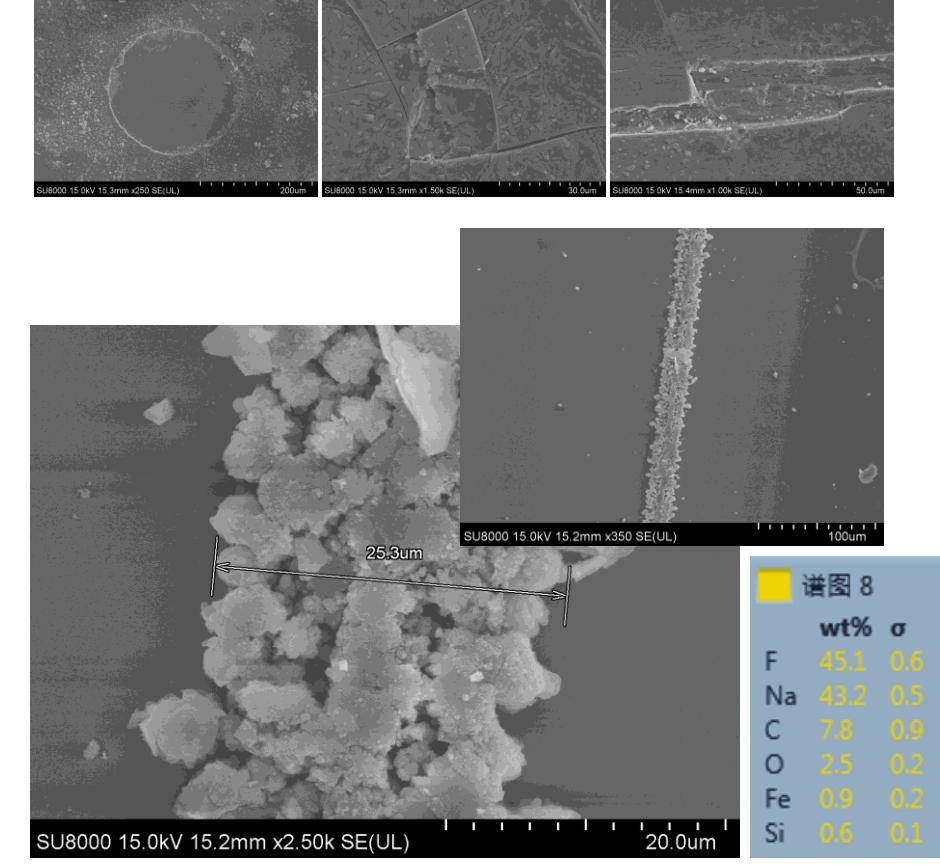
A comparison of fishline region at anode (left) and cathode (right) side.

Damage of glass —— crack along the fishline, at sparking spots. The reason why those visible structures cannot be removed.

Na —— positive ion, move under electric field, concentrate at fishline

F - - found at both sides. High fraction at damaged zones.

Dark current must be controlled in MRPC operation to mitigate the aging effect.

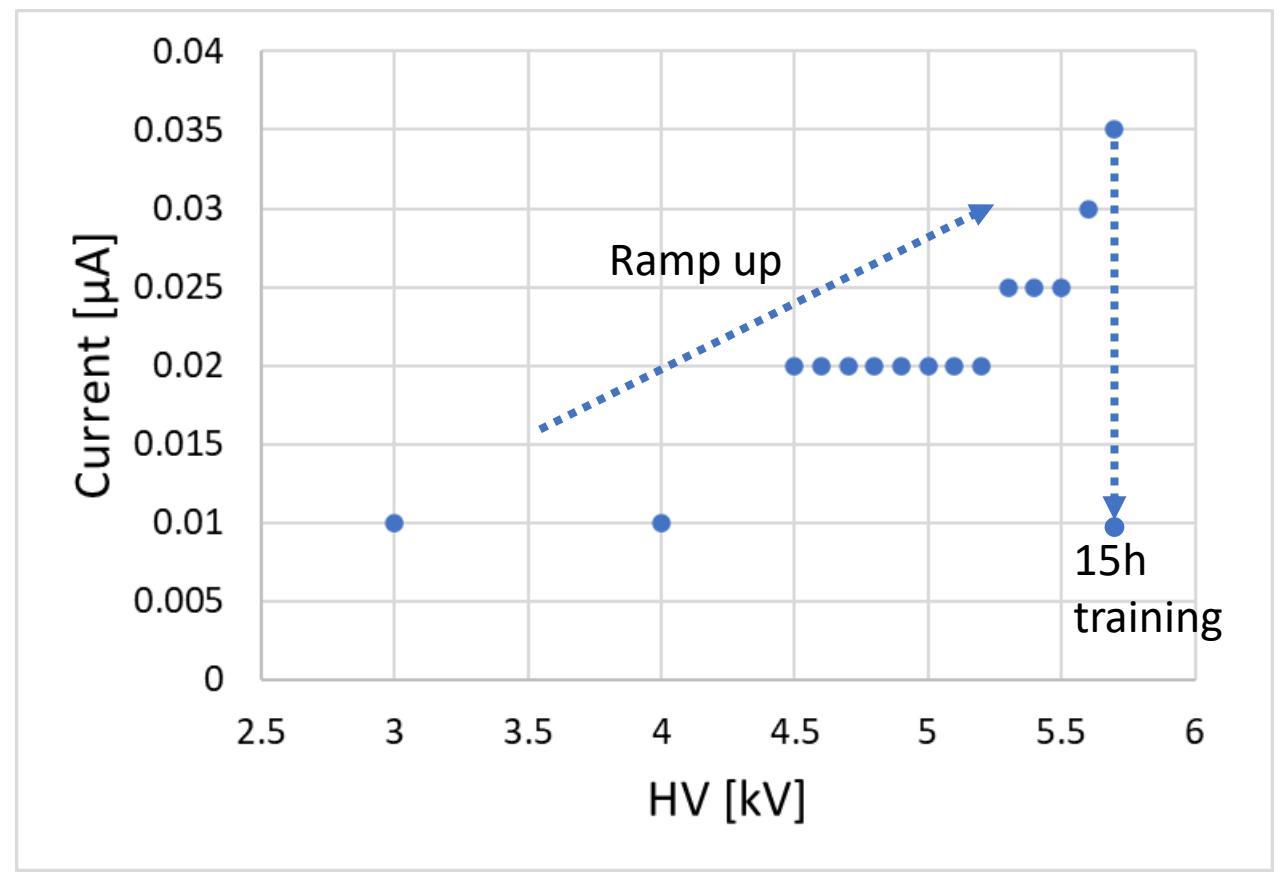
Reasonable dark current. Dark current relaxes slowly.
