Gluing Tests for the PANDA Endcap Disc DIRC

PANDA CM 18/1 | PID Cherenkov

2017/03/06

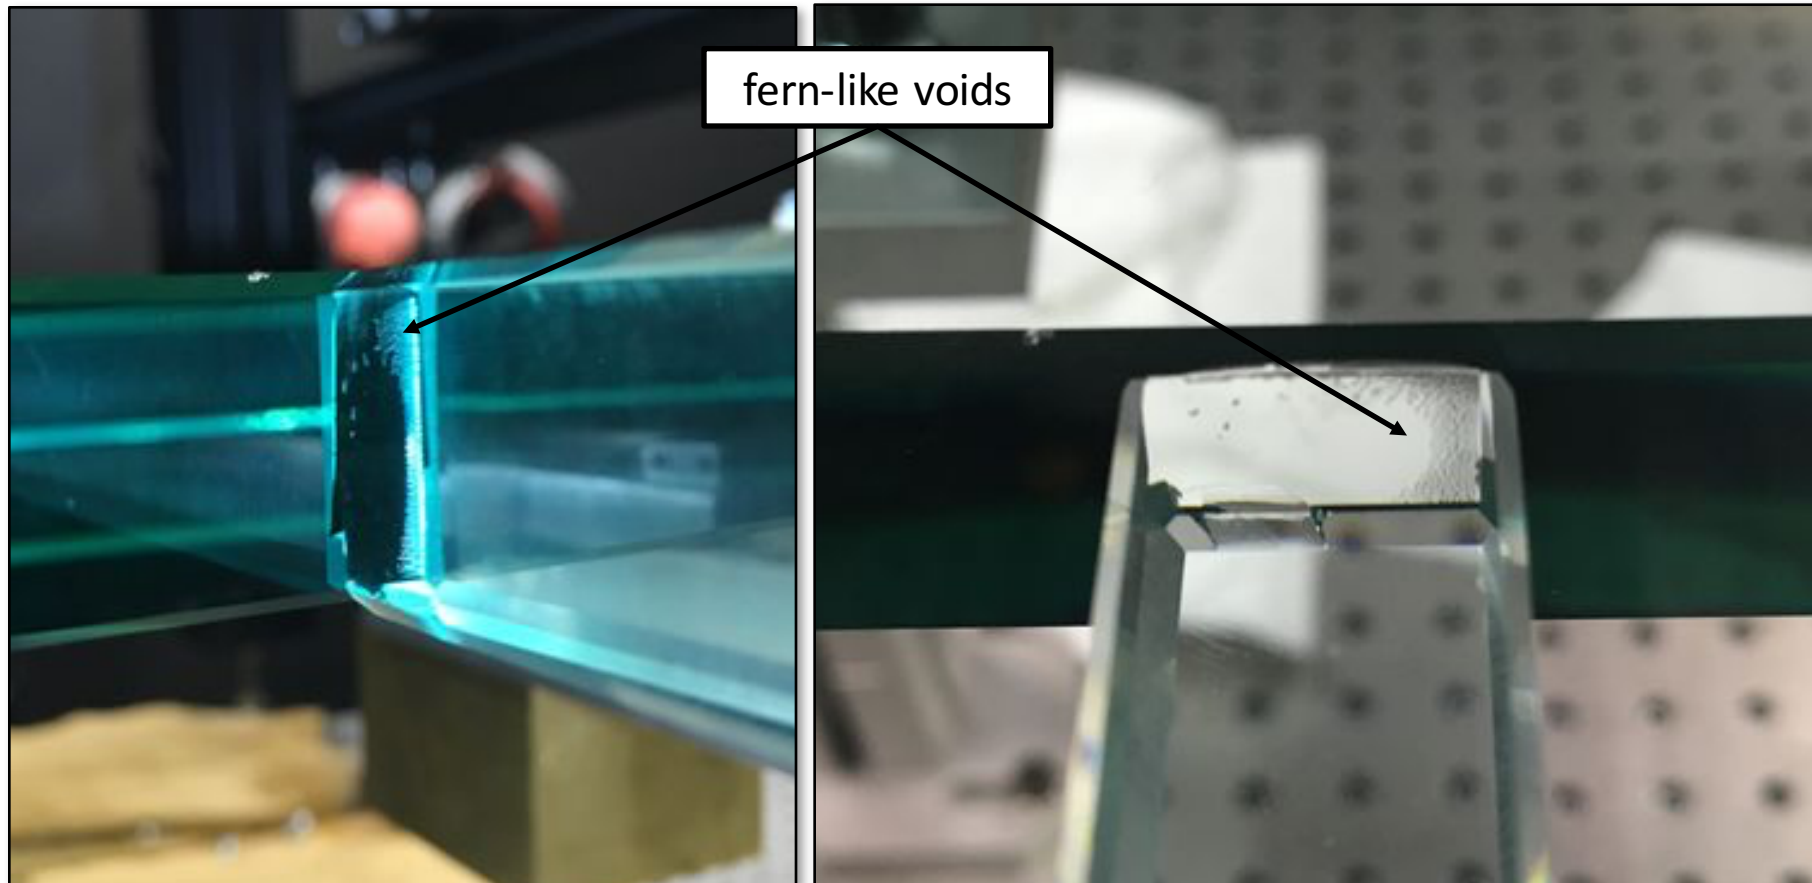
Gluing with NOA-61

- Known failure which occurs when the cement pulls away from itself
- Probably caused by uneven curing

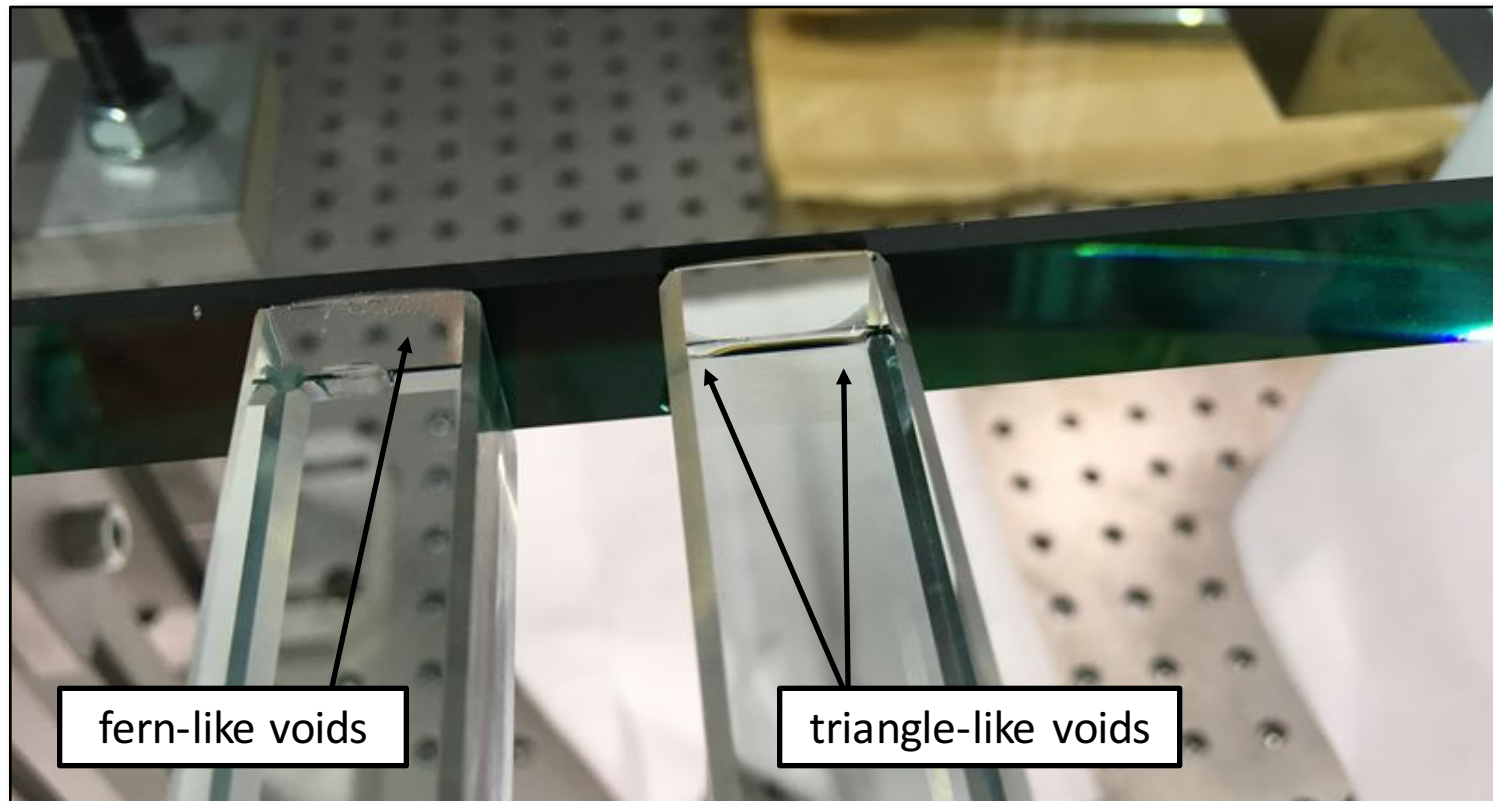
Gluing with NOA-61 (2nd try)

- In a second try problem could not be completely solved as two triangle-like structures at the bottom of the glue joint appeared

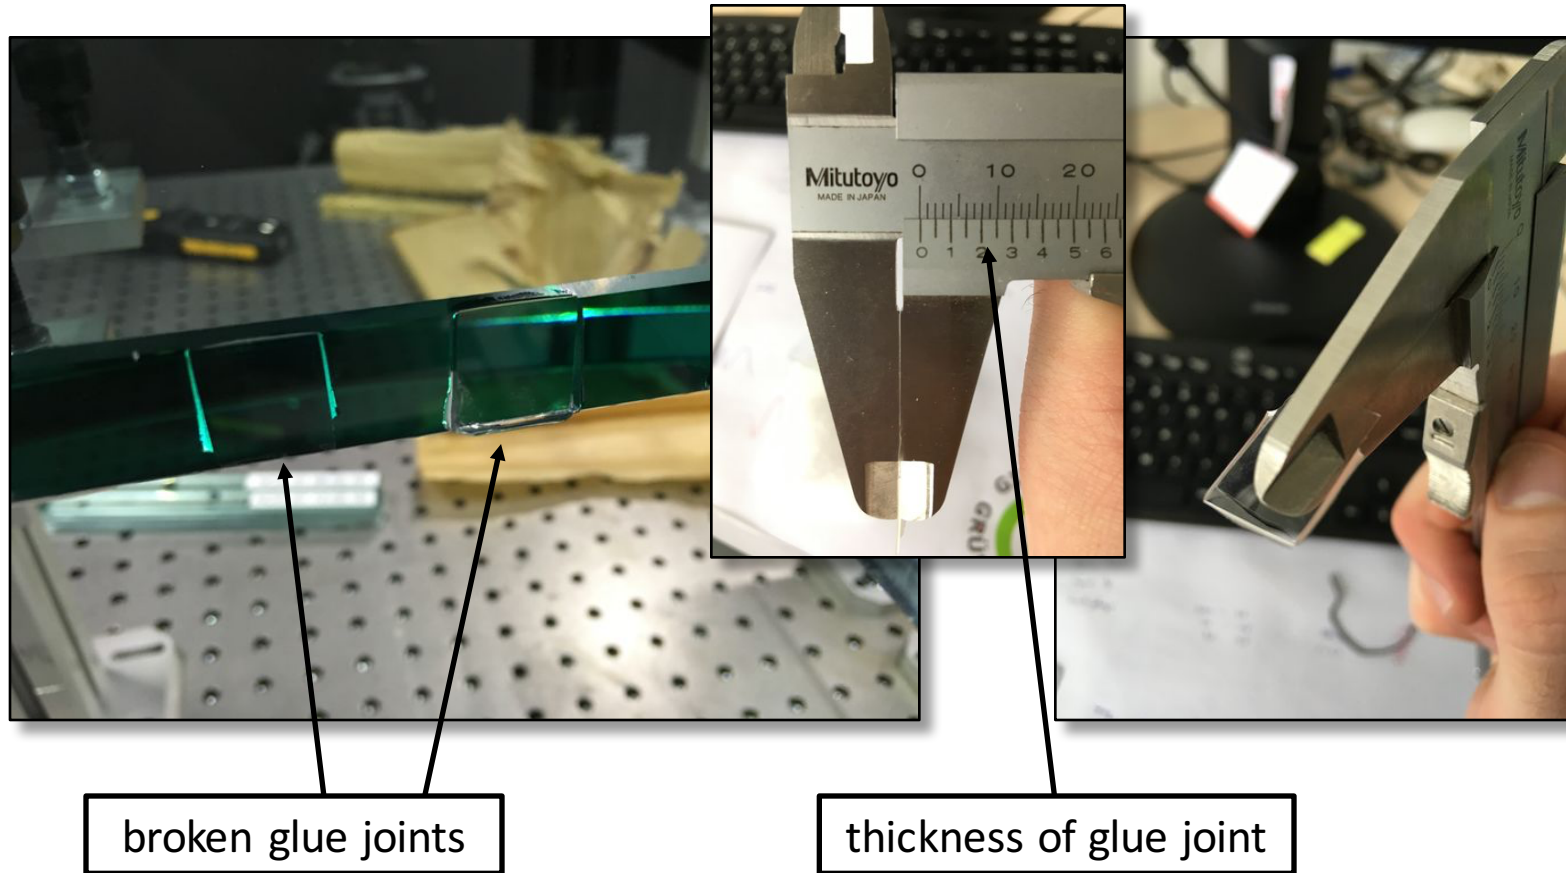
Gluing with NOA-61 (failure of glue joint)

- Little stress led to a break of both glue joints
- Glue joints were removed and inspected

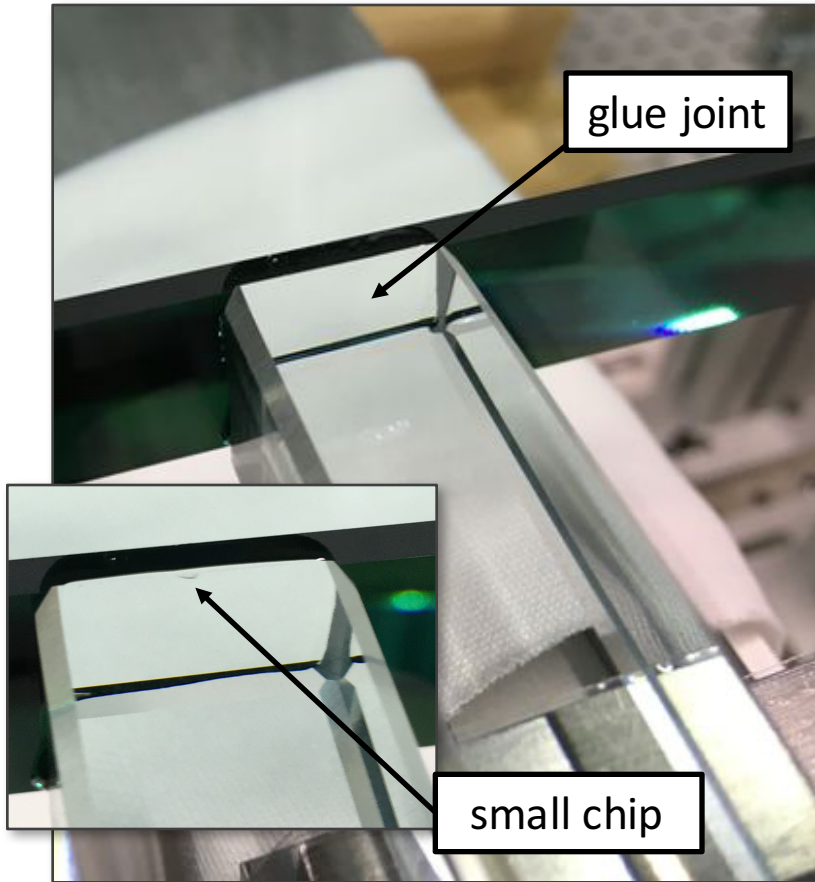
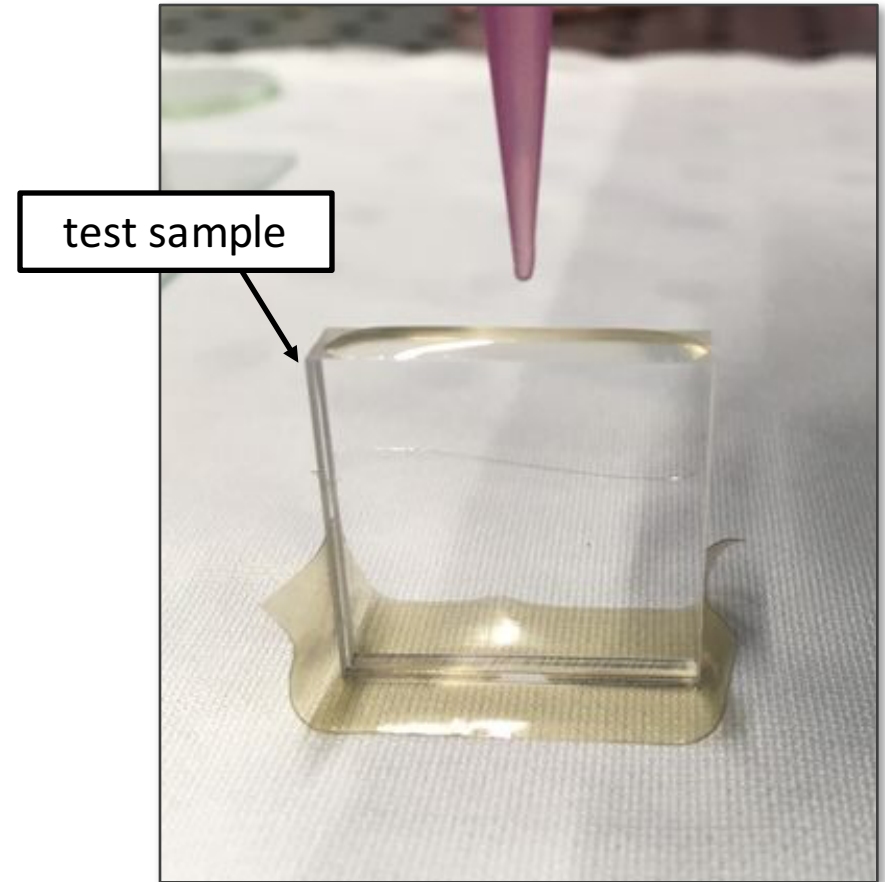
Gluing with Epotek 301-2 (application and result)

- gluing went well, not bubbles or inclusions could be detected
- small chip vanished as glue filled it out

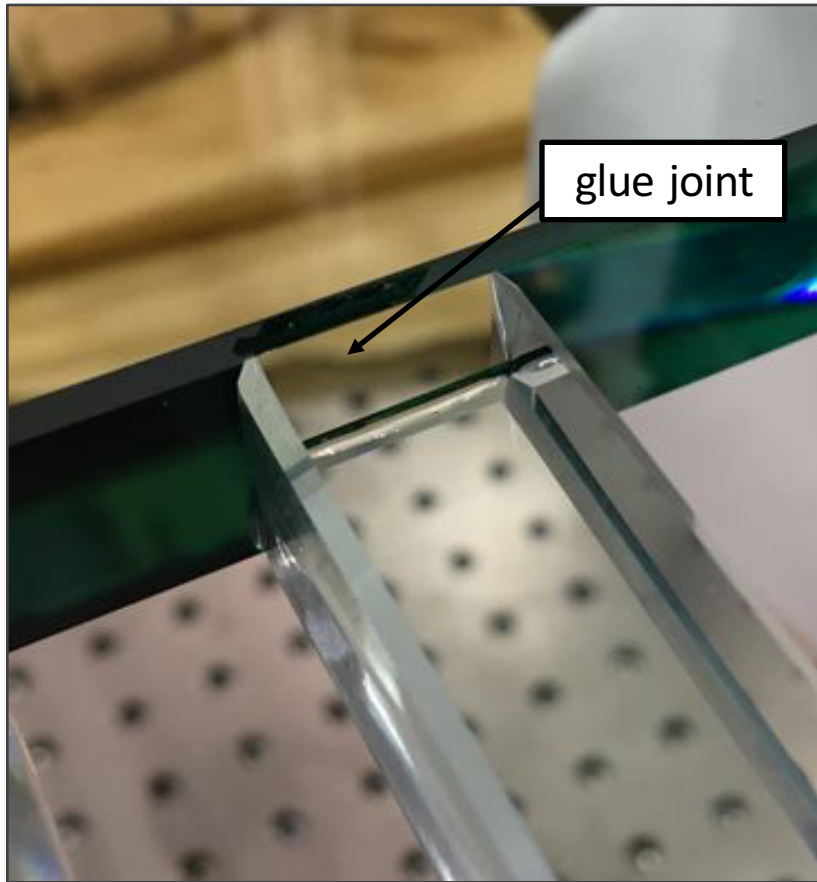
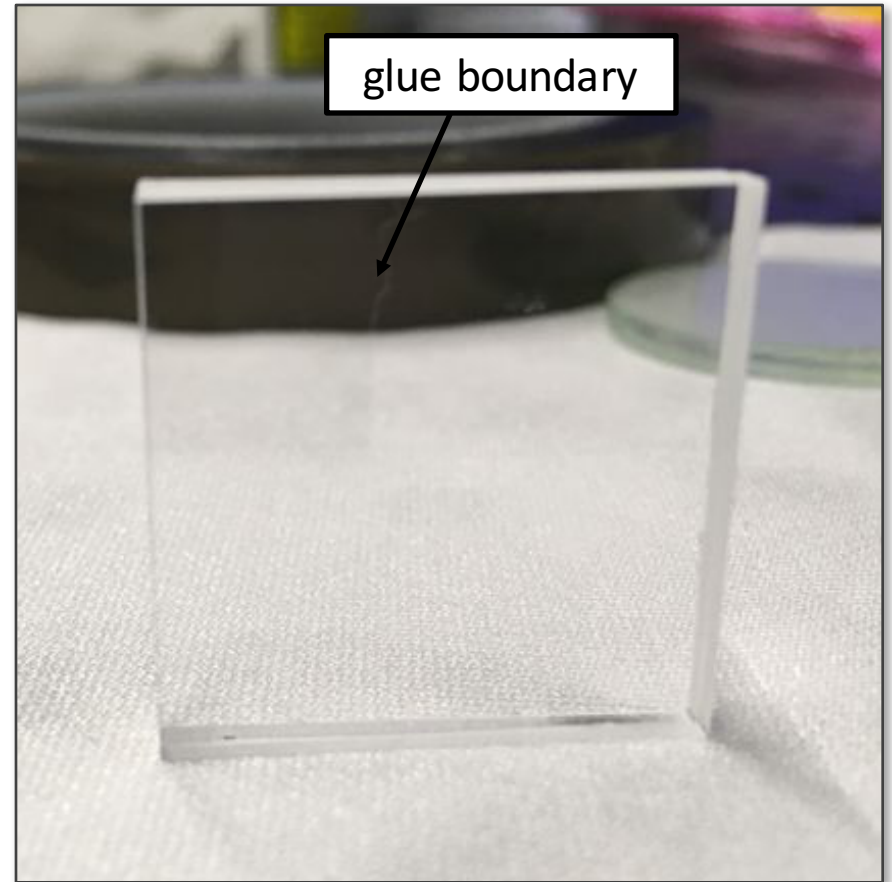
Gluing with APM Epicol (application and result)

- gluing went well, however:
- capillary forces did not fill full test sample, glue residuals appear bluish
- residuals cured slower than expected (wrong mixture -> precision scale ordered)

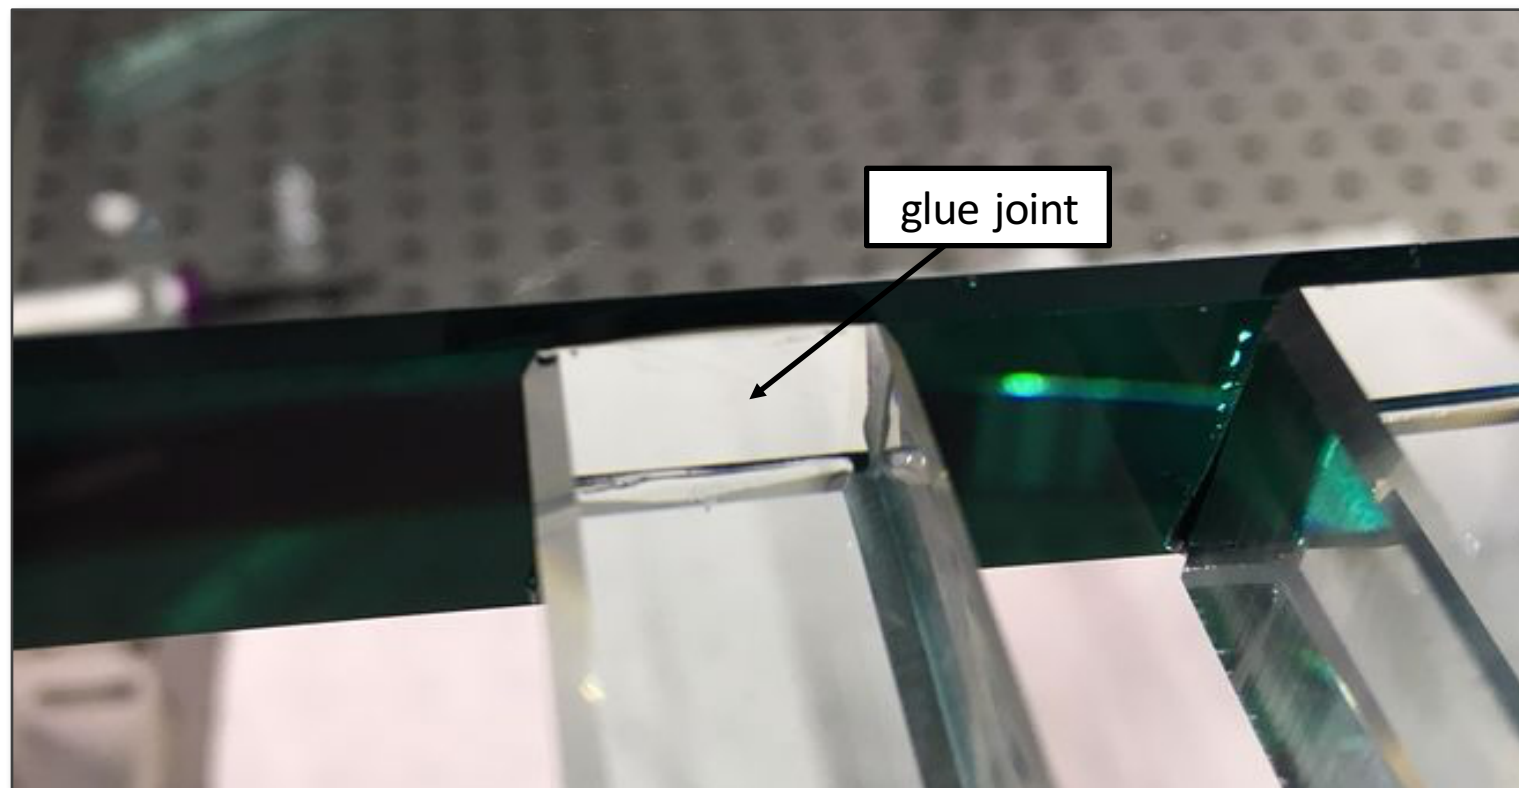
Gluing with NOA-61 (3rd try)

- NOA-61 was gassed out in vacuum
- illumination with UV light was done in several steps from various positions
- glue joint does not show any inclusions or defects even after several days
