# **Mechanics and Cooling**

#### Christof Motzko on behalf of the Luminosity Detector Group

> PANDA Collaboration Meeting November 6, 2018

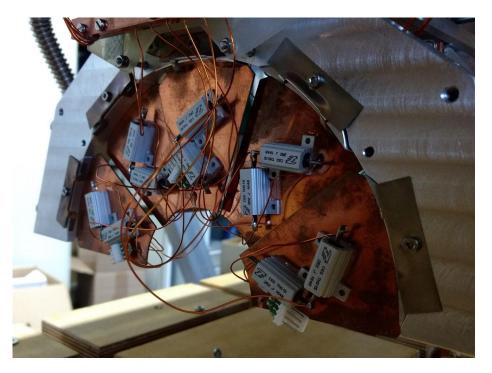
- For cooling test: copper dummys and high power resistors
- Temperature sensor on each module
- Additional temperature sensors on the half planes

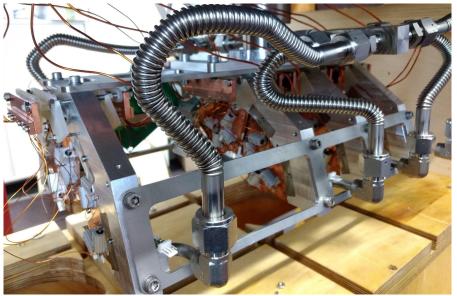
- Complete half detector equipt
- Cooling liquid: Ethanol at -20 °C
- Heat load: 25 W per module

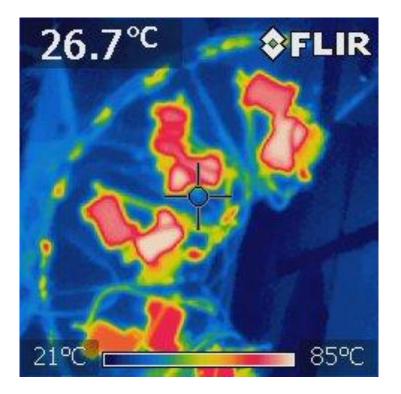
- Test of the cooling and heating elements (resistors) in air
- Total power: ~ 500 W
- Measurement with thermal camera:
  - Resistors: T ~ 100 °C
  - $\circ$  Copper dummies: T ~ 20 °C

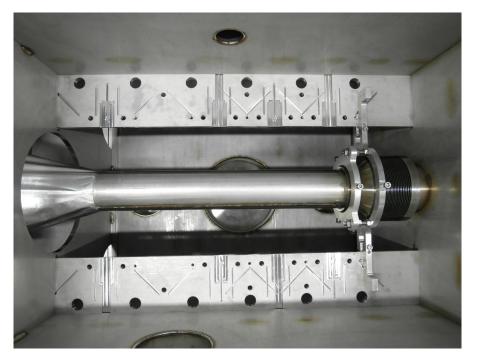
- Beam pipe installed in the box
- No cleaning of the box
- Vacuum box filled with PCBs: approximately the same amount as in the final detector
- Use of a Beagle Bone as control computer of the valves: PLC not ready

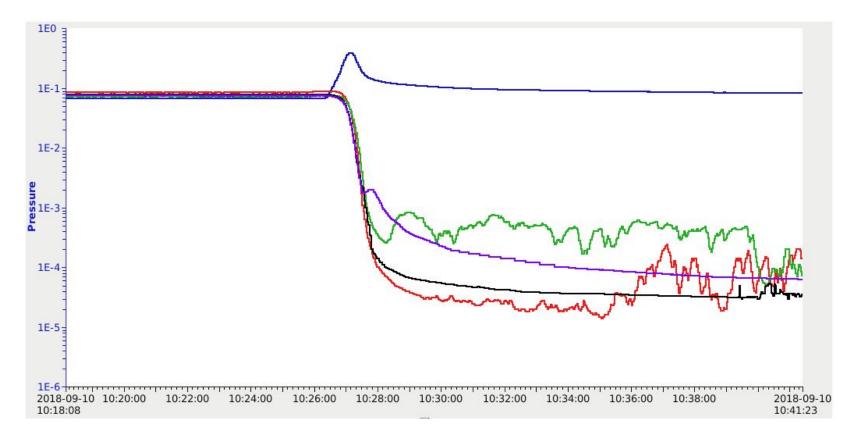
#### Results

- After two weeks of pumping with material in the box:
  - Vacuum box:  $< 10^{-5}$  mbar
  - Beam pipe:  $< 10^{-6}$  mbar
- Outgasing of PCBs visible in the pressure measurement
- Connection between vacuum box and beam pipe visible

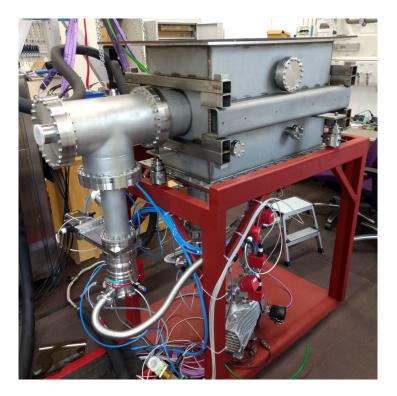
### Accident

- Problem with the LAN programmable socket: Relays switched on and off with about 1 Hz
- Control computer has rebooted and closed all valves

- Use of an PLC for a safe operation of the vacuum system
- Use of an USV for the PLC and the fore vacuum pump
- Glueing and installation of the inner beam pipe have to be improved
  - prevention of holes in the cone foil
  - smooth surface
