Status Forward Endcap EMC

PANDA Collaboration Meeting 18/3, GSI, November 7, 2018

Outline

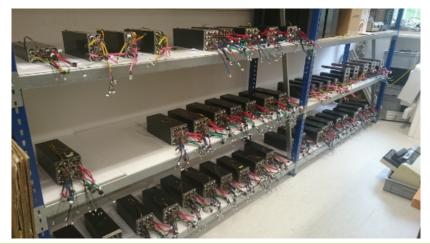
All VPTT submodules currently stored in Bonn, will go to Jülich in one batch when tests are finished

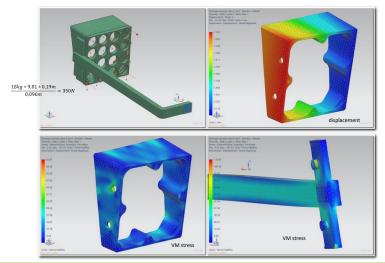
Jülich Installation

Mounting subunits

Mounting tool to hold the subunits when mounting
