Development of a test bench for the Aluflex cables in the PANDA Luminosity detector at FAIR

PANDA Collaboration Meeting, 11/05/2019

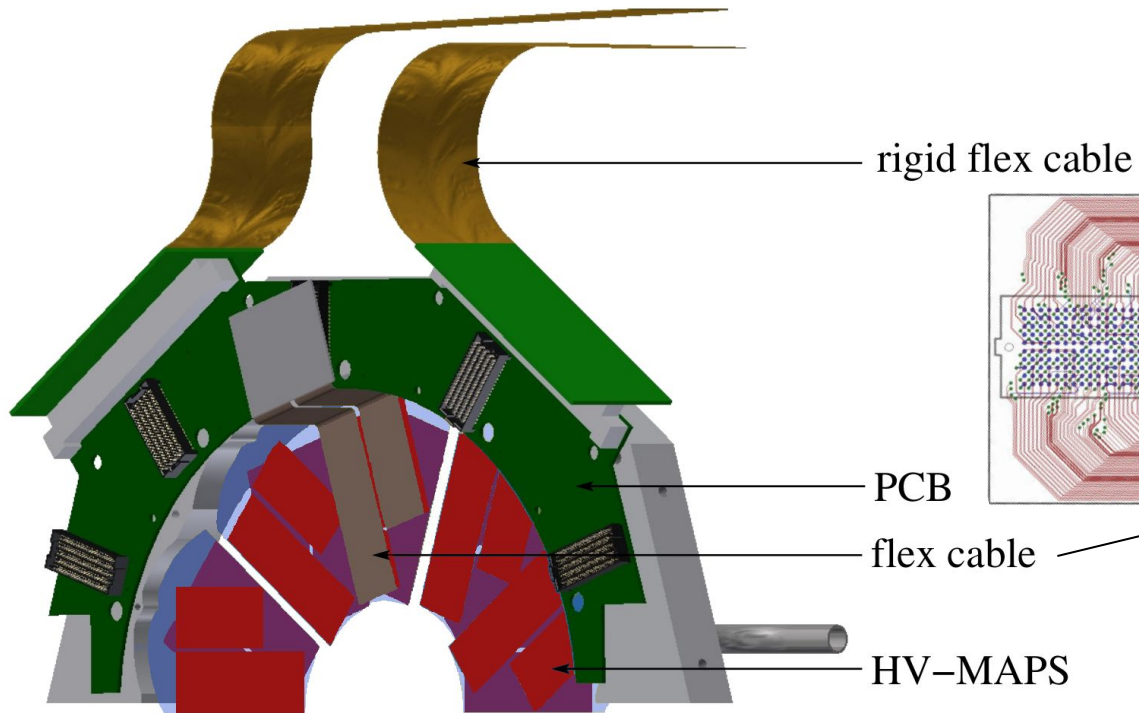
Signal Routing

Radiation length for the prototype module:

Average $X/X_0 = 0.3 \%$

Average $X/X_0 = 0.4 \%$

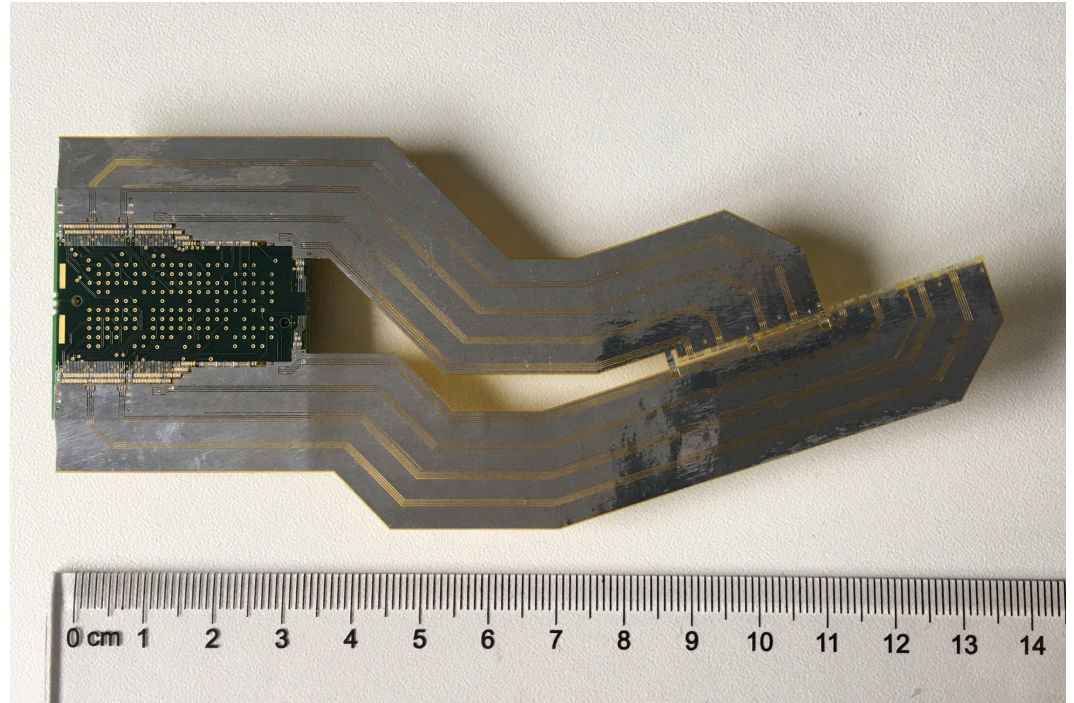
The Aluflex Cable

- 4 MuPix8 sensors
- 50 pins per sensor
- Pad size = $80\mu\text{m}$
- min. pad distance = $70\mu\text{m}$

- LVDS pairs for data transfer
- HV, LV for power supply
- Single line traces for control

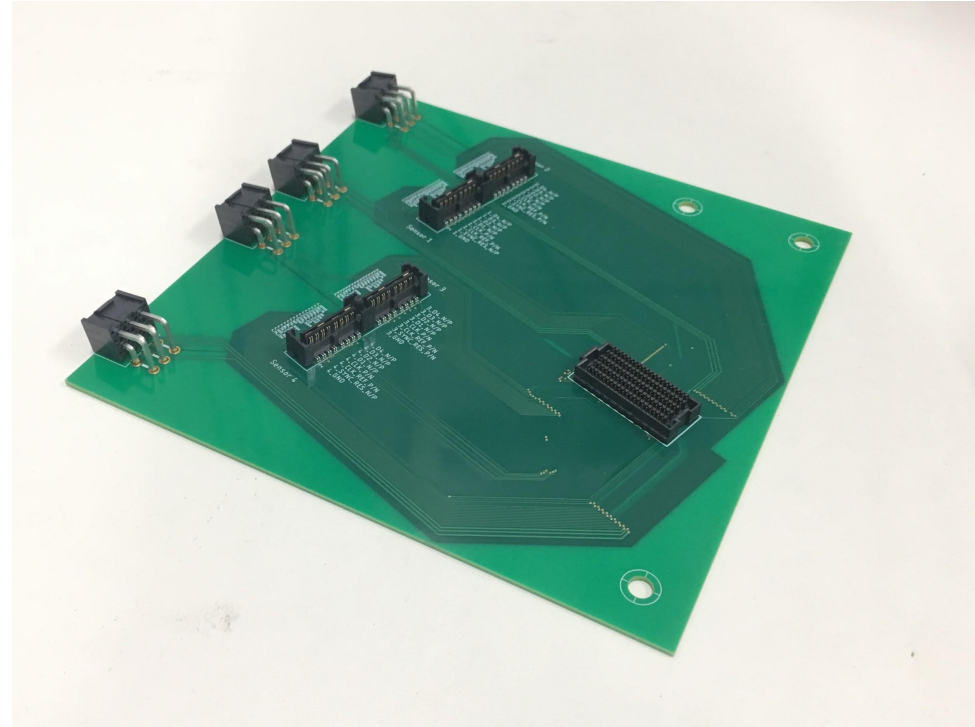
Adapter PCB

- Impedance matched traces
- Aluflex angle adjusted
- Screwed onto the clamping table

- 4 Samtec IPBT connector
- 2 Samtec QFS-DP connector
- 1 Samtec SEAF connector

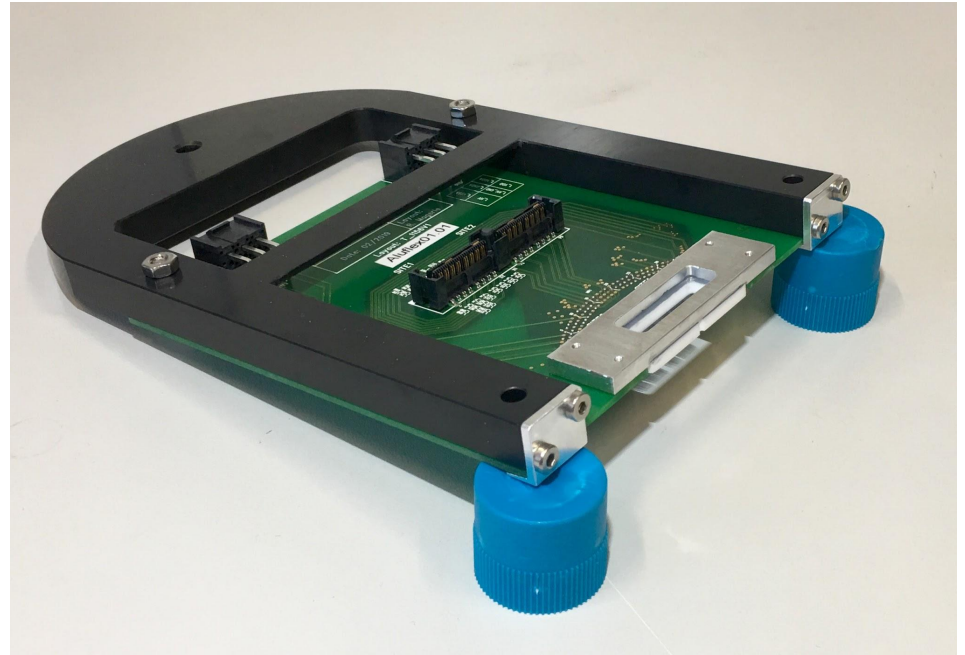
The Probe Card

- 100 tungsten probes
→ two “sensors” at same time
- Probe depth 2mm
- Mounted on vertical stage via holder

- 2 Samtec IPBT connector
- 1 Samtec QFS-DP connector

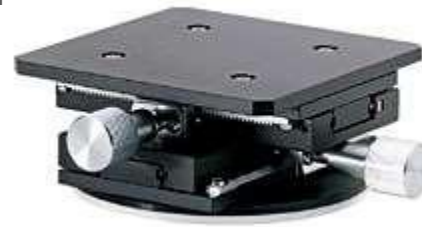
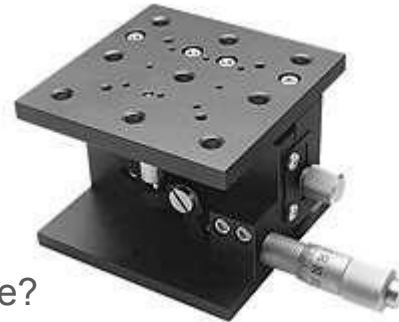
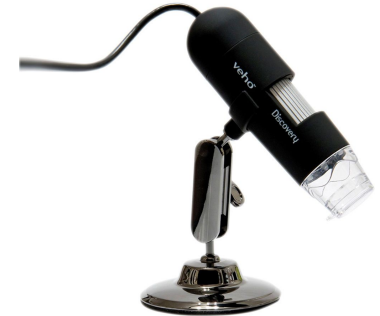
Positioning Elements

Precise connection can be achieved with **micrometer stages**

- XY Positioning Stage
- 360° Rotary Stage
- Vertical Translational Stage

To ensure successful connection to the cable a **USB microscope** will be used

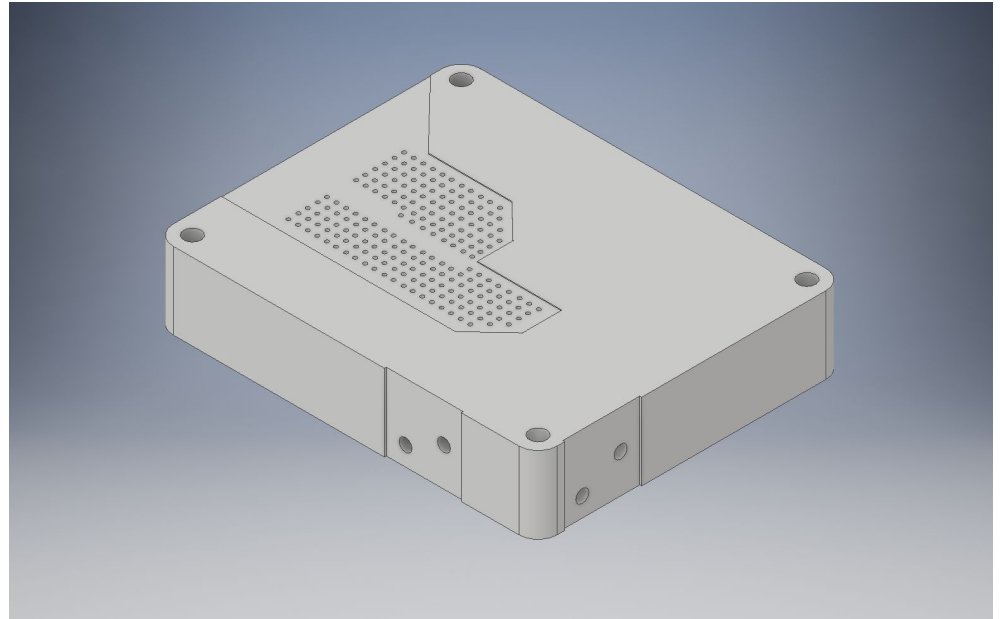
Vacuum Clamping Table

Custom-made vacuum clamping table made by 3D-printer at HIM

- Carefully fixes the cable
- Easy on-/off-fixation
- Uses rotary vane pump from Lumi box

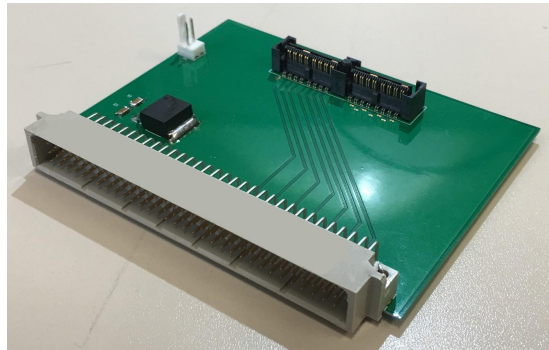
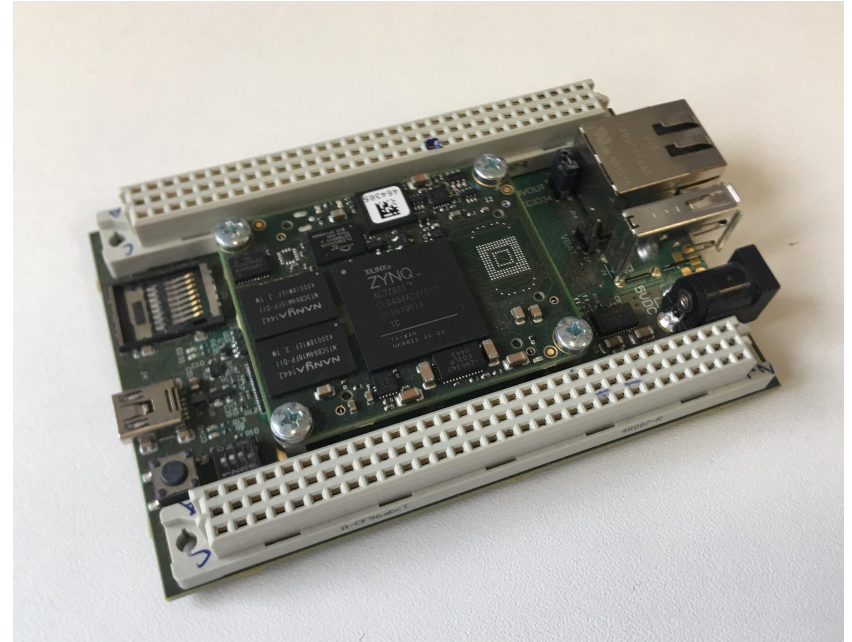
TE0720 Carrier Board with a XILINX ZYNQ XC7Z020

Used to produce LVDS signals

- Bandwidth: 800 MHz
- Transmission rate: up to 950 Mbit/s

Requires additional adapter board

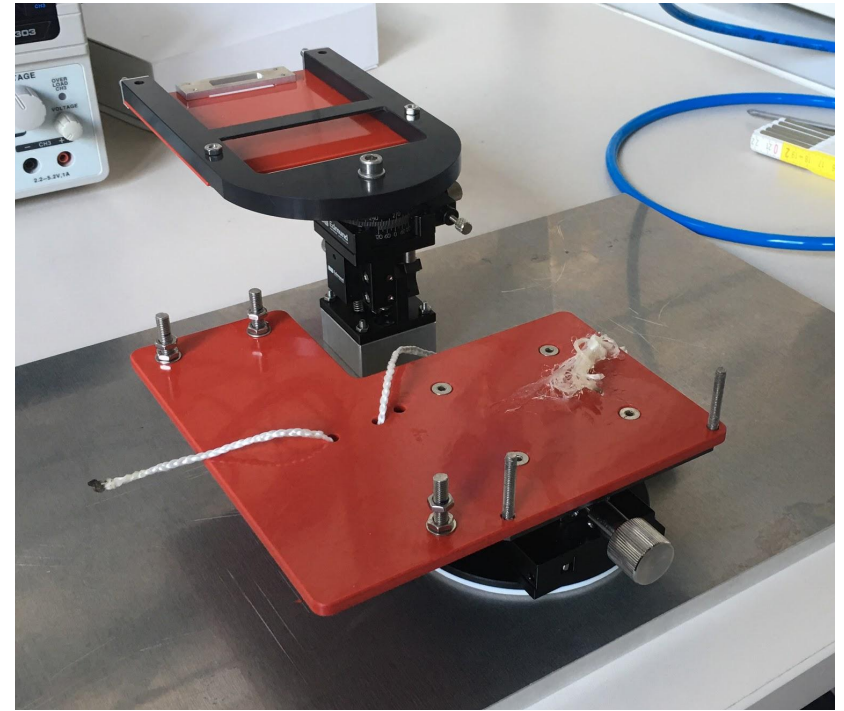
Test Bench Setup 1/4

- Aluminium ground plate
- Positioning stages
- Adapter plate (red L-shaped plate)
- Probe card holder (black U-shaped) + dummy

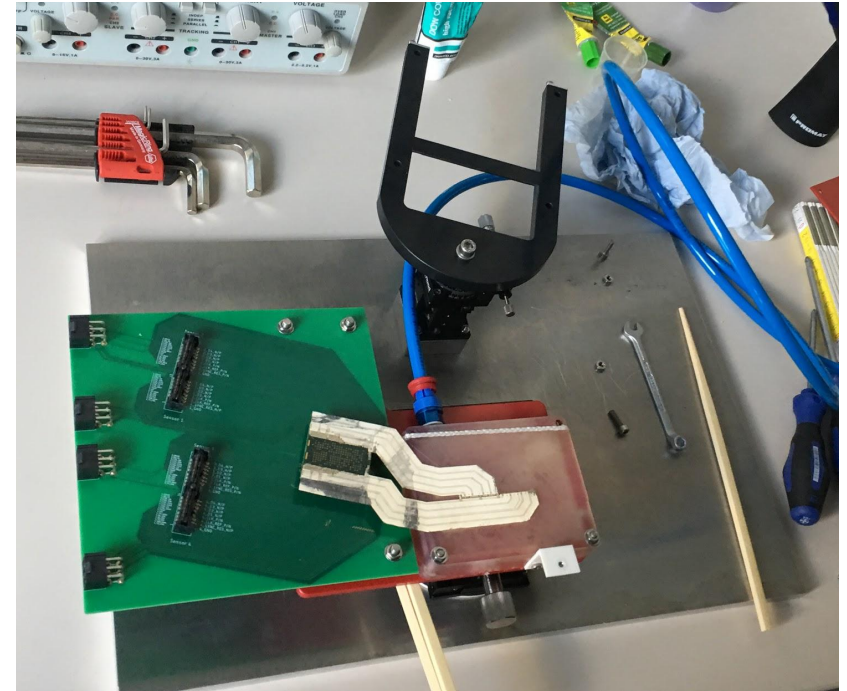
Test Bench Setup 2/4

- Vacuum clamping table
- Adapter PCB
- Aluflex cable

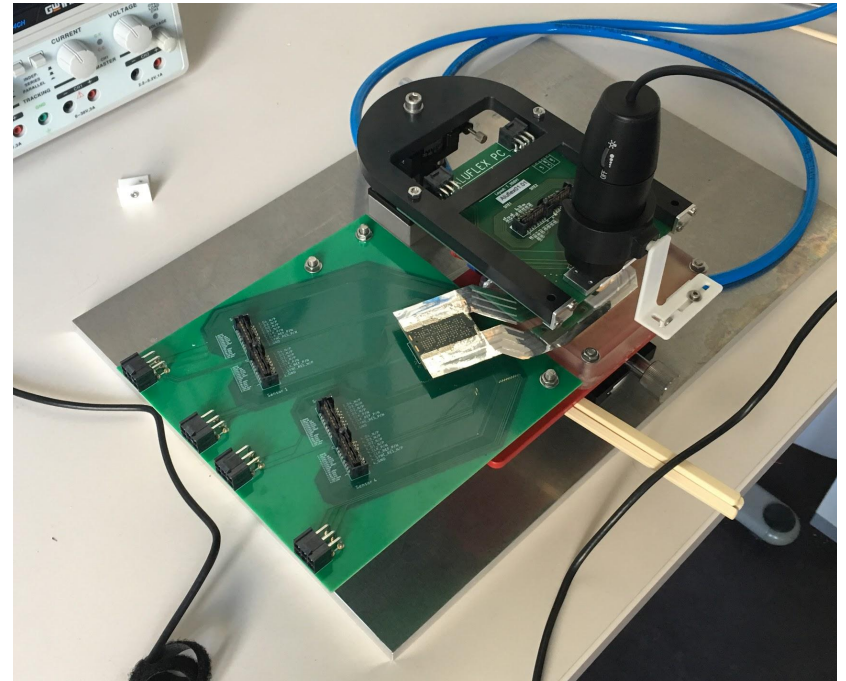
Test Bench Setup 3/4

- Probe card
- USB microscope

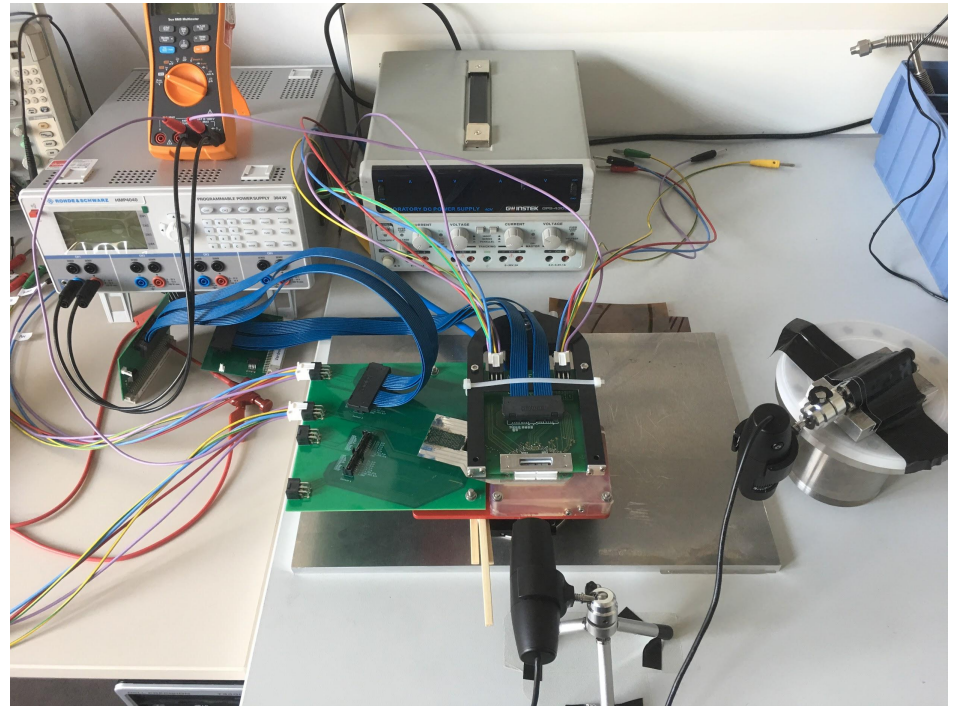
Test Bench Setup 4/4

- Rearranged USB microscopes
- 6QDP cables
- Power and HV cables
- FPGA Adapter board

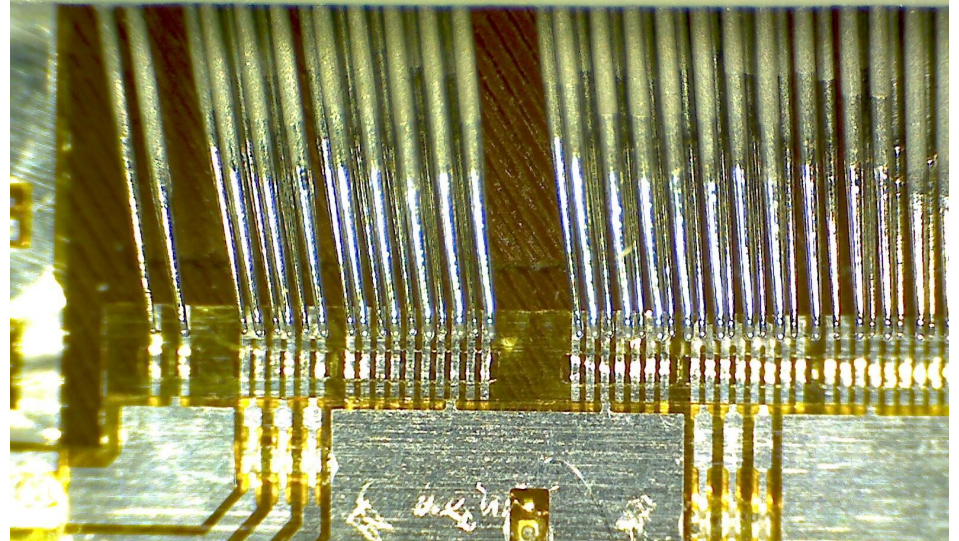
Good electrical contact between probe tips and bond pads!

Contacting process in perspective of the USB microscope

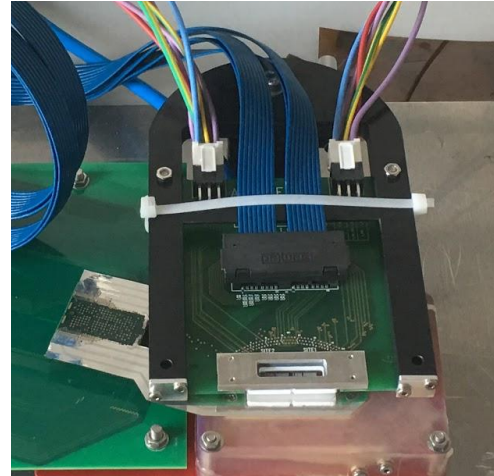
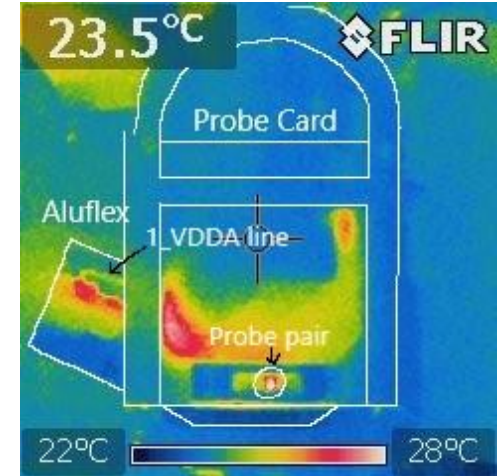
Determination of the power drop in a single line under stress conditions

- LV-lines must withstand at least 0.4A (corresponding to the power consumption of a single MuPix8 and its supply voltage of 1.8 V)

Infrared camera makes loaded line and needles visible

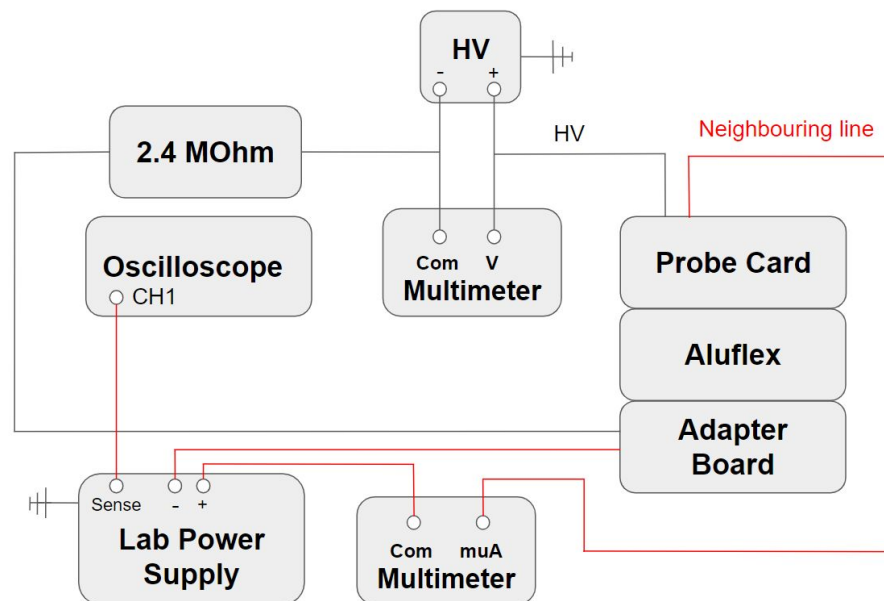
Are the lines next to the HV line influenced by the applied HV?

- MuPix8 sensors are operated at a maximum HV of 100V

HV applied on line 4_HV with voltages measured in the neighboring lines

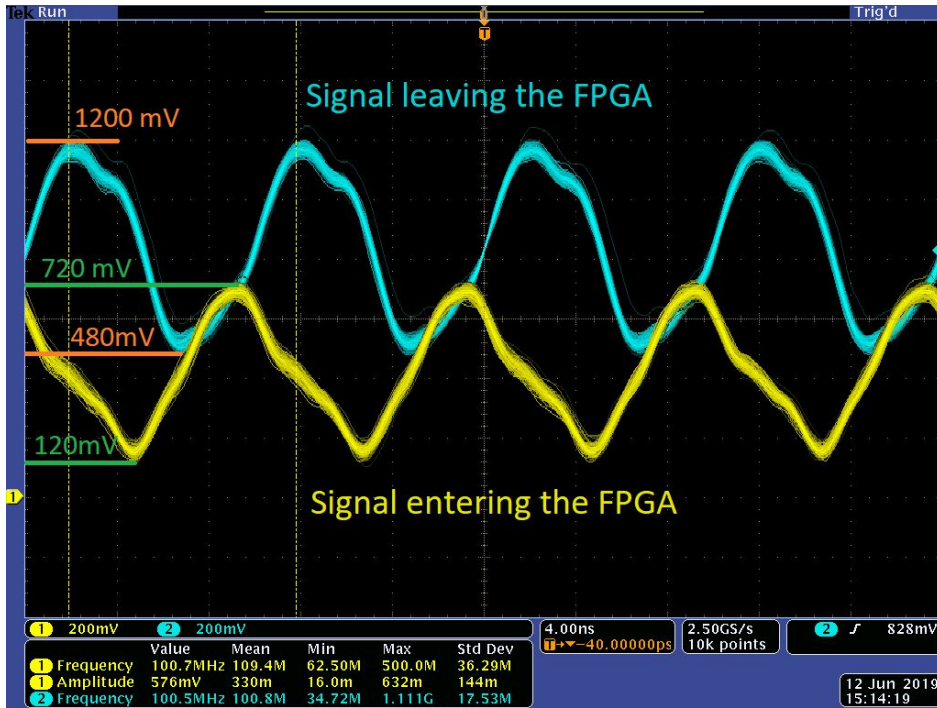
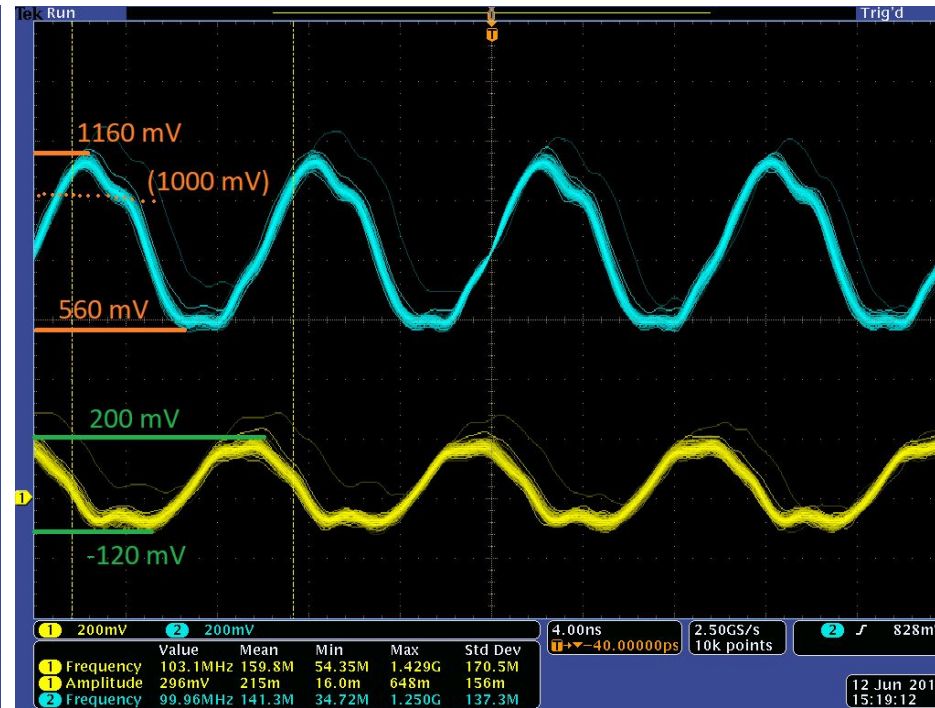
Data-Line-Test Results (Single Line)

What is the influence of the data lines on the signal quality?

- Test bench works, **but** positioning wasn't as precise as hoped for
- LV- and HV-test were successful
- Data-Line-Test have to be repeated in order to get significant results
