News on the Forward Tracker

- Status of the STS2 station for the Phase-0 at HADES
- Studies of aging with a strong ^{55}Fe source

JERZY SMYRSKI
JAGIELLONIAN UNIVERSITY, KRAKOW, POLAND

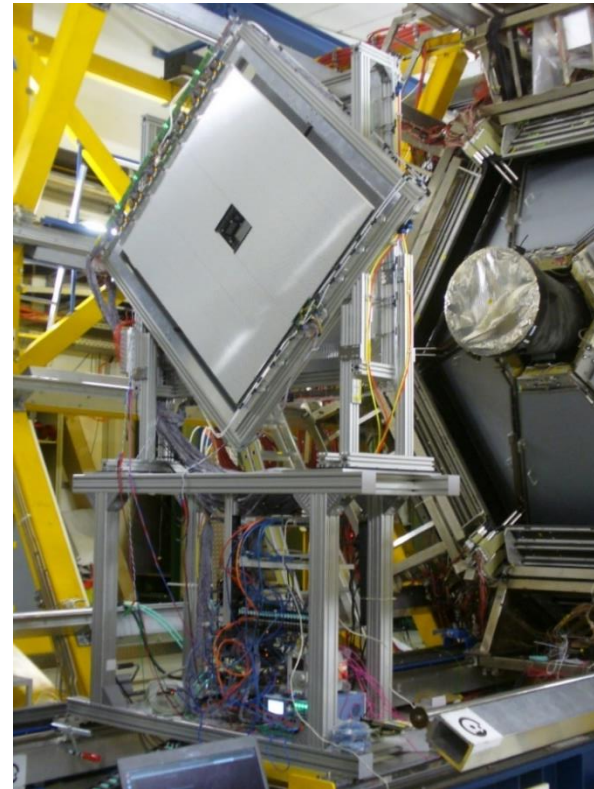
STS2 installed at HADES

- Four double layers of straws (0° , 90° , $+45^\circ$, -45°) mounted on two frames; total of 1024 straws

front

rear

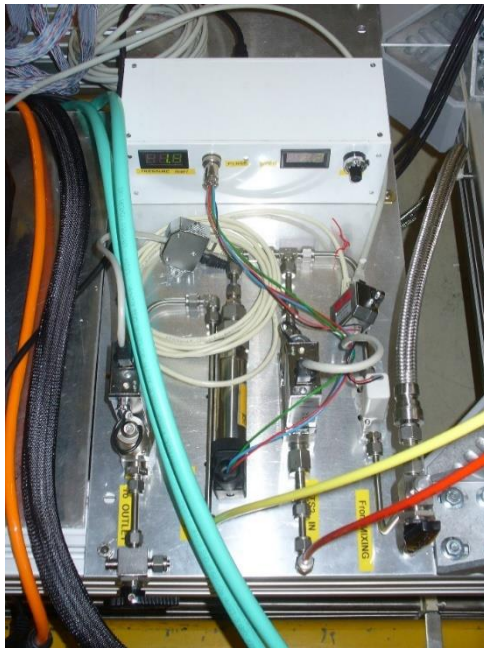
Gas system:

gas mixing + gas distribution (2 lines)

Control:

EPICS + GUI based on CSS

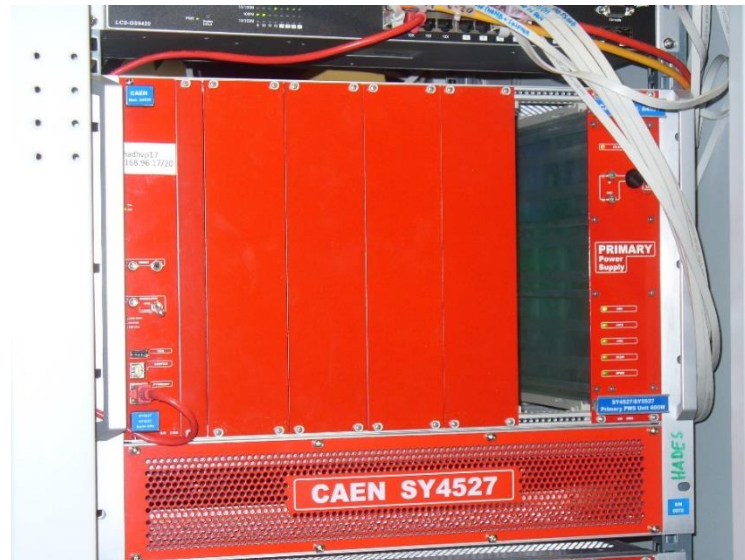
HV supply:

CAEN SY4527 – 8 channels for STS1+STS2

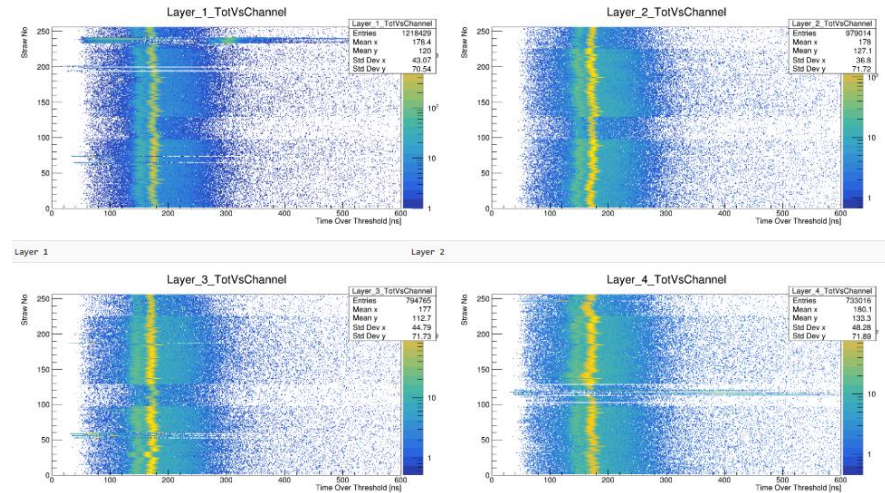
Online ToT spectra taken for ^{55}Fe

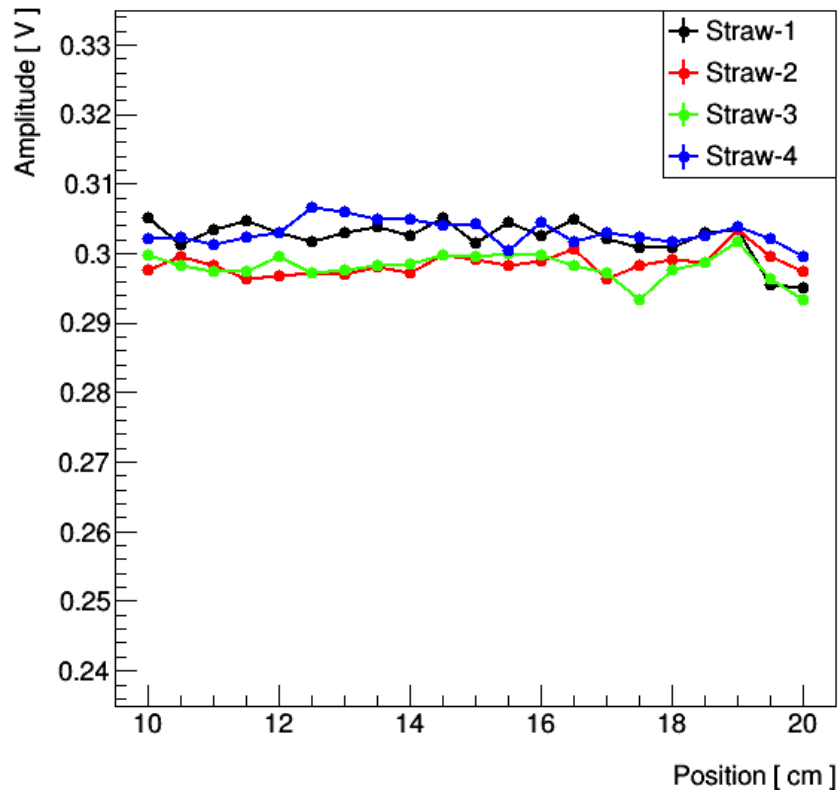
Amplitude vs. coordinate along straw

New ($Q/I = 0 \text{ C/cm}$)

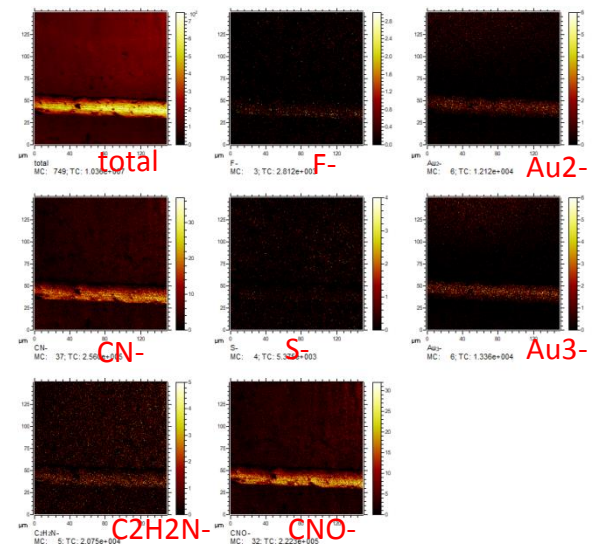
Imaging of various deposits on irradiated wire

- Deposits on the irradiated wires and on the Mylar foil has been scanned using the **TOF-SIMS** (Time Of Flight - Secondary Ion Mass Spectrometry).
- Cathode and anode deposits contain H, C, N and O which may originate from organic compounds
- The main suspect is outgassing from applied epoxy adhesive (UHU Endfest 300) or PVC gas pipes.
