# Nikon Bar Production Status of Delivery and Acceptance

G. Schepers, PANDA Collaboration Meeting,  
GSI Darmstadt, 27.10.2020

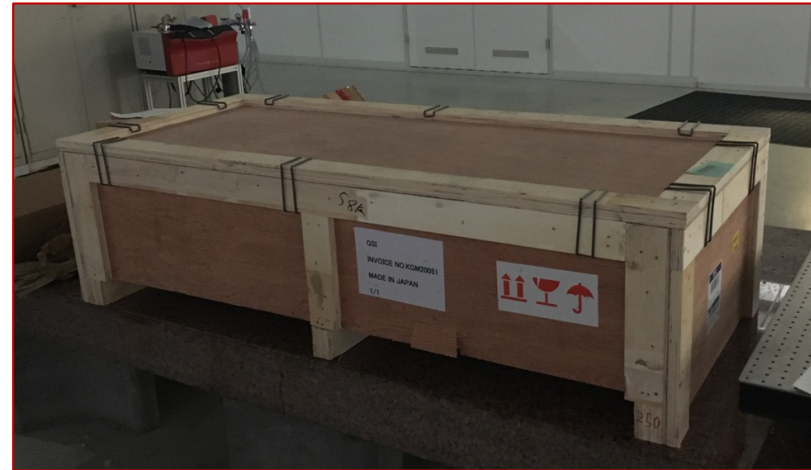
- Q3 2019                    Call for tenders for Fused silica bars successful
- Sep 5, 2019             Placed order for 98 bars with option for up to 8 more bars (need 96) with Nikon Corp, Japan.
- Sep 2019                Production started
- March 20                Delivery started
  - March 20                5 bars
  - April                    35 bars
  - July 20                 20 bars
  - August 20              10 bars
  - September20         10 bars
  - October20             10 bars
  - **90 of 98 Bars at GSI**
  - 8 bars to come in 2020
  - Order of additional bars in preparation

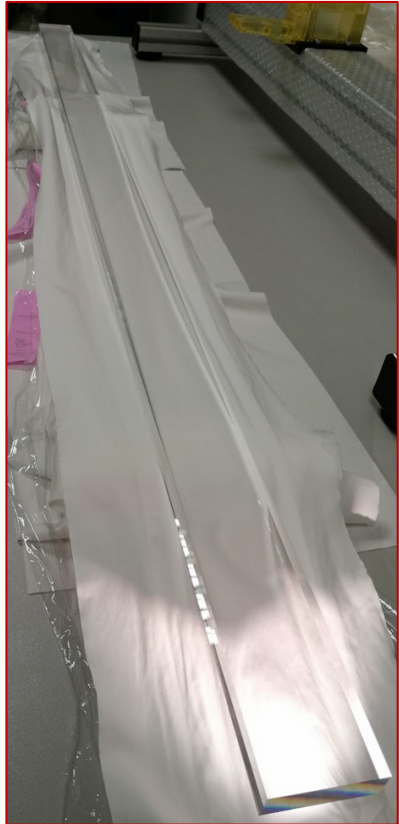
- Clean surface
- Sharp edges
- Clear view through the bar

- **Visible inspection**
  - Clean surfaces, no residue from cleaning nor packing, sharp corners?

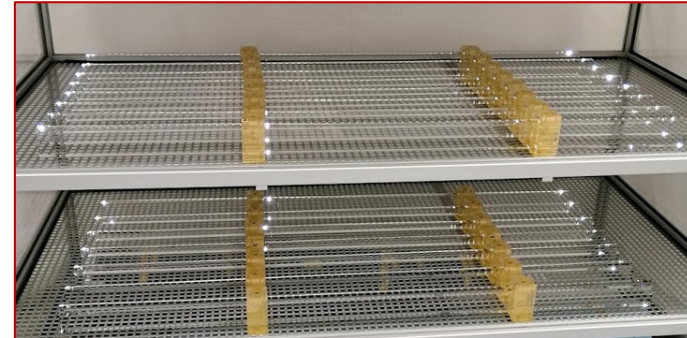
## Preparation

Stand with labeled horseshoes  
and end stop

Bar stays in horseshoe (holder)  
for all tests until it is placed in  
barbox

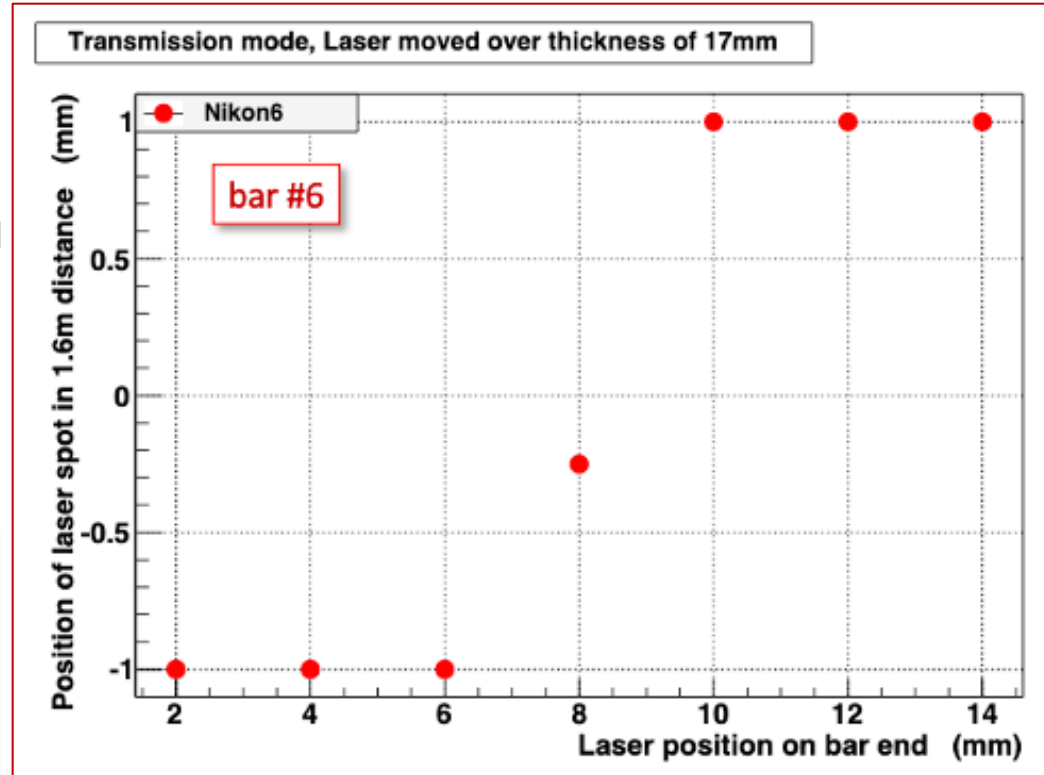
Observed position shift during thickness (17mm) scan

Primary photon propagation in a DIRC is along the length of the bar -  
 Check if the effect is larger or similar for photons bouncing many times

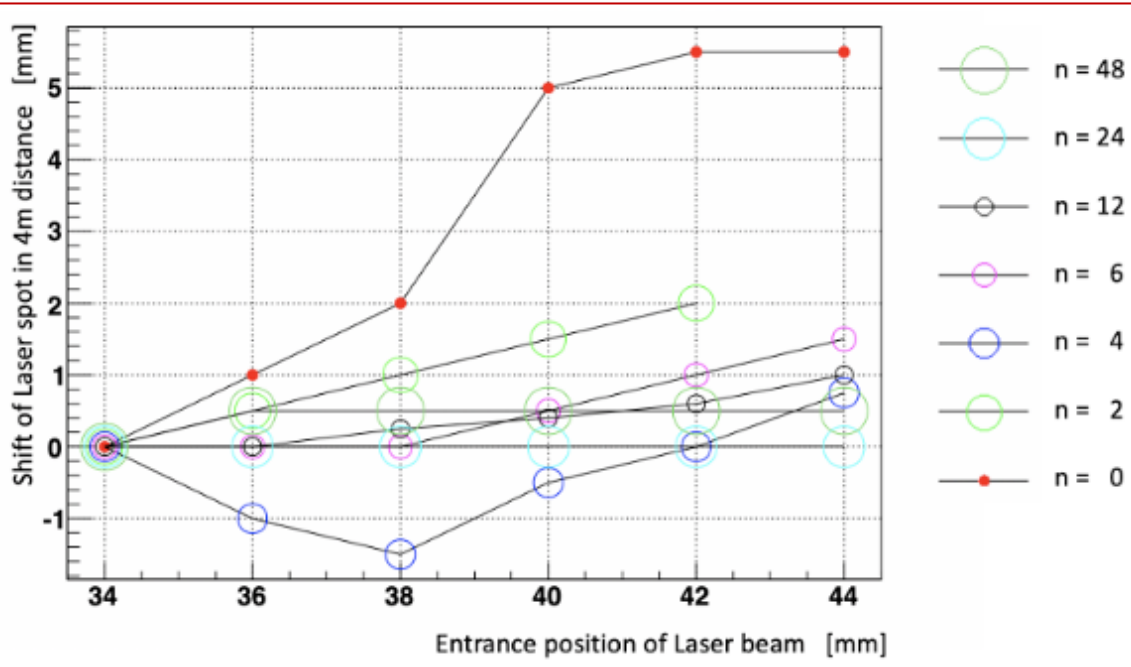
- n: number of internal reflections
- The bar was scanned over its thickness from face2 to face 1
- The shift is shown relative to the spot position of each first laser entrance

Impact of effect is smaller for larger photon angles

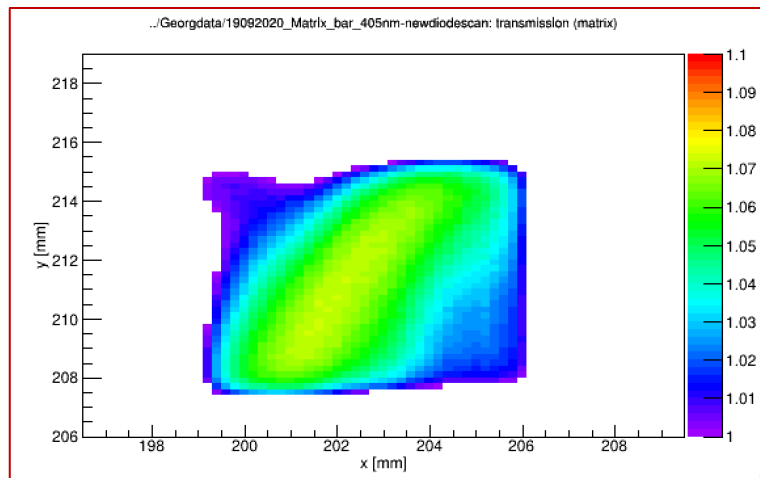
New Diode 1

Homogeneity:  
Scan with Laser (405nm) in 0.5mm steps
