AGATA detectors summary report

Peter Reiter for the AGATA detector working group

12th AGATA week
11-13 June 2012
GSI Darmstadt, Germany

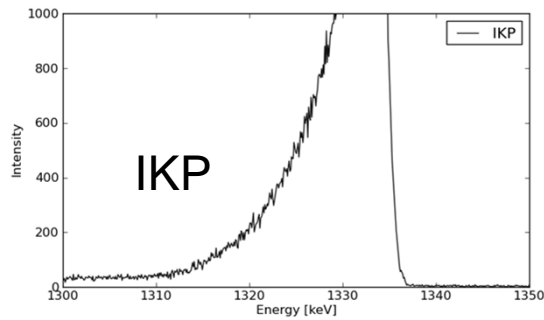
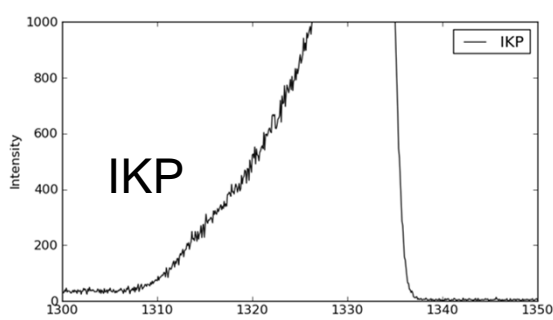
Status after LNL campaign: before (LNL) and after warm up (IKP), no annealing

It's difficult to determine the FWHM due to the peak shapes, varies between 5 and 20 keV.

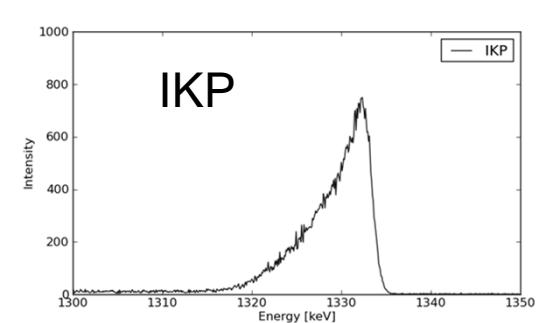
Status after LNL campaign: before (LNL) and after warm up (IKP), no annealing

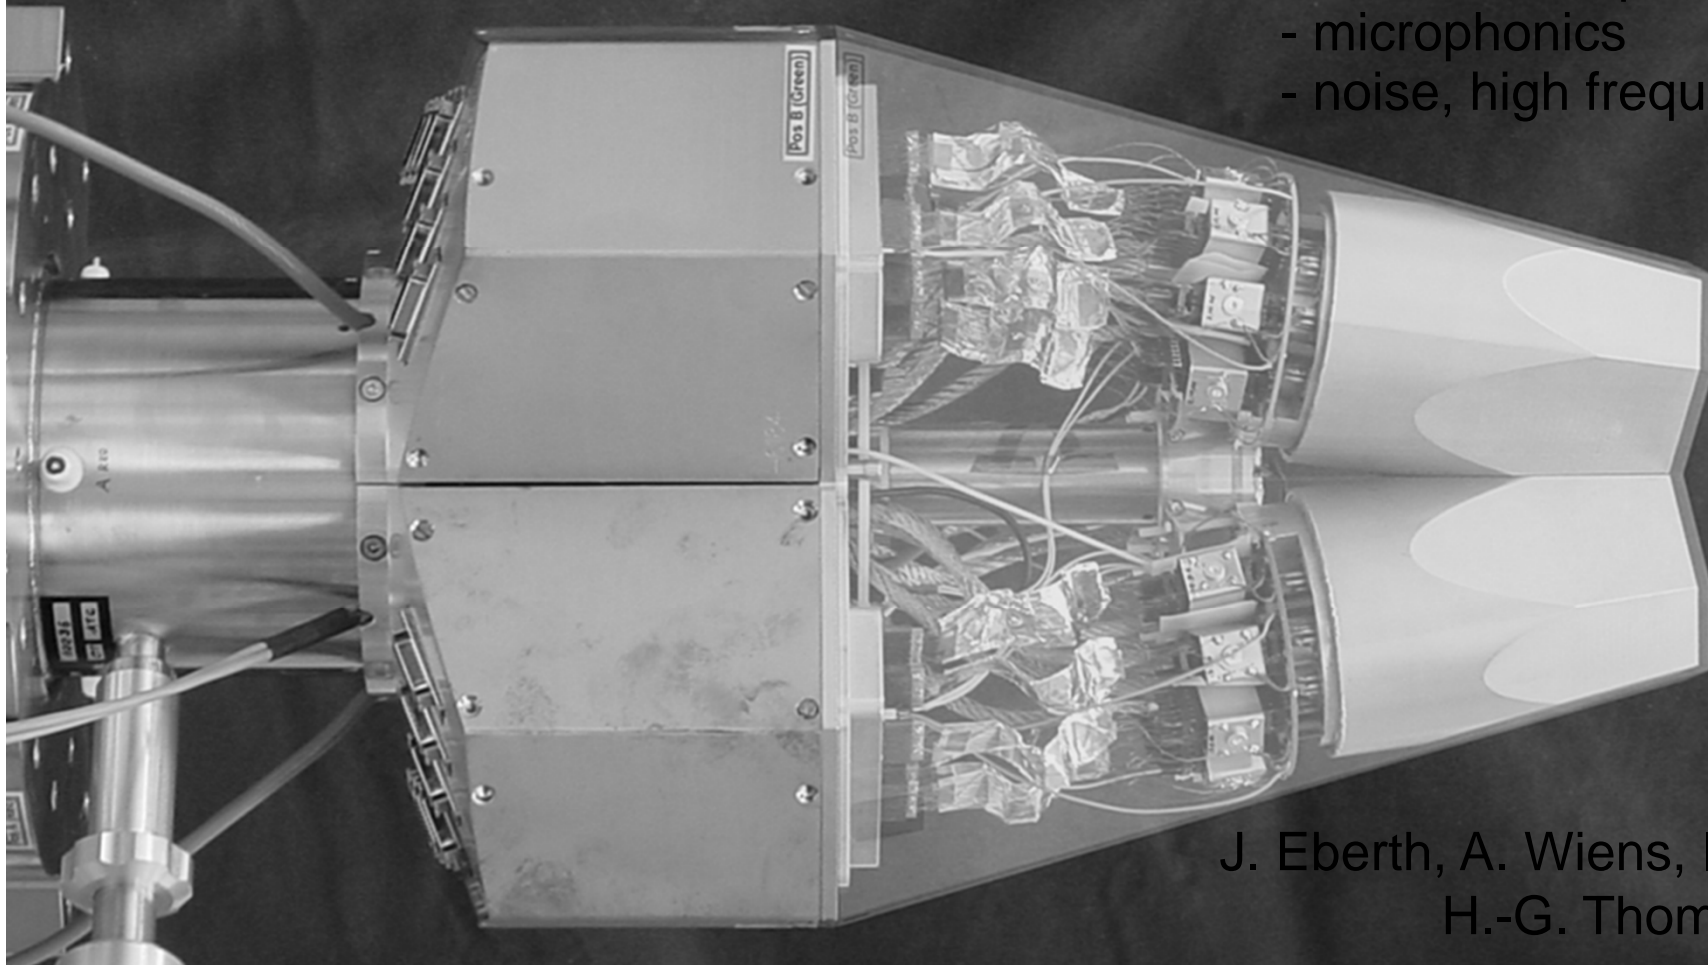
Disassembly and Reassembly of five AGATA Triple Cryostat @ IKP

- integration of 111 high resolution spectroscopy channels
- cold FET technology for all signals

- mechanical precision
- heat development
- LN2 consumption
- microphonics
- noise, high frequencies

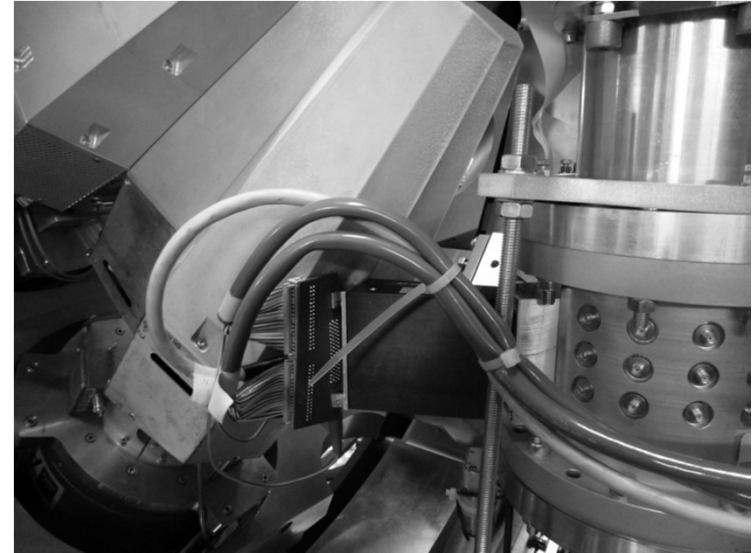
10. May 2012, ATC 1 at GSI:

ATC 1 accident at GSI

- ATC1 is affected by mechanical damage.
- Three detectors were tested at IKP after accident to be within specs.
- Reassembly is ongoing with new end cap
