Stairways to heaven: the STS Ladder

46th CBM Collaboration meeting

BRIEF INTRODUCTION TO THE SILICON TRACKING SYSTEM OF CBM

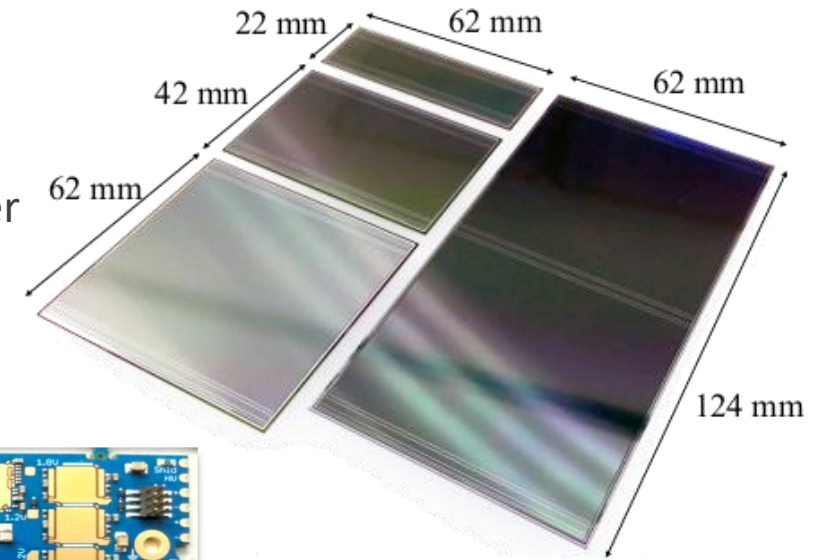
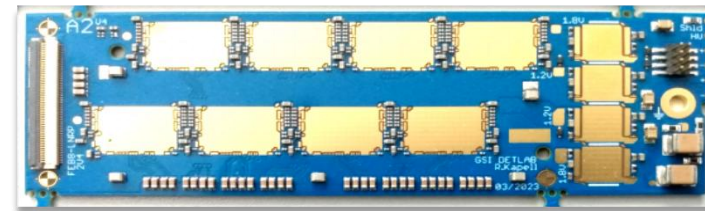
- Thickness: 320 μm
- 1024 strips per side
- Pitch: 58 μm
- Double metalization layer in p-side
- 32 microcable stacks

- 8 custom-design ASICs per Front-End Board (FEB)
- 128 channels per ASIC

Schematics of the STS detector module and its main components

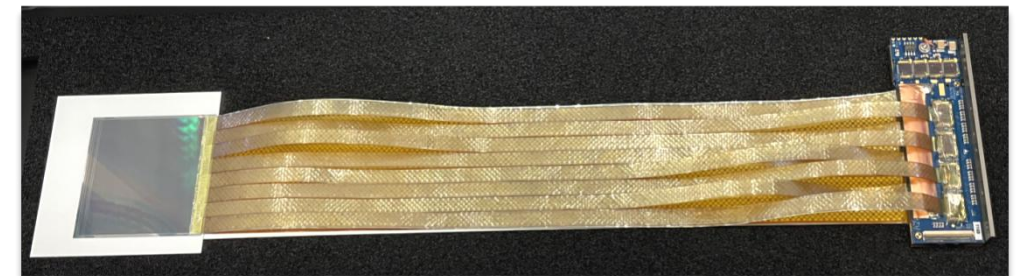
STS module before the shielding layers are soldered

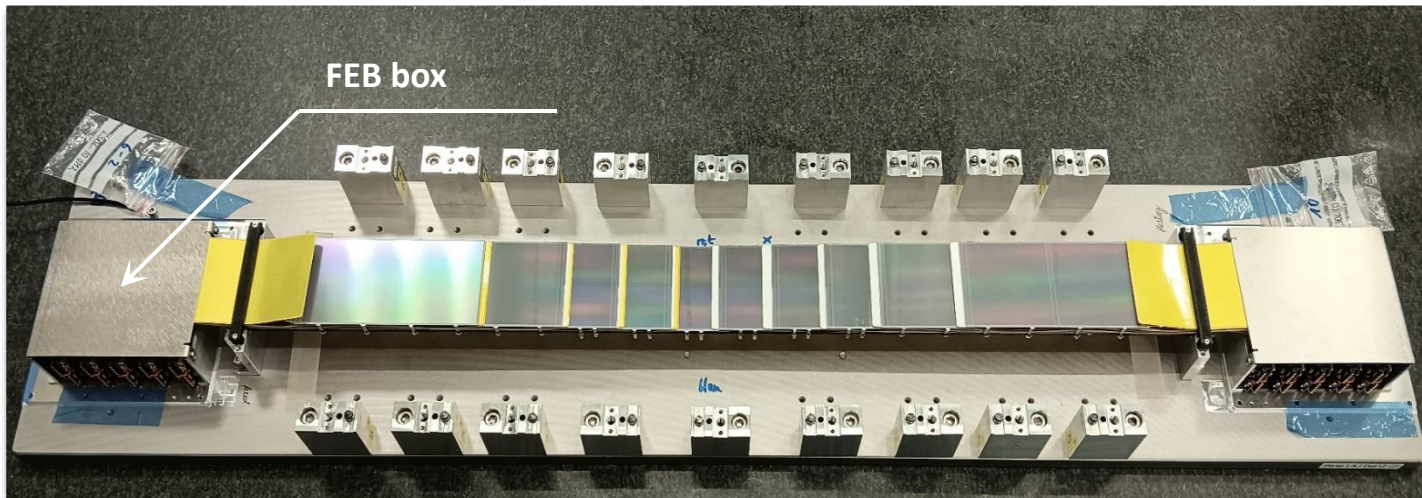
Fully assembled STS ladder carrying 10 modules

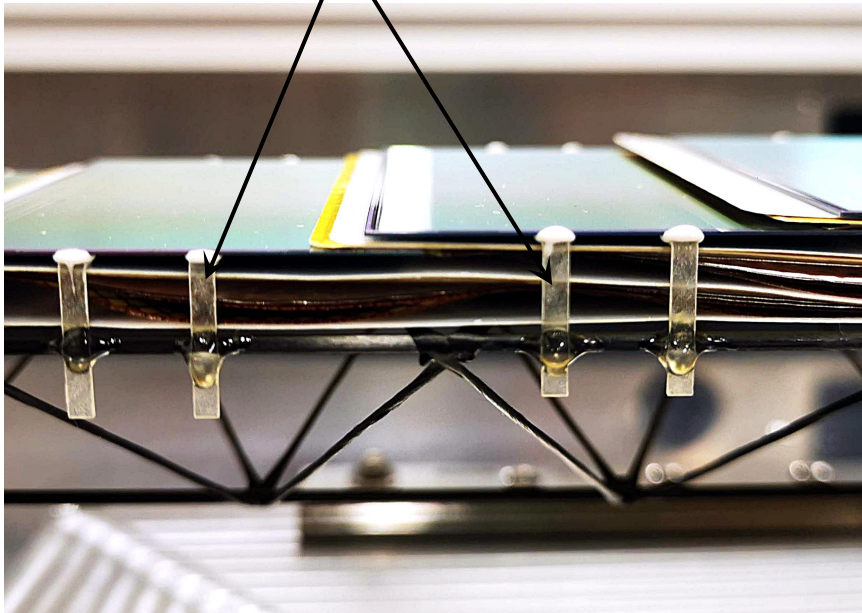
Detail of an assembled ladder, where sensors can be seen glued to the so-called "L-legs"

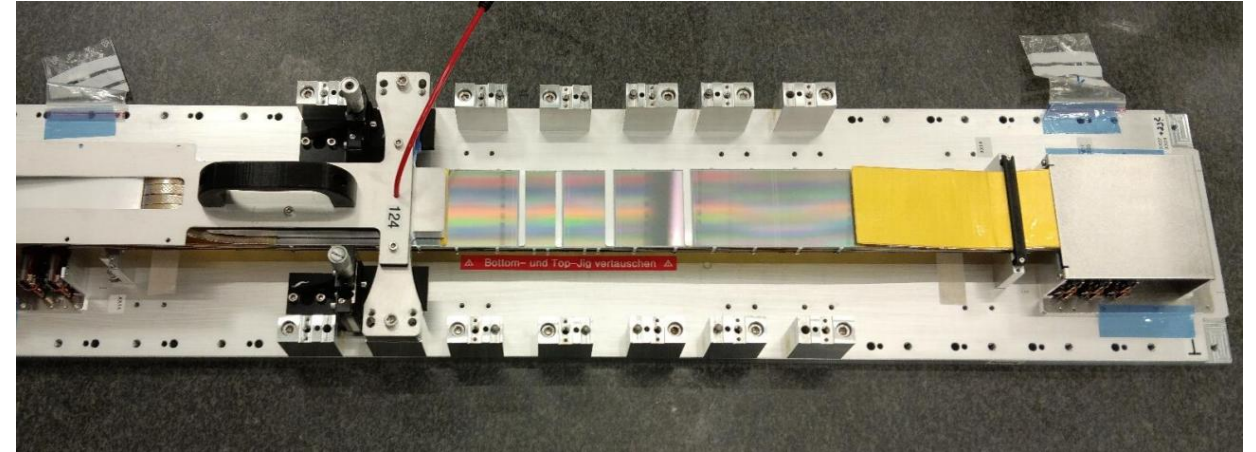
Fully assembled STS ladder carrying 10 modules

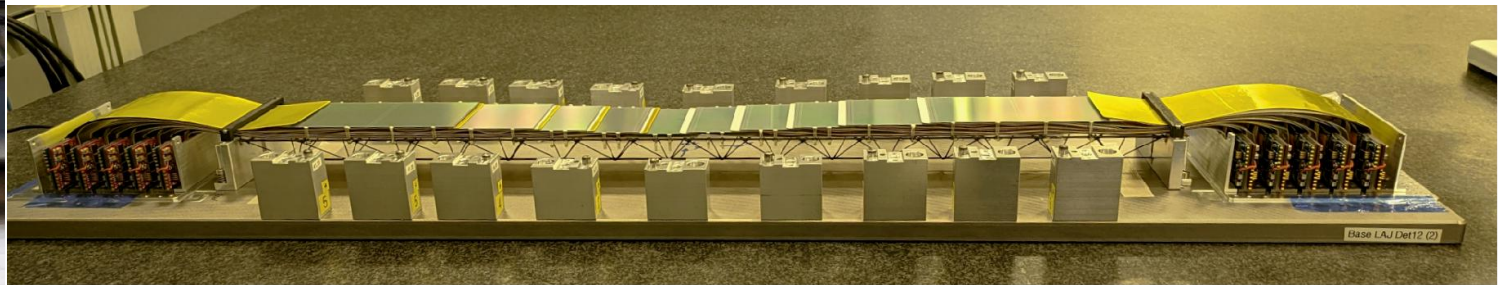
Fully assembled STS ladder carrying 10 modules

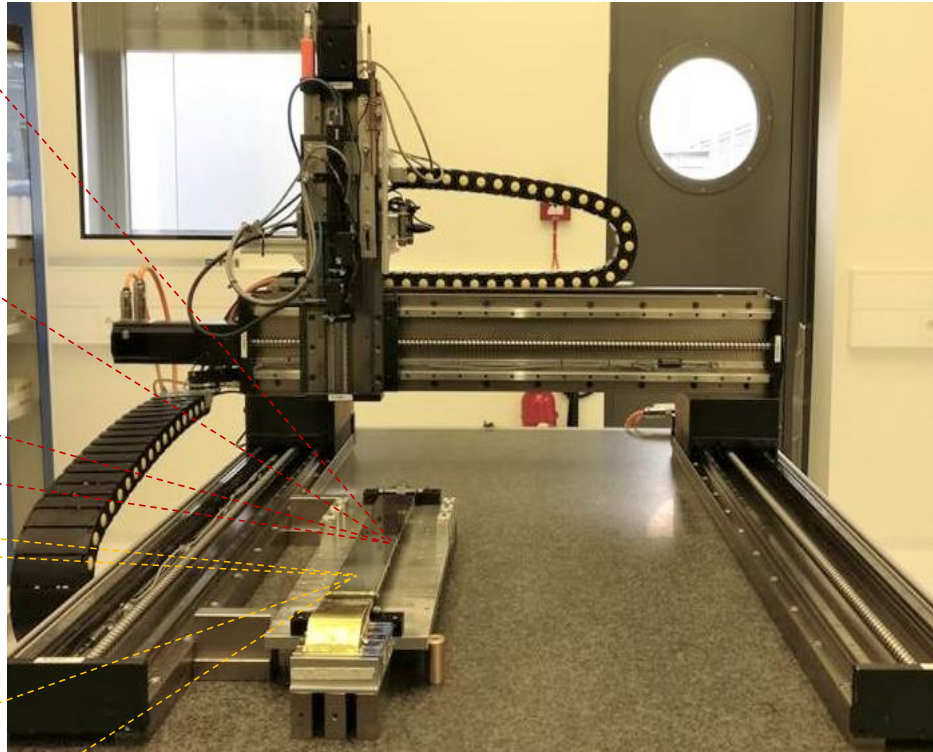
Setup to evaluate ladder assembly based on optical inspection of the sensor surface with precision better than $10\text{ }\mu\text{m}$

- XY based on pattern recognition
- Z (high) based on focus variation

Optical inspection setup

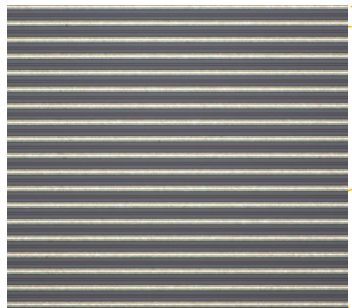
Deviation from nominal position [Z]
mm

XY deviations enhanced factor 100

Optical inspection confirmed the precise mounting of sensors, meeting the STS requirement of $\sim 100\text{ }\mu\text{m}$ accuracy

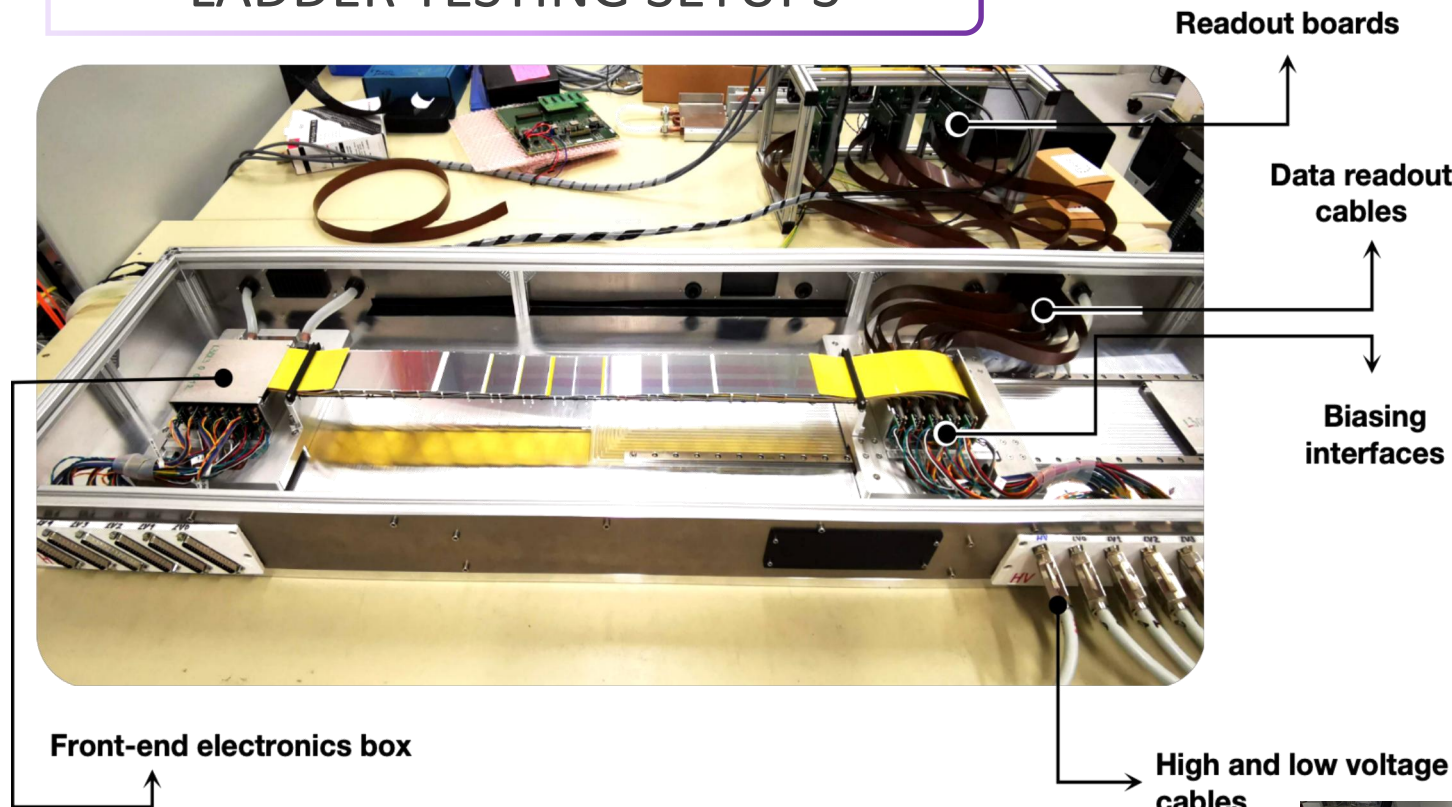
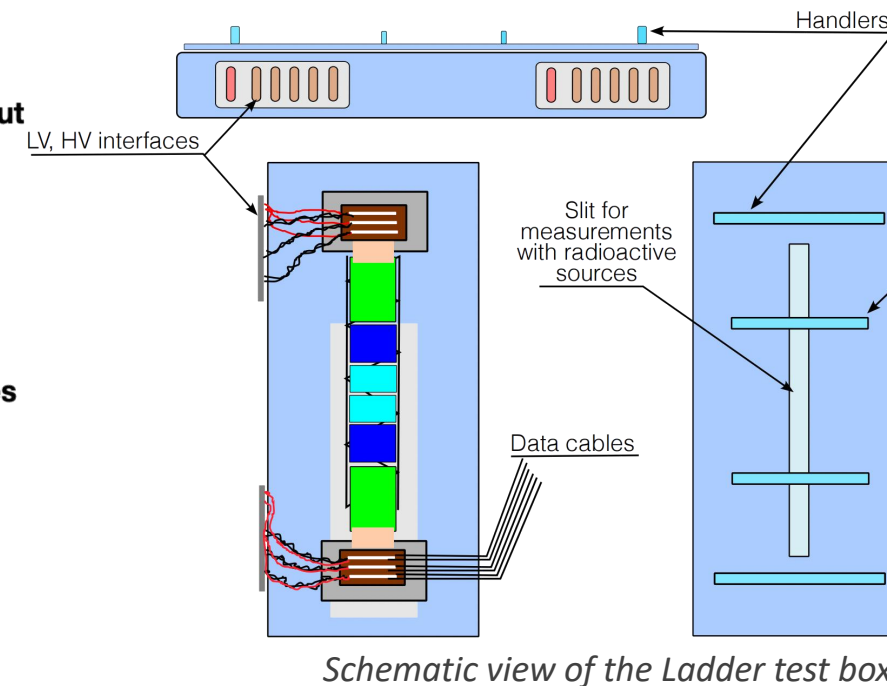
- Modular design that can accommodate all ladder types
- All interfaces for operation (LV, HV, data readout, cooling)
- Light tight, EMI protection
- Slit for measurements with radioactive sources
- Two testing stations are used to streamline ladder testing

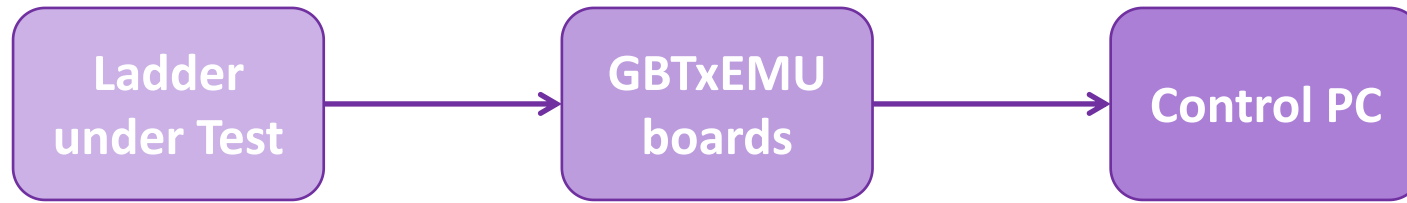
Existing readout chain

LADDER TESTING SETUPS: READOUT CHAIN

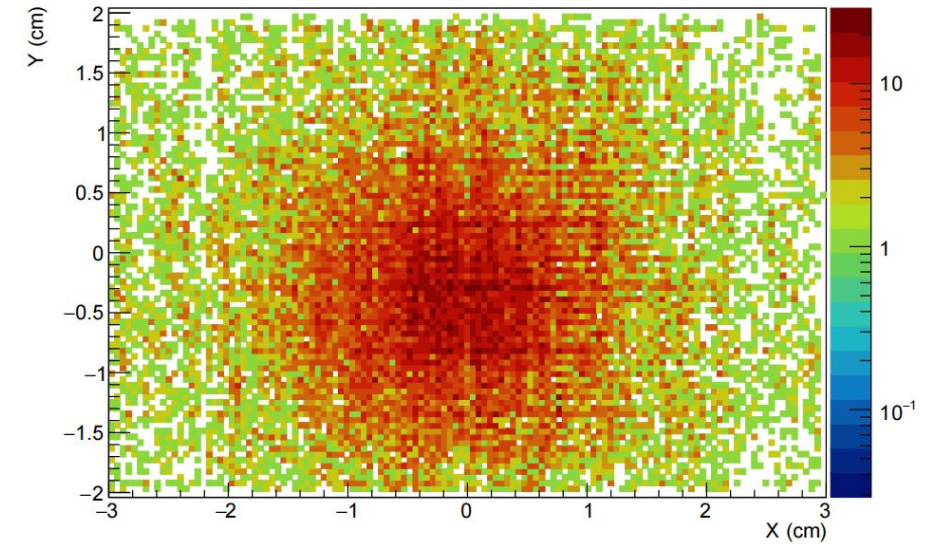
$^{90}\text{Sr}/\text{Y}$ source spot measured with a module of ladder L3DL100112. Channel artefacts linked to the limited readout bandwidth.

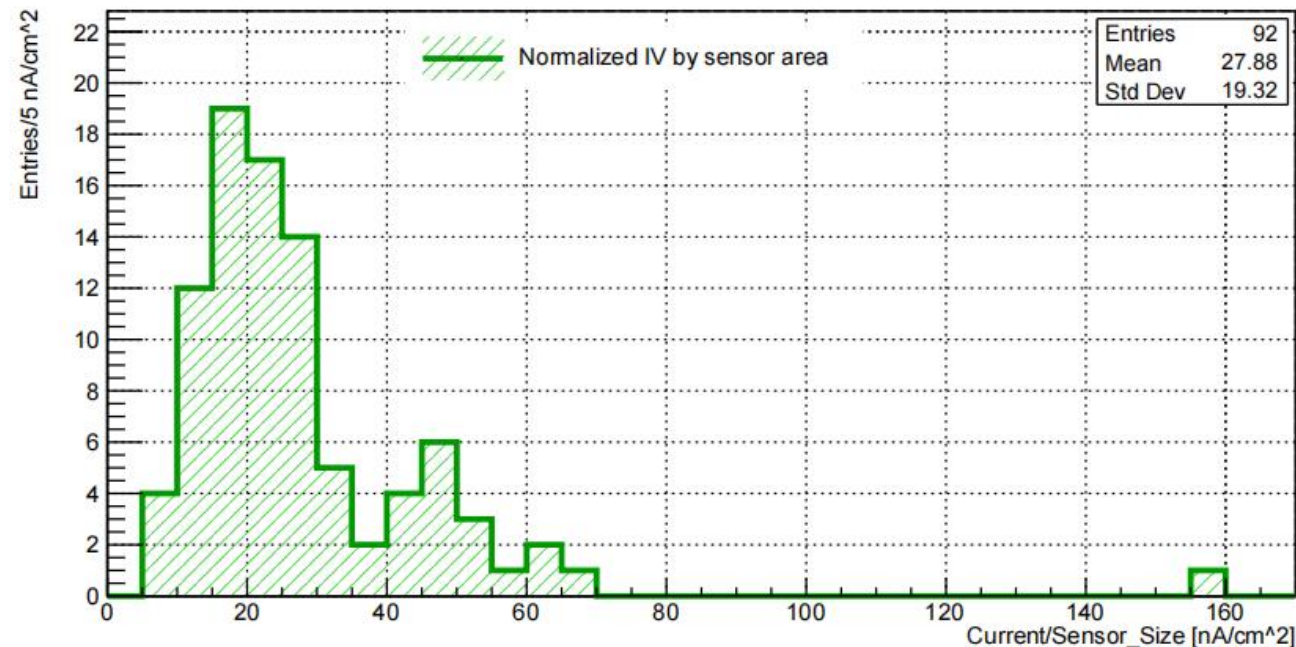
Sensor current measured at 150 V during IV measurements. The values are normalized by sensor area.

FINDINGS: All sensors from the tested ladders can be biased up to the voltage required at EOL

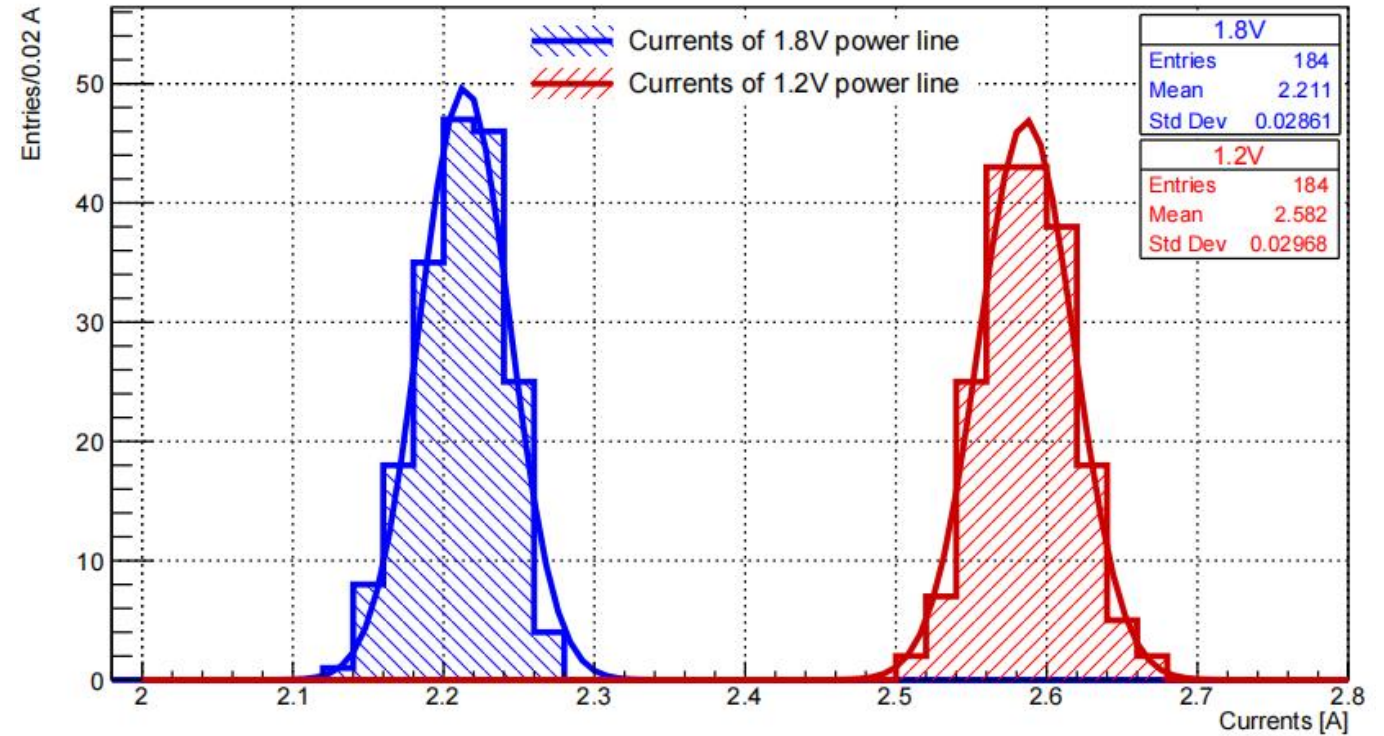
Current consumption measured for the two main power domains of the Front-End Electronics during testing. The red histogram represents the current distribution of the 1.2 V analog power domain, while the blue histogram shows the currents of the 1.8V power line, which combines the analog and digital domains.

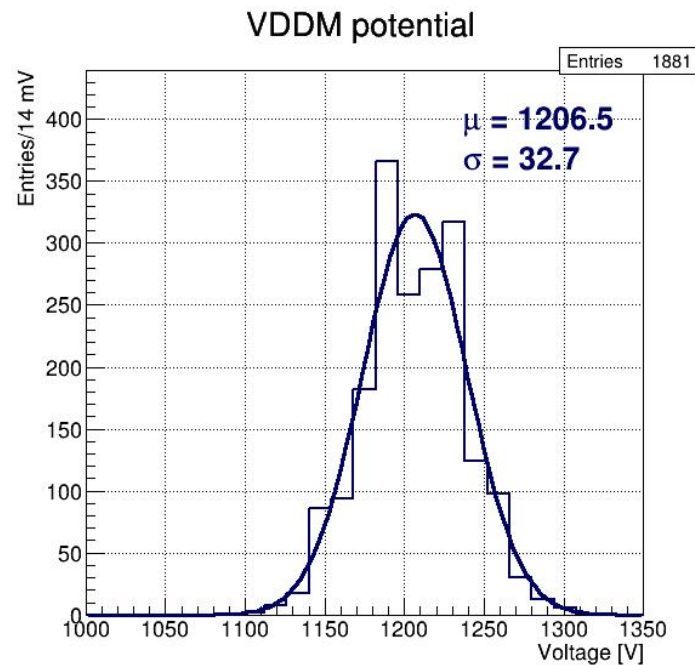
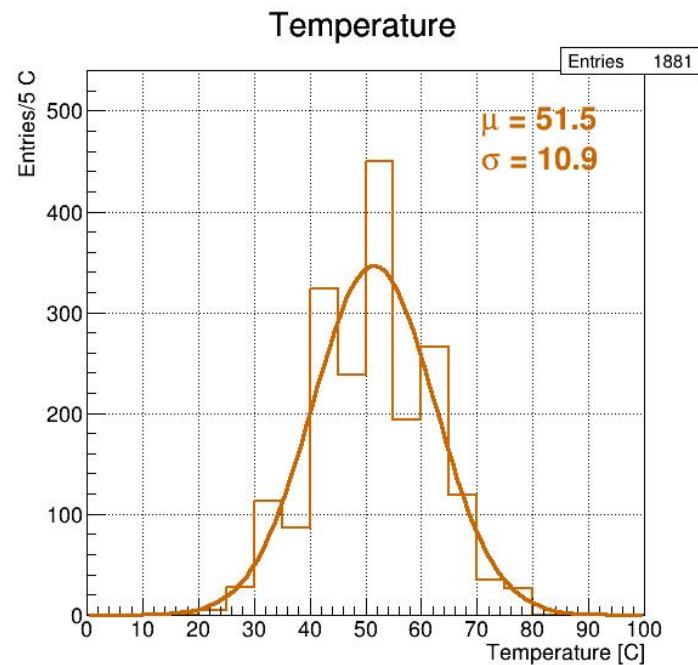
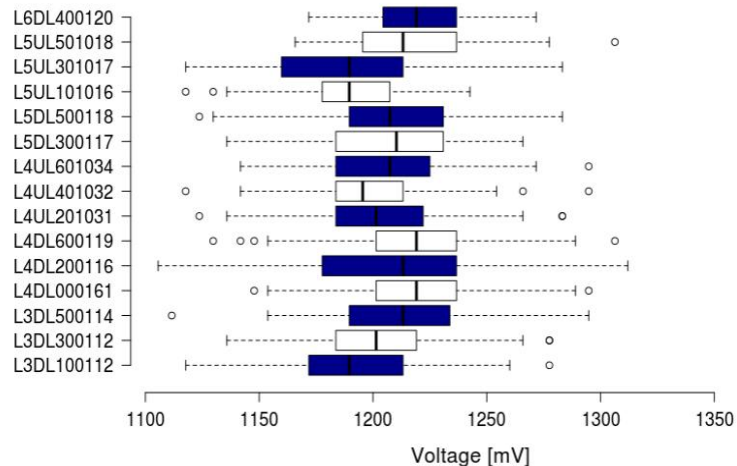
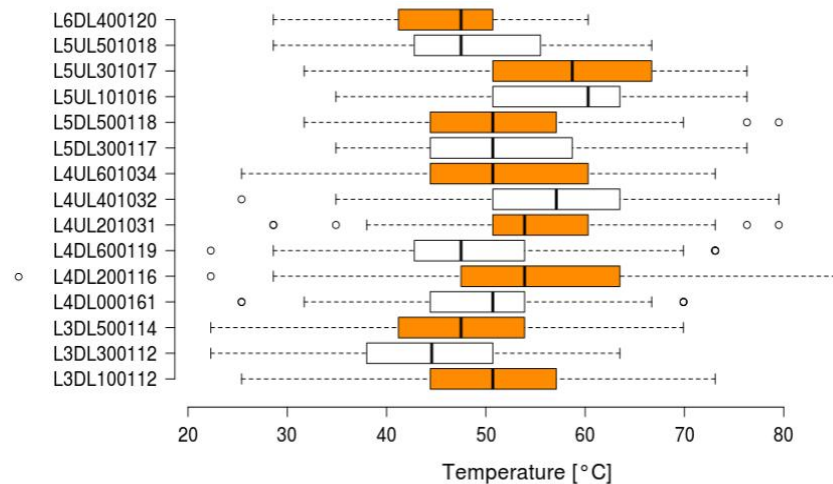
Distributions of ASIC operating potential (VDDM) and ASIC temperatures (TEMP) measured for all modules in ladders.

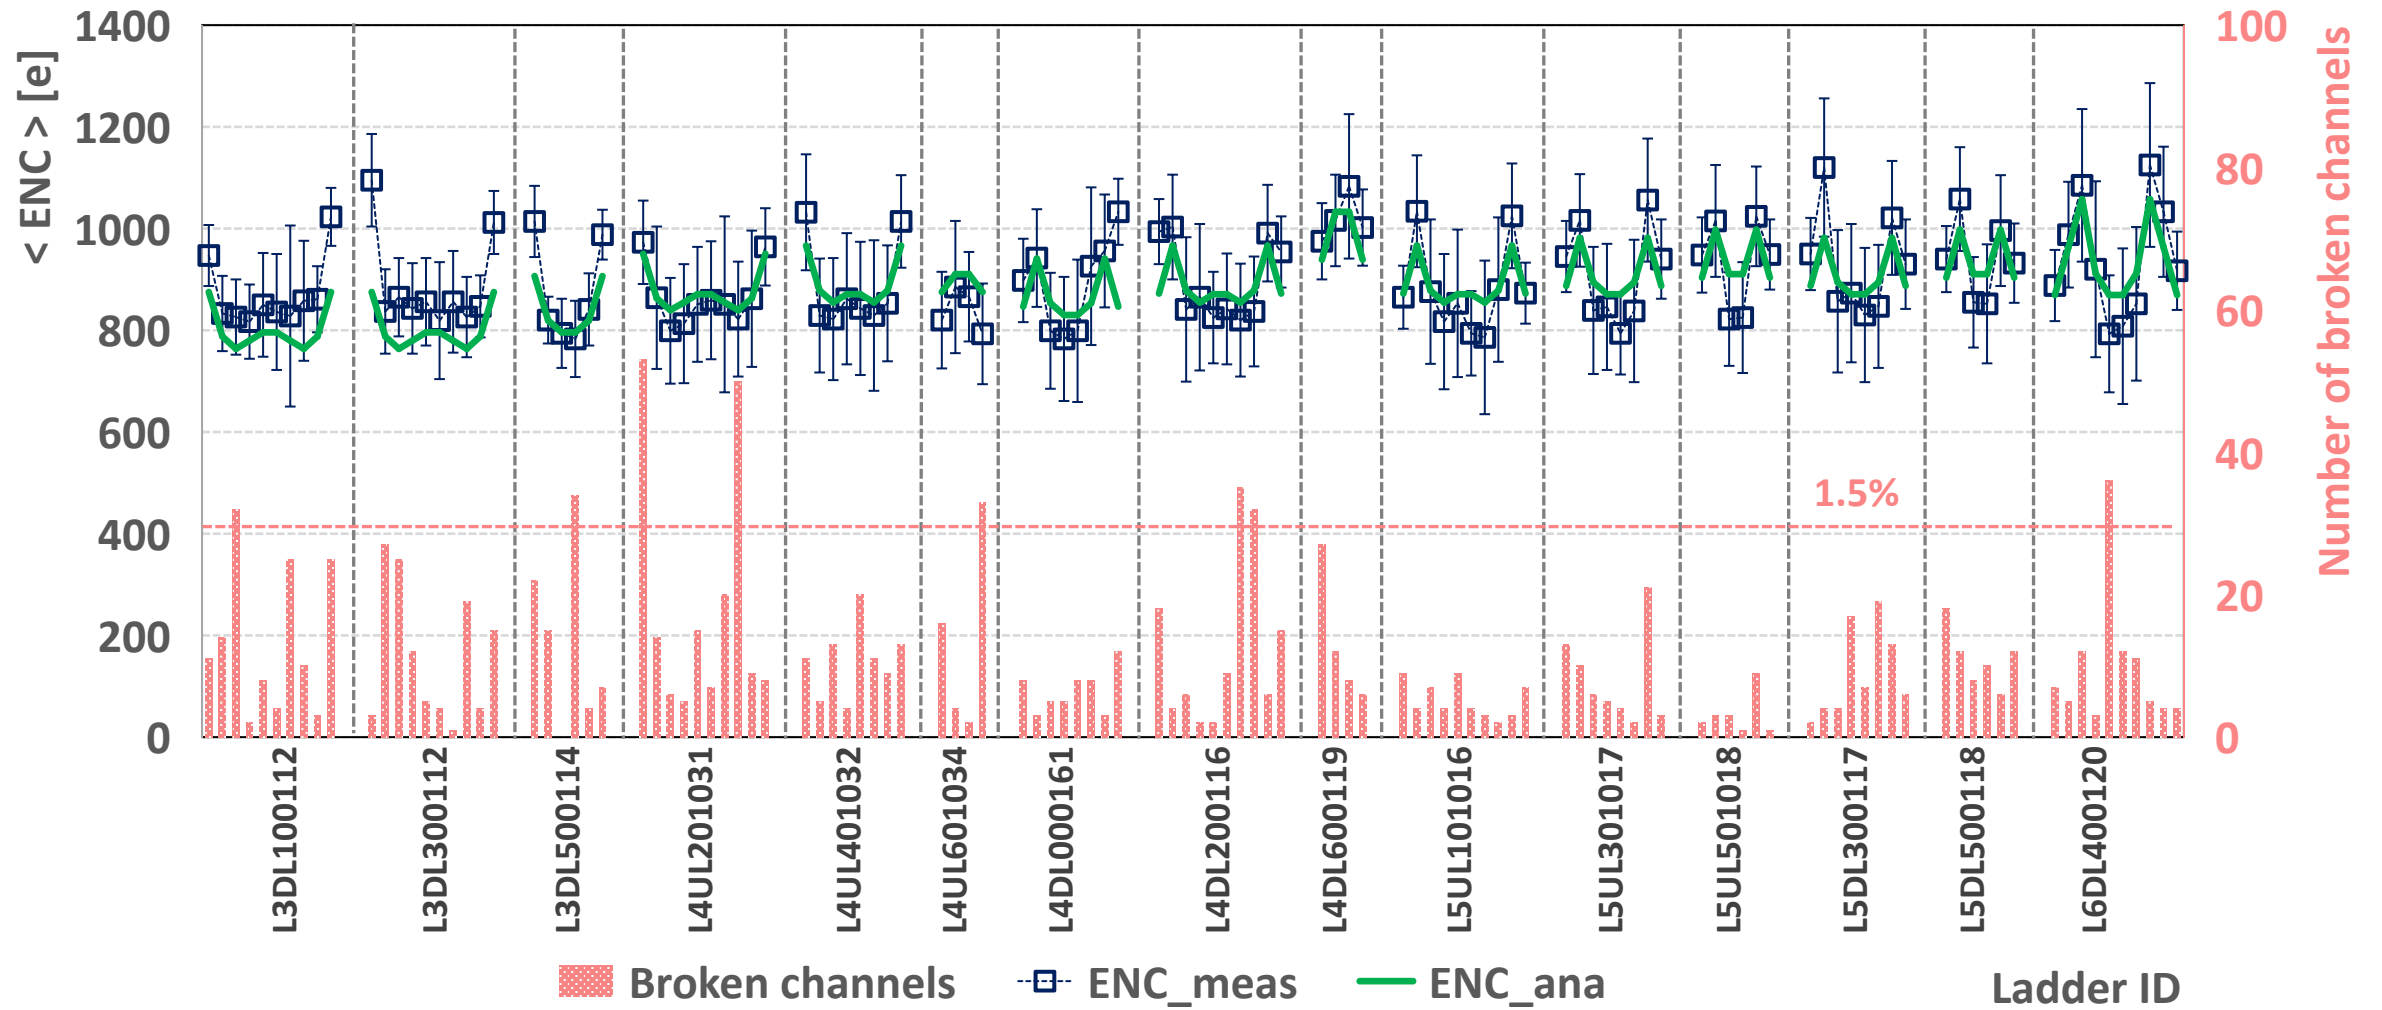
Noise values measured for each N-side module mounted on a ladder. All modules were biased at 150 V and fully configured. The average noise behavior is consistent with the ENC parametrisation based on the overall capacitance. Number of broken channels within the guiding lines of STS.

$$ENC = \left[\underbrace{L_{\text{sensor}} \cdot 1.02 \frac{\text{pF}}{\text{cm}}}_{\text{sensor}} + \underbrace{L_{\text{cable}} \cdot 0.38 \frac{\text{pF}}{\text{cm}}}_{\text{microcable}} \right] \cdot 25 \frac{e}{\text{pF}} + \underbrace{350 e}_{\text{ASIC}}$$

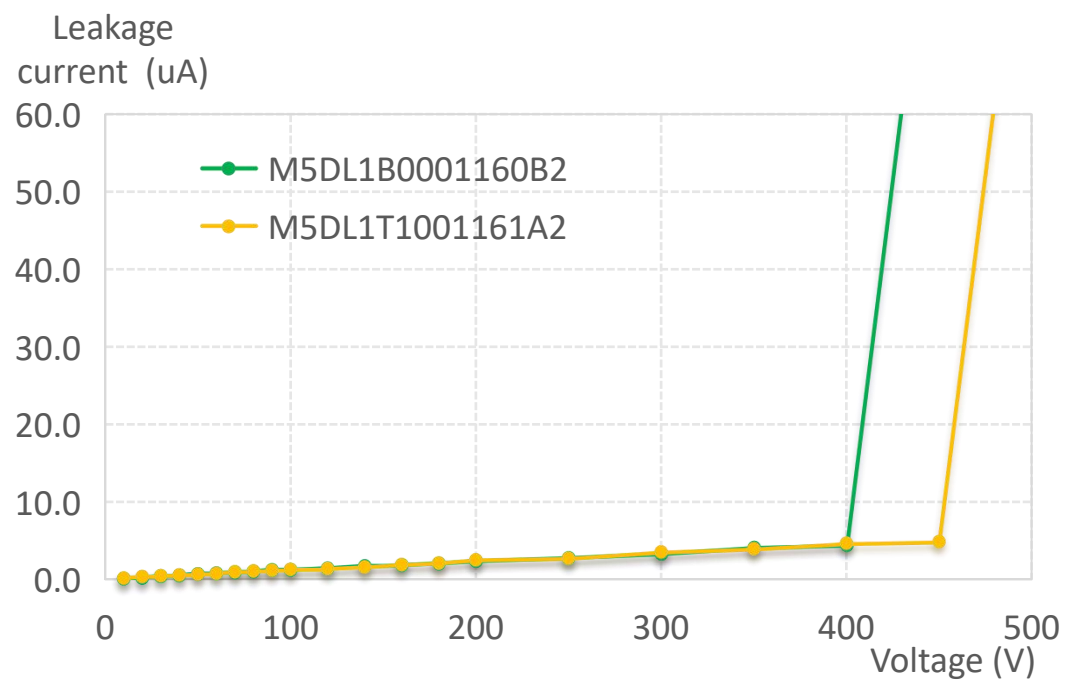
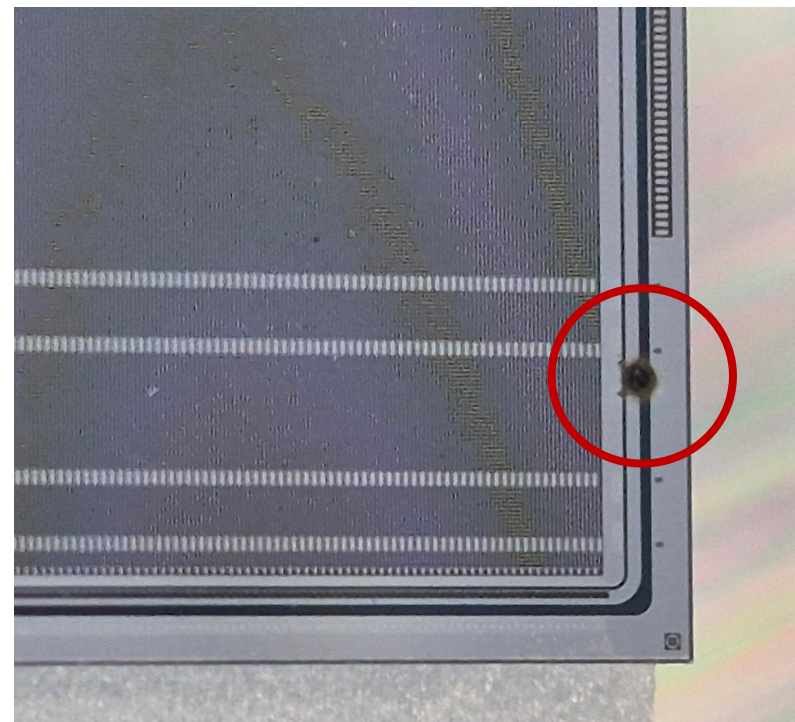
L5DL100116:

- All modules were biased at the same time to measure the IV
- LV and data cables were connected

Discharge onto HV-ring of B0 sensor

- An extra isolation layer of 7.5 um Polyimide (Kapton) was added to each shieling of modules with grade A (500 V)
- Modifications in the IV measurement procedure: LV and data cables are not connected when measuring IV

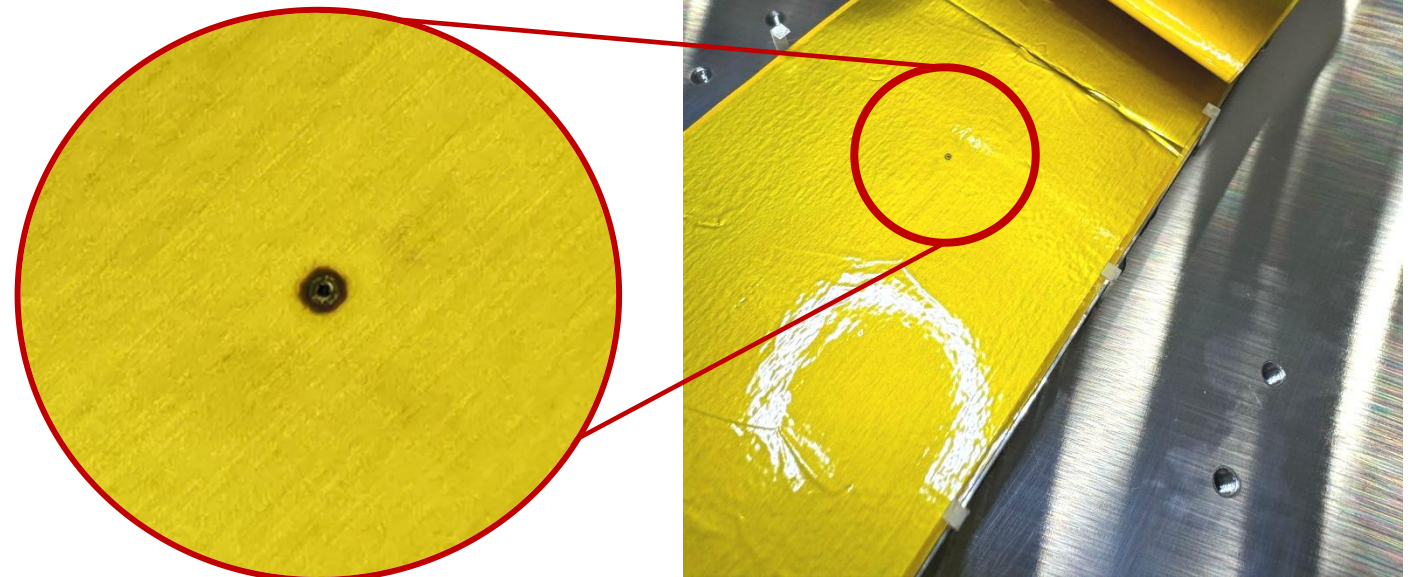
L5DL100116:

The T1 breakdown triggered multiple malfunctions in the setup:

- The LV PS lost communication with the software
- The EMU board, where T0 and T1 were connected, failed along with the uplink_1 driver on the n-side for T0 and the p-side for T1

RESULT: Three non-functional modules

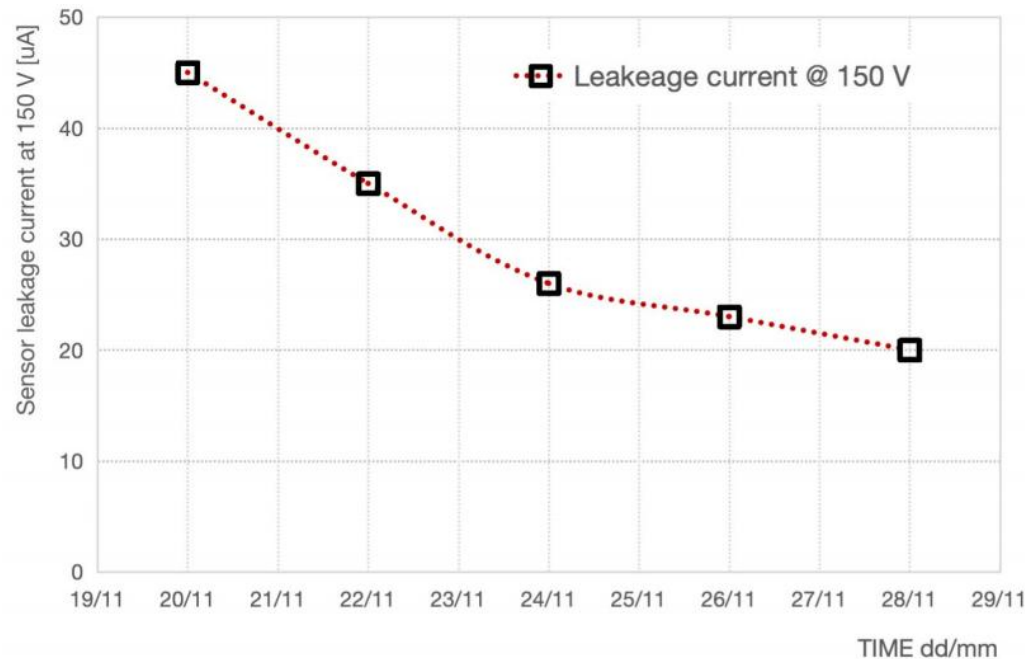
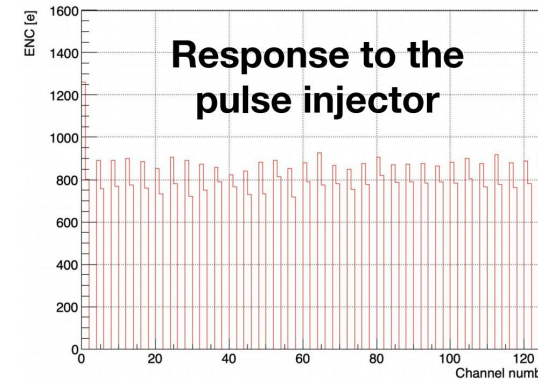
ASIC with problematic analog responses to injected pulses

- Monitoring the noise events in the counter indicates that the AFE of all channels was functioning properly.
- The analog functionalities on the ASICs were verified using $^{90}\text{Sr}/\text{Y}$ measurements.

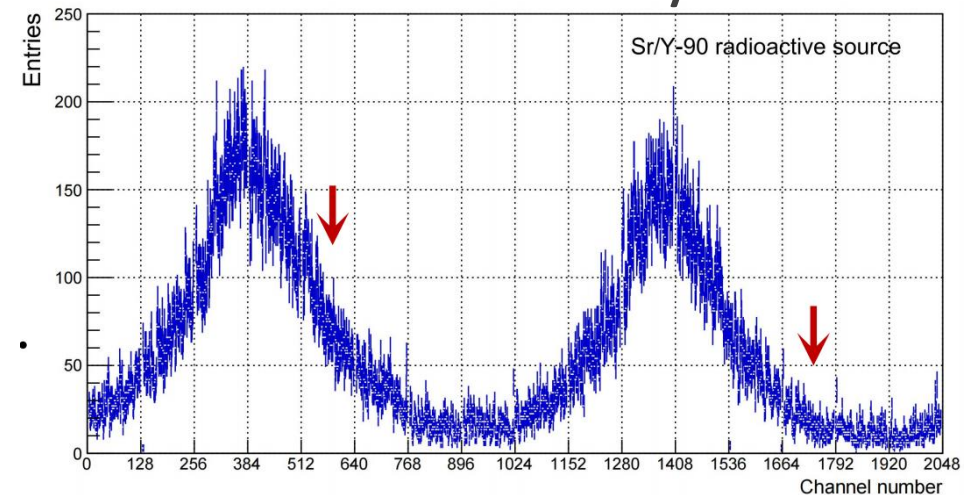
Measurements with $^{90}\text{Sr}/\text{Y}$ source

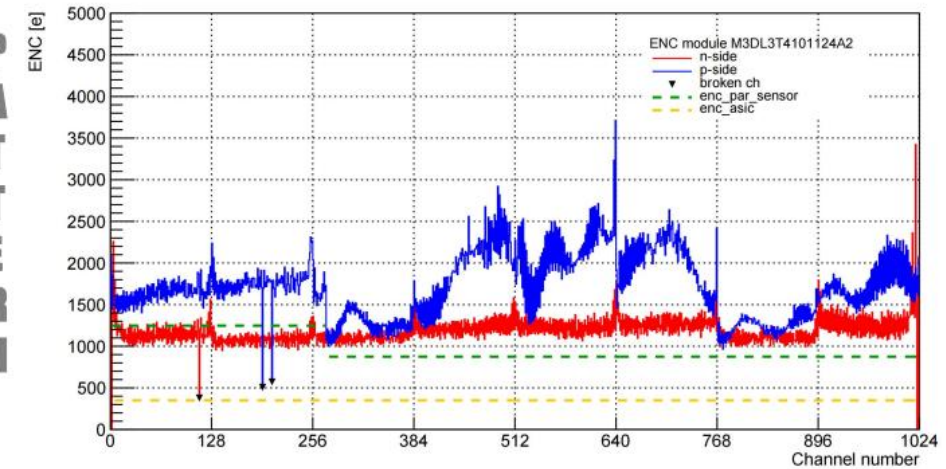
P
A
T
T
E
R
N

- Identified during Ladder Testing
- Also observed in standalone modules
- Up-to-date it has been observed ONLY in p-side.
- Mostly visible in 12 cm sensor modules
- Pattern changes after re-arrangement of the shielding -> (change in C).
- The pattern can be present in all ASICs of p-side.
- Within one ASIC, the pattern has a smooth behaviour (no jumps)
- It is reversible

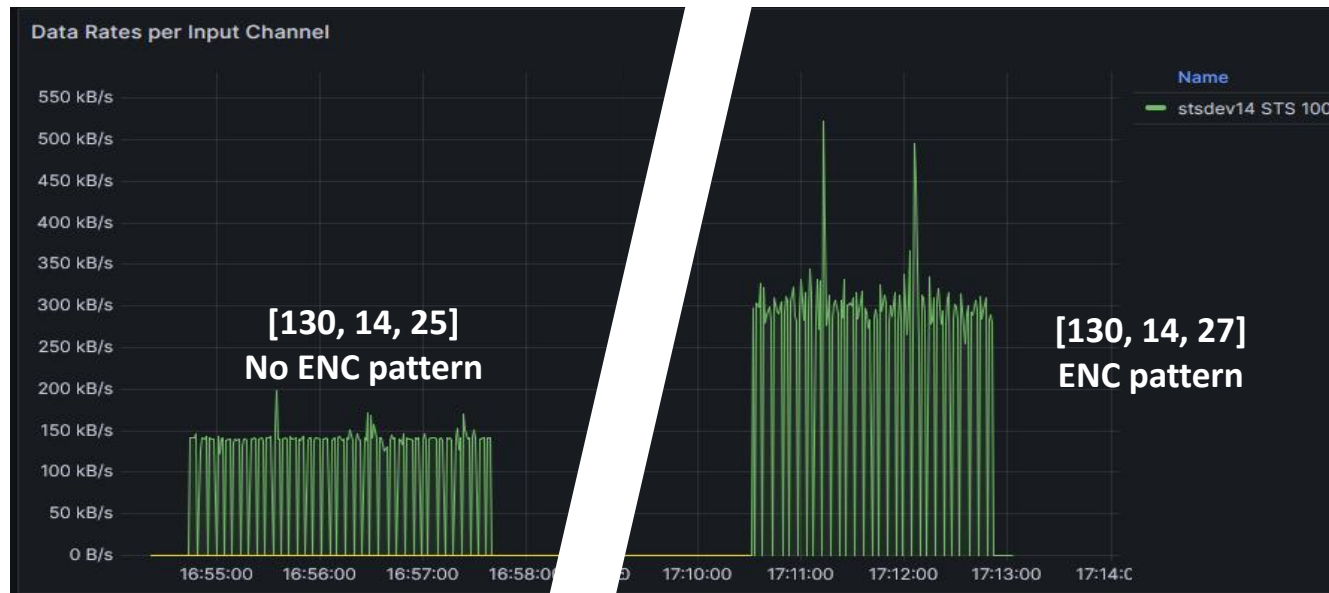
Findings: The **cascode current** plays a fundamental role in suppressing or worsening the ENC pattern.

Large **cascode current** values worsen the ENC levels.

Example of data rates of background measurements at different settings in Grafana. Data rate at high threshold (~10500 e) different settings comparison.

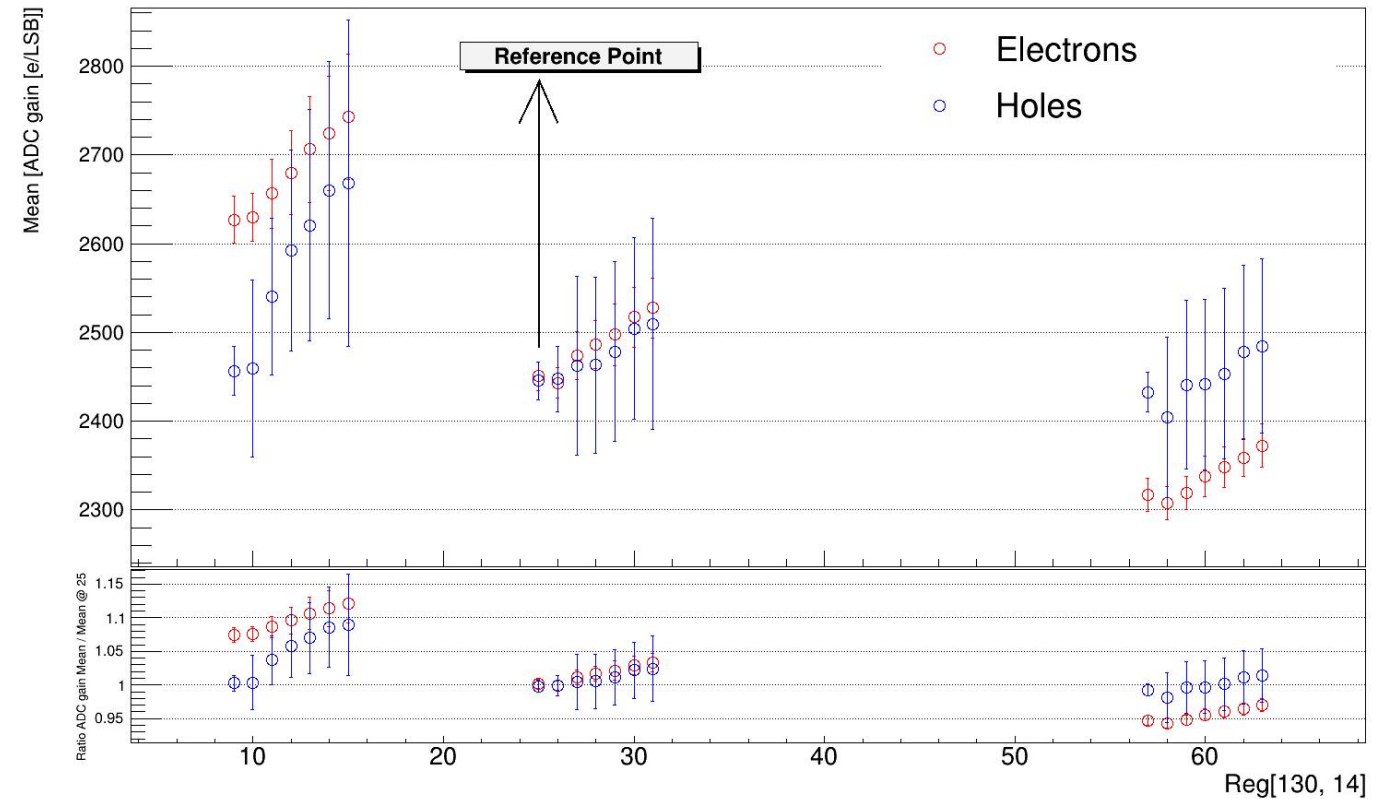
Average ADC gain shown for different values of the CSA buffer and cascode current. The former value used was 27 while the new value is 25. The variation of the ADC gain for these two values is minimum.
