Quality Assurance and radiation tolerance tests of double-sided silicon sensors for the CBM Silicon Tracking System

Pavel Larionov, Goethe University, Frankfurt, for the CBM Collaboration; e-mail: p.larionov@gsi.de

The Compressed Baryonic Matter experiment at FAIR

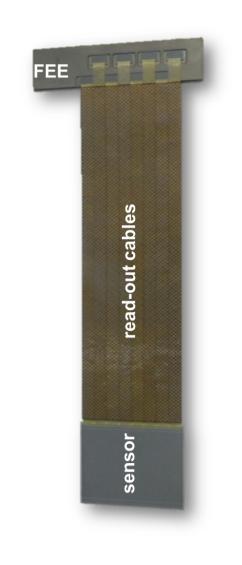
STS Module

A building block of the STS

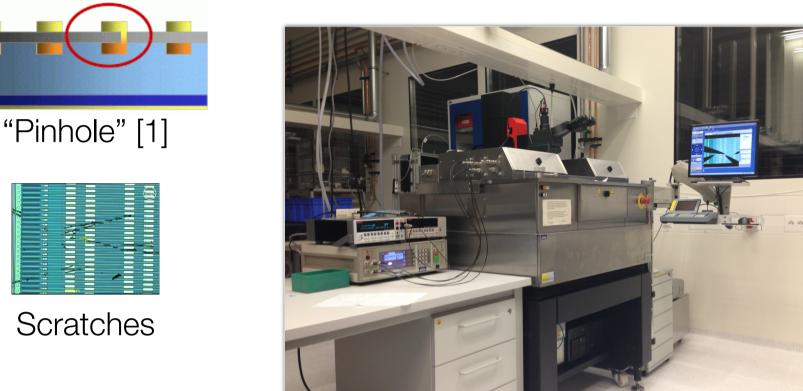
Metal short [1]

Metal brake [1]

Strip defects
