STT Activities in Jülich

STT @ COSY-TOF

PANDA - STT

16-Jun-09, PANDA Meeting, Torino

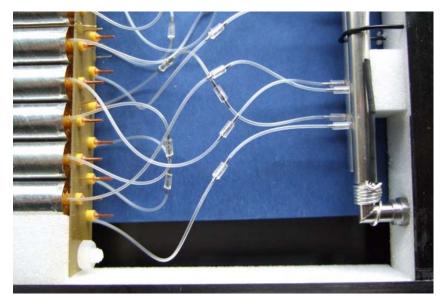
- Old design (glued PP-profiles) with micro leaks after months in vacuum
- New design: steel pipes (Ø=6mm, d=100μm)
 - 37 gram per double-layer of 204 straws
 - X/X₀ ~ 1.2% per double-layer (2 pipes for in-/outlet)
 - STT leakage at permeation level, measured: ~ 5 litre/day (Ar/CO₂ 10%)

gas pins (52×30) fixed by laser welding (FZJ-ZAT)

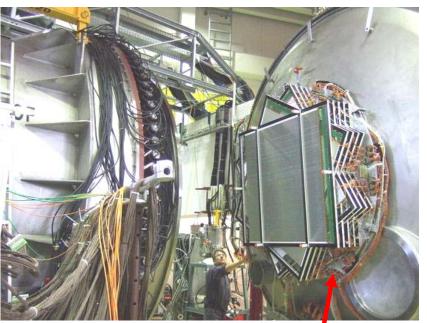
Mounting the front cap with STT to the vacuum barrel

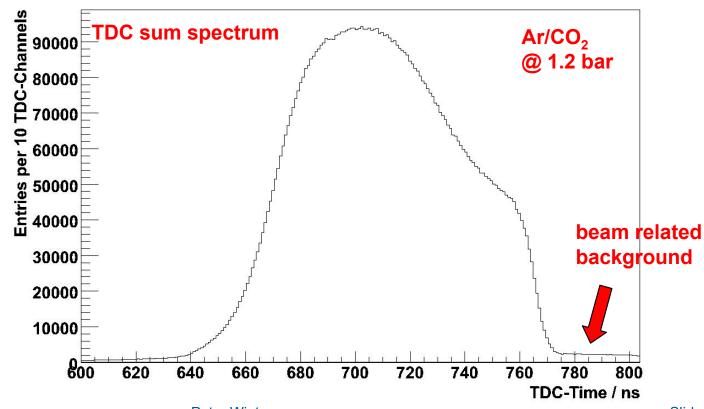
Clean and same TDC spectra for all 2700 straws

- σ (t_{max}=115ns) ~ 1ns $\Rightarrow \sigma$ (r_{max}=5mm) ~ 50µm (incl. wire sag)
- confirms precise straw diameter definition by pressurized film tube
- global space-time calibration for all straws
 talk by Matthias Roeder

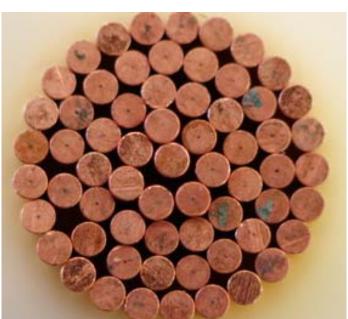
Quality problems of copper pins ('08⇒'09)

- unexpected for a repeat order at same company
- improper cutting (1.00×0.10mm OD×ID)
- cleaning by electrolytic etching possible
- but imperfect, inner hole diameters, ..
- stopped now

view at pins from top

Must find new production company, maybe

- new material (steel?)
- new design
- new mass production
- new crimping test

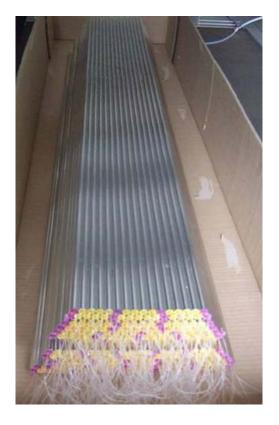
New straw production during past months:

- 1200mm length
- unwired due to lacking crimp pins
 - check mechanical setup
 - check skewed layer setup
- to be mixed later with wired straws for tracking
- removal of single straws inside d-layer tested
 - weaker mylar films (2×windings) than before
 - similar mylar (winding) imperfections than before
