# Setup of the Test-Station

## Si-Strip-Detector:

# Measurements and Results

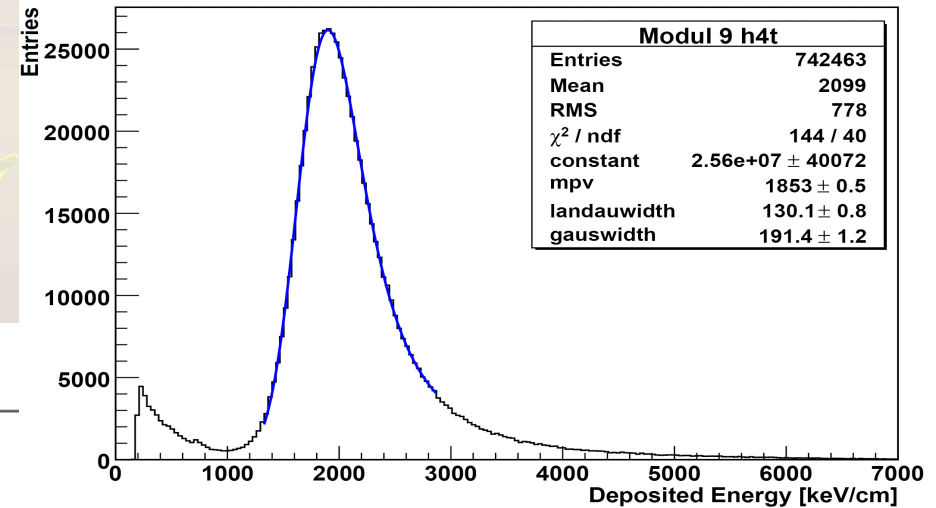
Histogram of a 23-hours energy loss measurement, peak fitted with convoluted Landau-Gauß-distribution

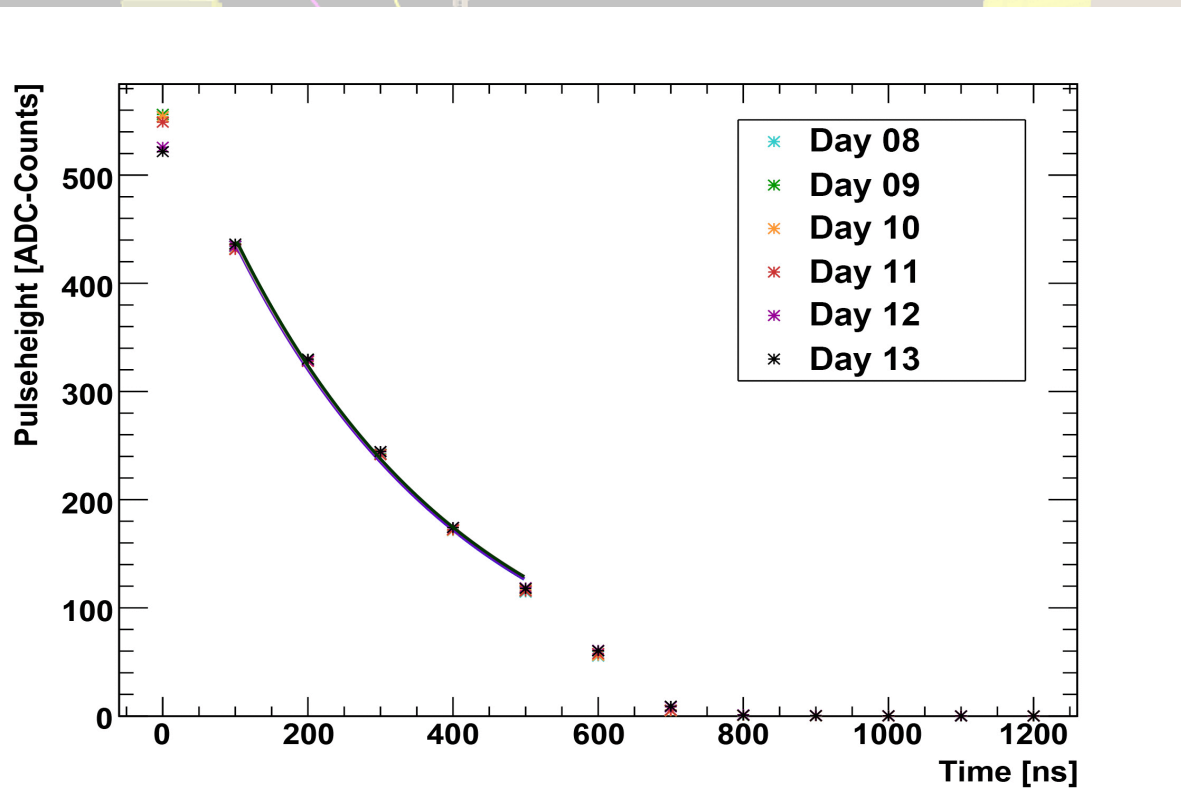
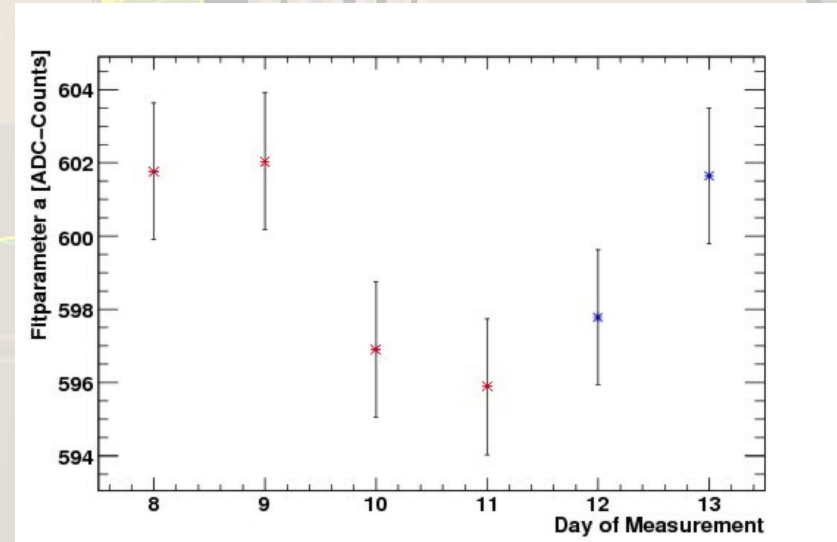
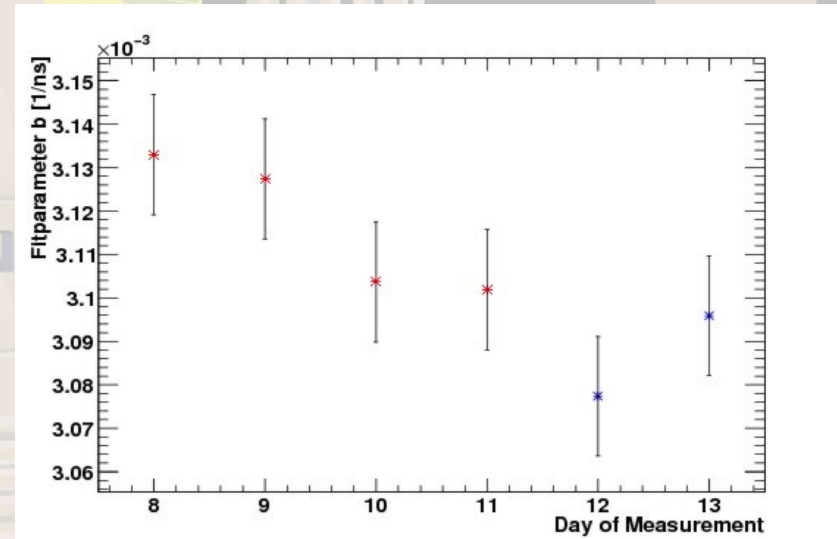
Analysis of the pulshshape for one selected strip

- days 8 - 11 with direct sensor-absorber-contact
- days 12 and 13 with sensor-absorber-gap of 4 mm
