Problem with FRS dipole magnets

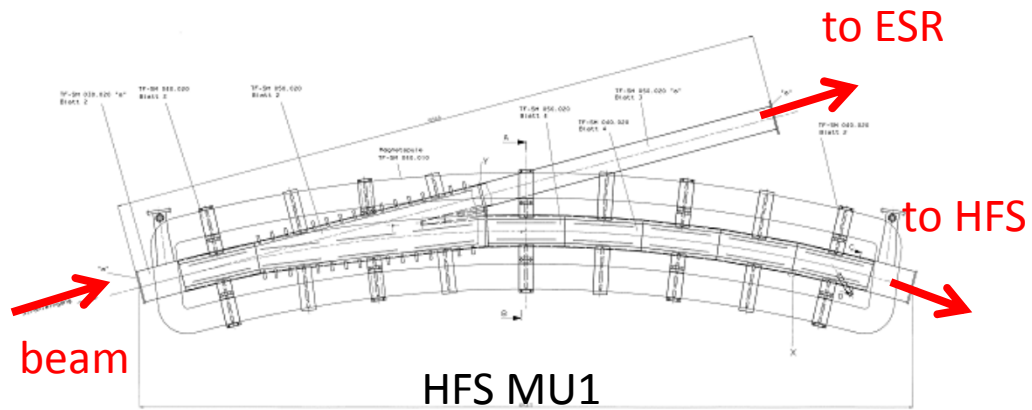
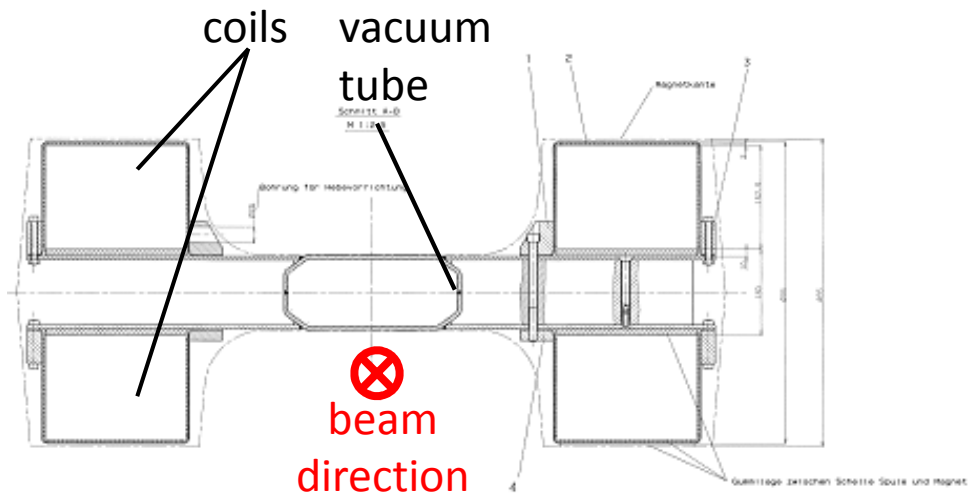
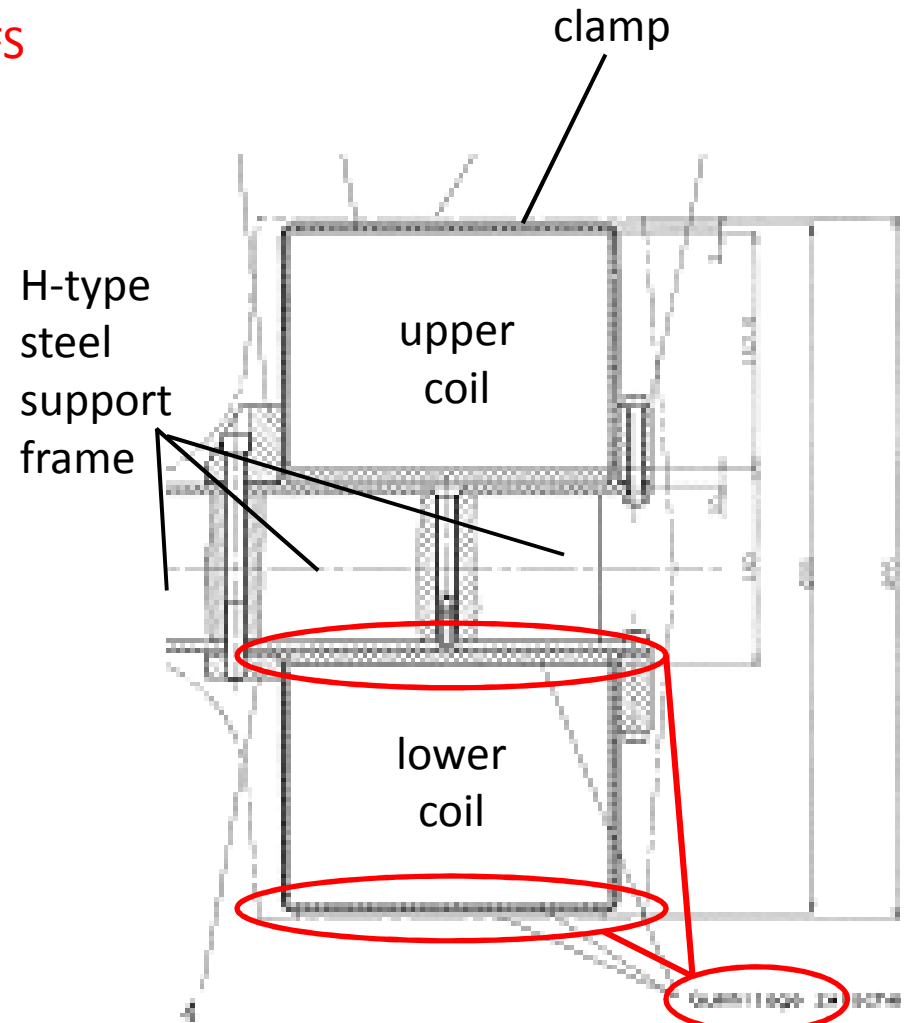
During the Hall-probe calibration procedure, it was noticed that the upper coil of a dipole is lifted by $\sim 1\text{cm}$

First result of scrutiny: the damping material ($\sim 2 \times 5 \text{ mm}$ rubber-type plastic) between the coils, which keeps the coils in position, has „disappeared“; it was found to lie between the yokes
