# KOrea Multi-Purpose Accelerator Complex

- About KOMAC
- Operation Status
- Trouble-shooting
- > Plan
- Summary

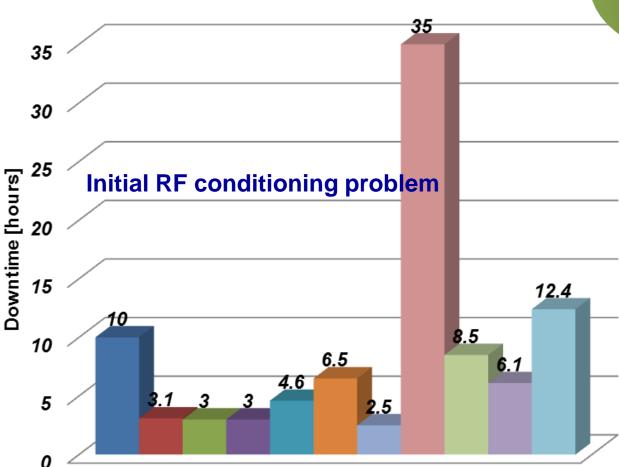
- Moulator IGBT blast
- MPS interlock
- Moulator controller malfunction
- Klystron magnet fault
- Moulator Oil pump failure
- HV fault at Ion source
- LLRF controller fault
- RF arcing at Power coupler
- Electrical failure
- Shielding door failure
- PSIS PLC fault
