# Update on MCP-PMT investigations

Klaus Föhl

PID session - PANDA meeting at GSI

6 March 2018

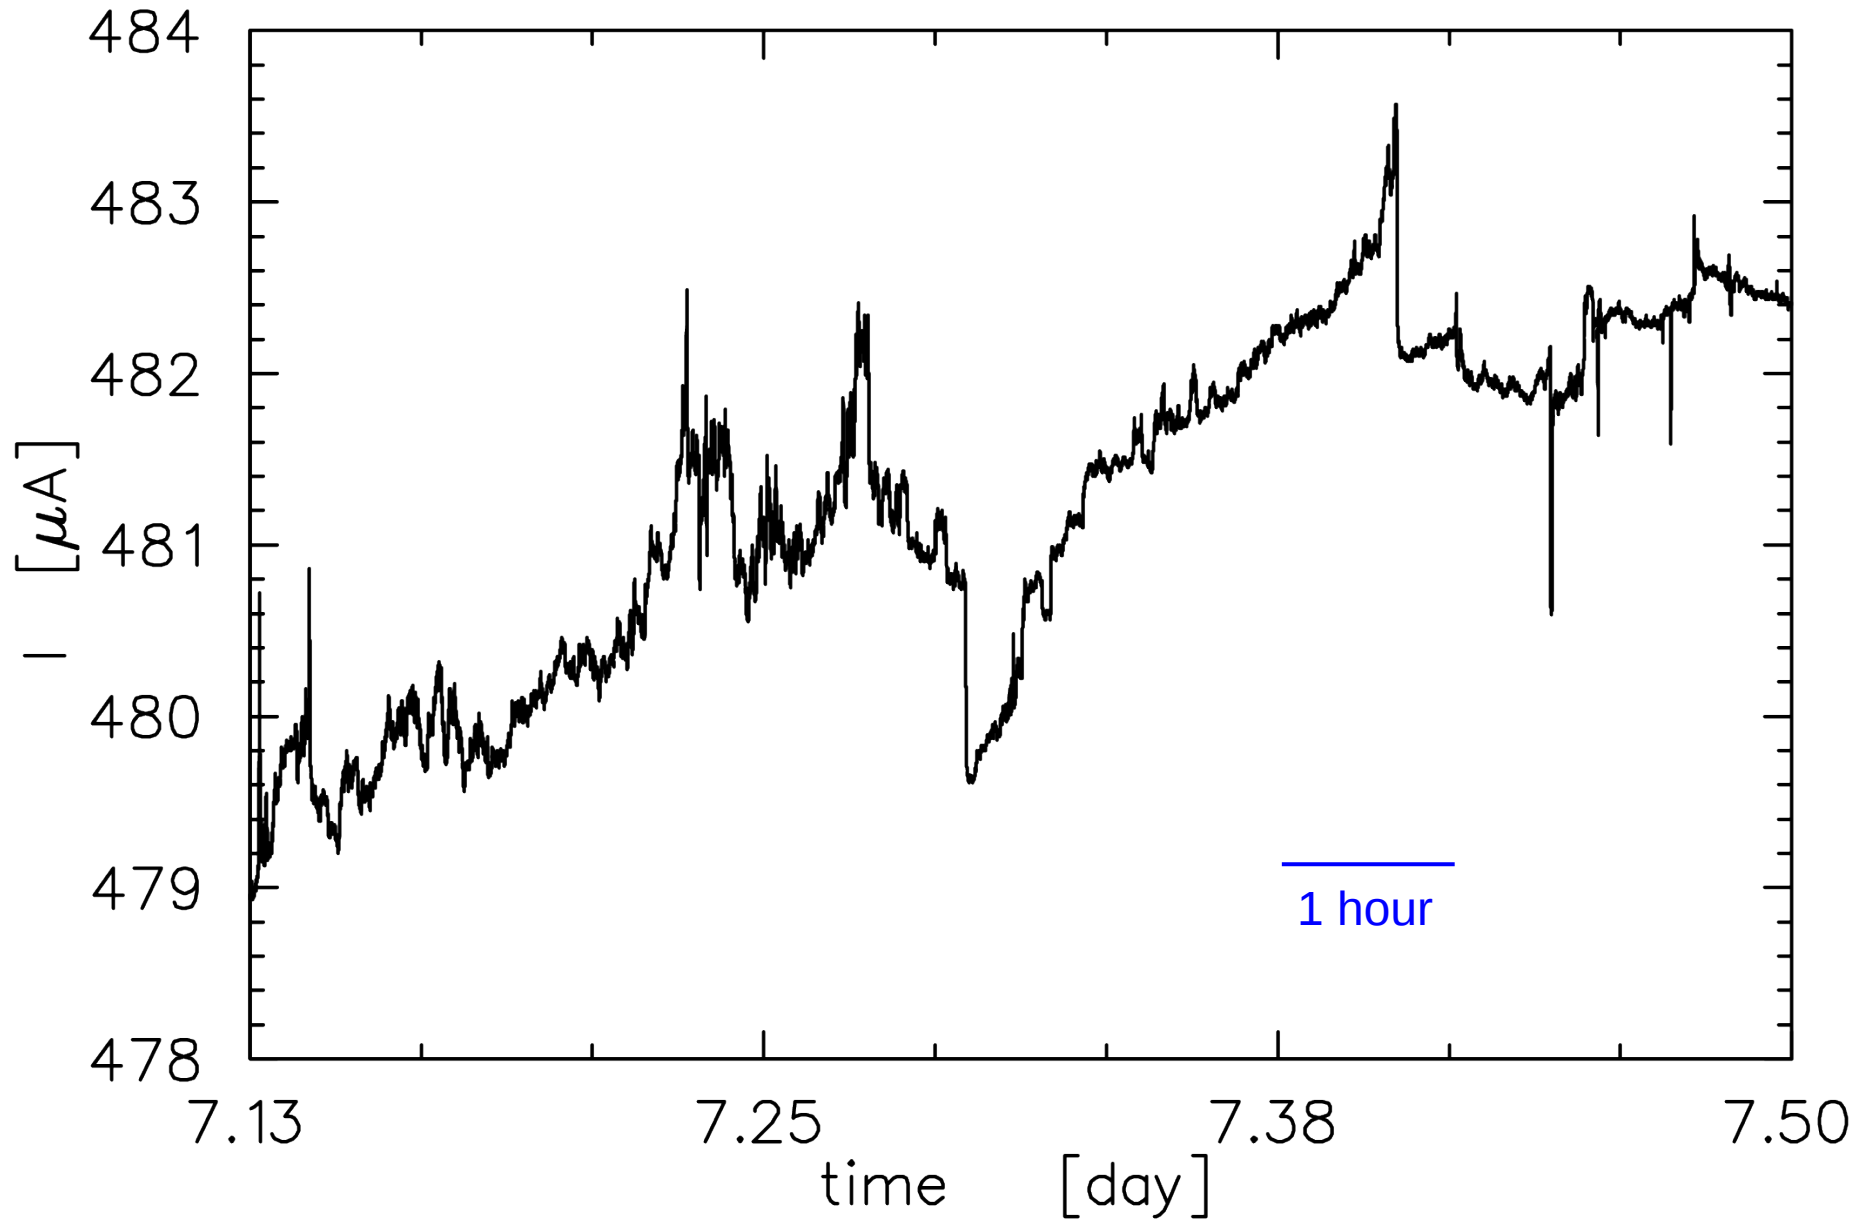
# Current - detail 1

~5 mW extra power – deposited into the sensor, unfortunately not only into the resistors

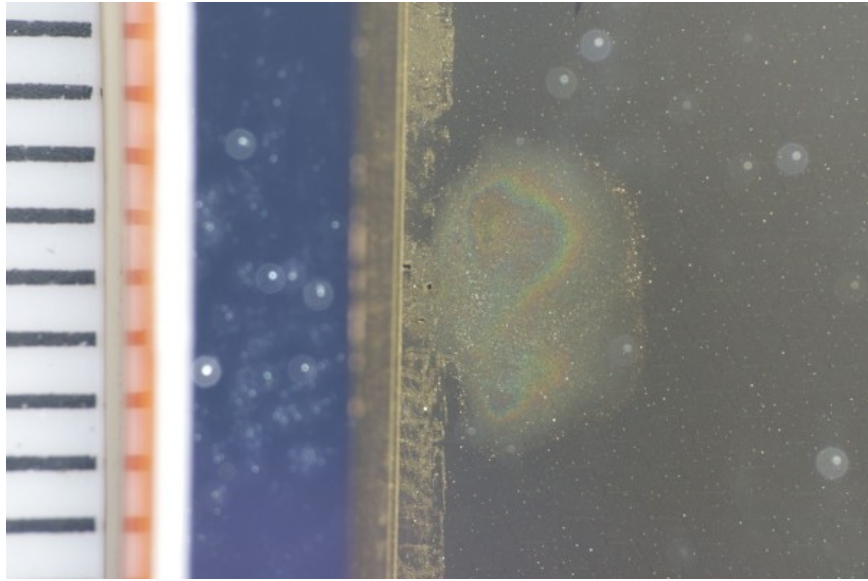
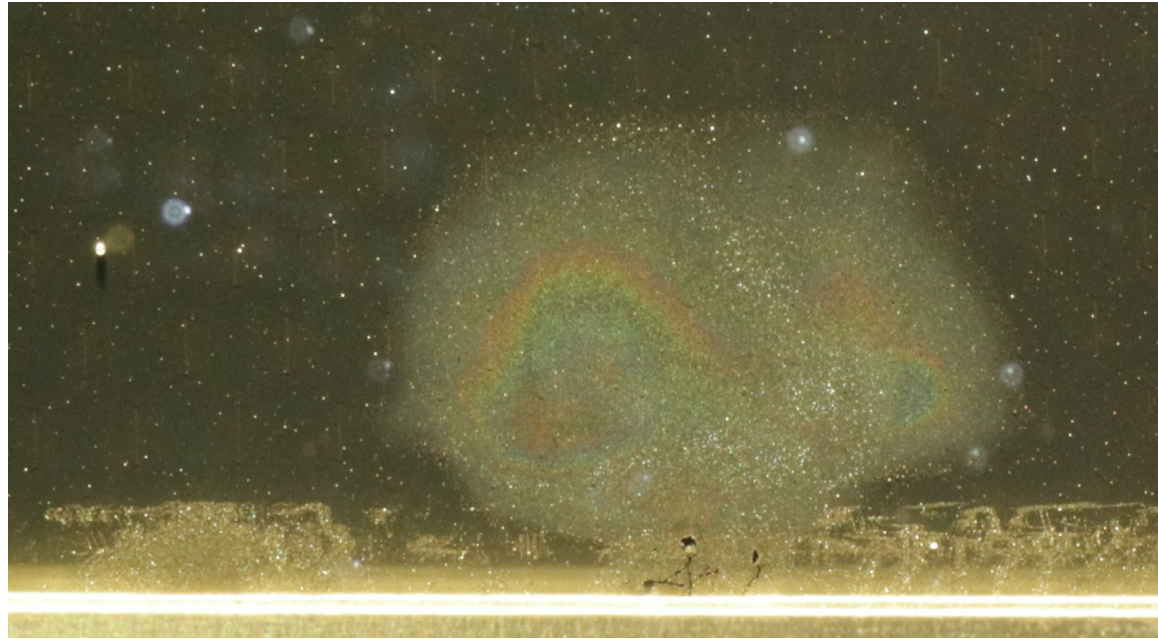
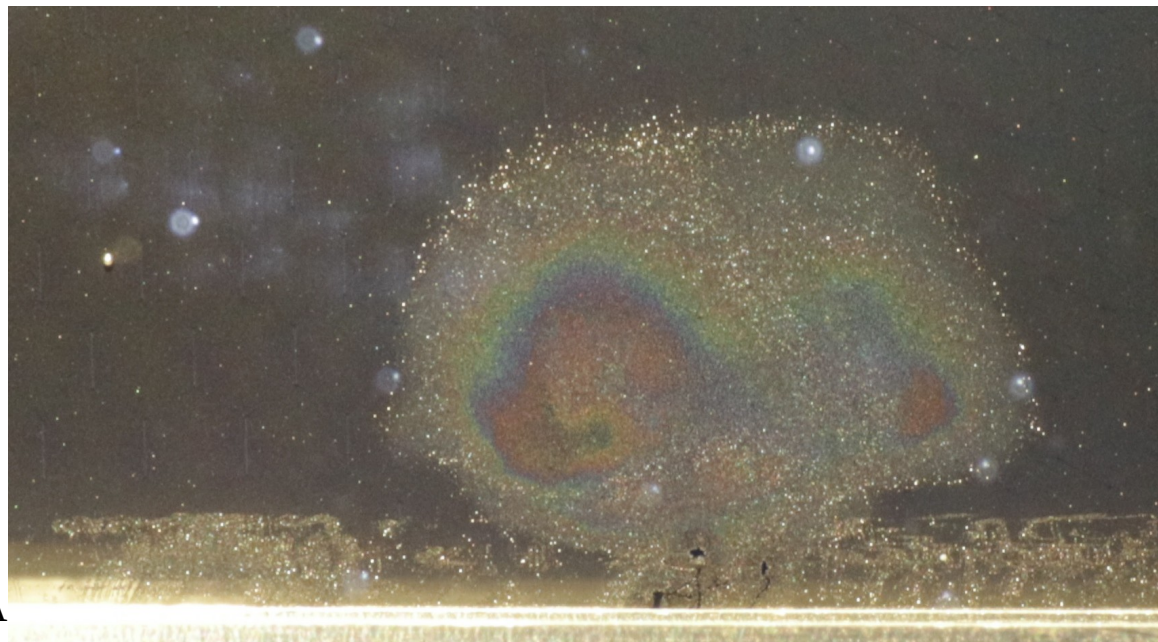
# Overview

- White granular cover on 1<sup>st</sup> MCP front
  - one big grain casting a shadow
- Patch ~ 5x3 mm<sup>2</sup>
  - thickness fractions of  $\mu\text{m}$
  - dielectric layer – presumed metal, source unknown
  - black filaments on 1<sup>st</sup> MCP leading to rim
  - matching filaments on photo cathode
- Some minor black mark in corner
