# Radioactive Material Leak at the Hadron Experimental Facility of J-PARC

Tadashi Koseki and Fujio Naito for J-PARC Accelerator group  
Accelerator Laboratory, KEK & J-PARC Center (KEK&JAEA)

**ABSTRACT:**  
In J-PARC, a radioactive material leak accident occurred at the Hadron Experimental Facility (HD facility) on May 23, 2013. The accident was triggered by a malfunction of the slow extraction system of the Main Ring synchrotron (MR). A beam of  $2 \times 10^{13}$  protons was extracted within a very short time of 5 ms and delivered to the gold target in the HD facility, whereas normally a total of  $3 \times 10^{13}$  protons were extracted for 2 s. The gold target was instantaneously heated up to an extraordinarily high temperature due to the short-pulse beam and partially damaged. As a result, the radioactive material dispersed from the gold target and leaked into the primary beamline room, because the target container was not hermetically sealed. Since airtightness of the primary beamline room was not sufficient, the radioactive material leaked into the hadron experimental hall (HD hall) and workers were exposed to radiation. Additionally, due to operation of ventilation fan

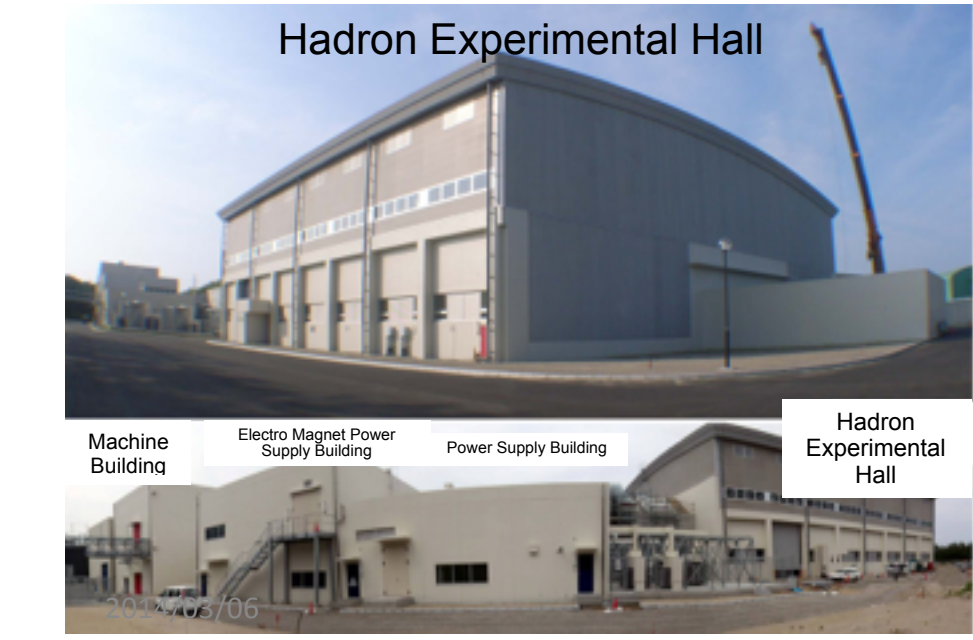
## Hadron Experimental Hall :

The building is 56 m long, 60 m wide, 16 m roof height with 6 m deep semibasement structure to accommodate experimental instruments.
