EDD Radiator Quality Measurements

PANDA CM 20/3 27.10.2020

Setup in the Clean Room

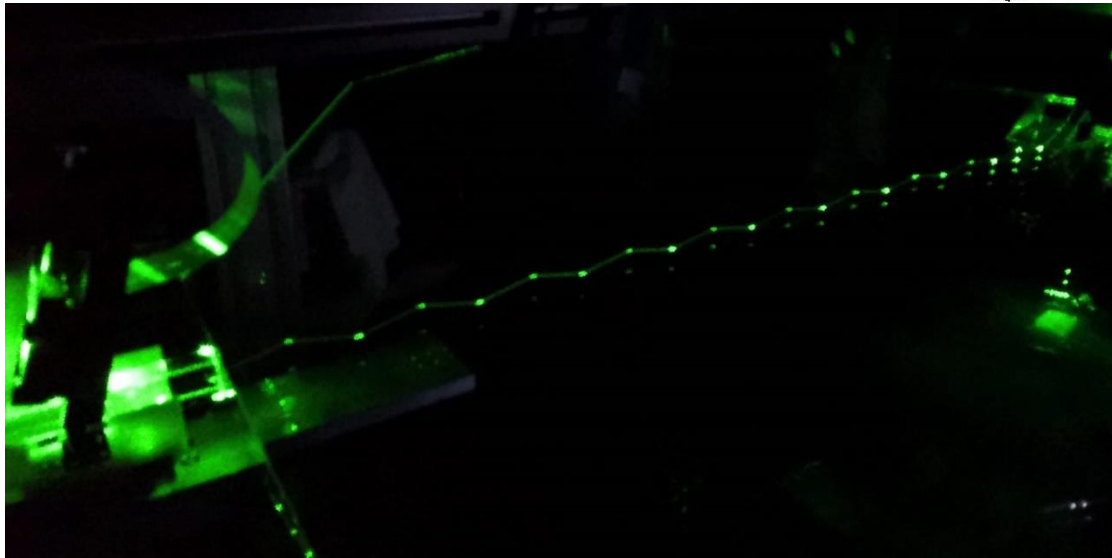
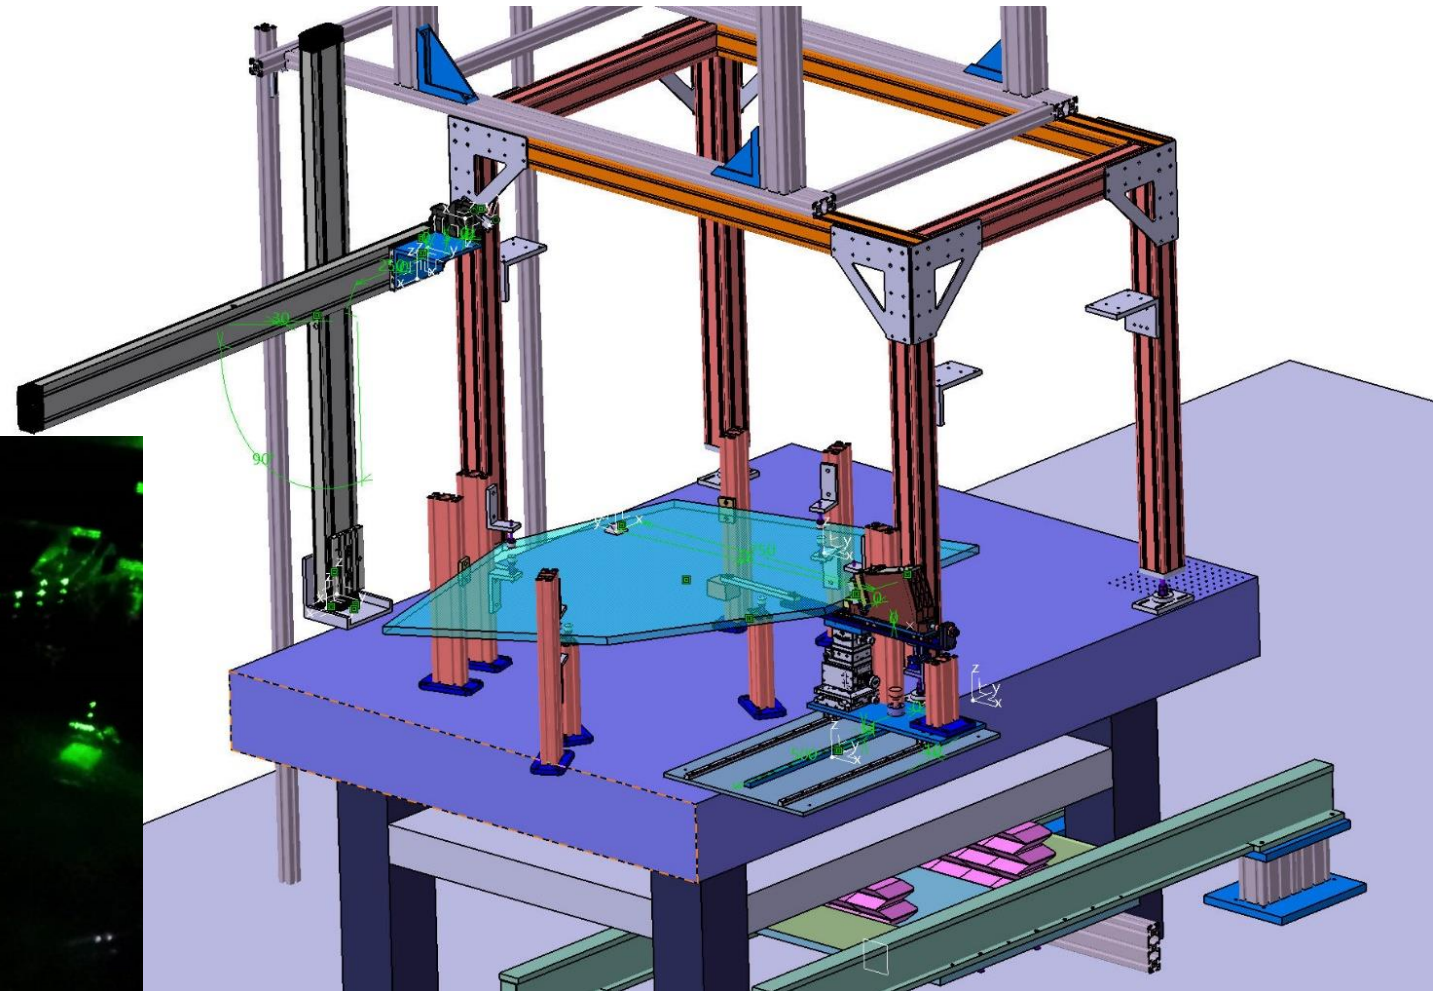
- Fused silica quadrant and ROM on the optical table
- Cross of linear stages on the side of the table

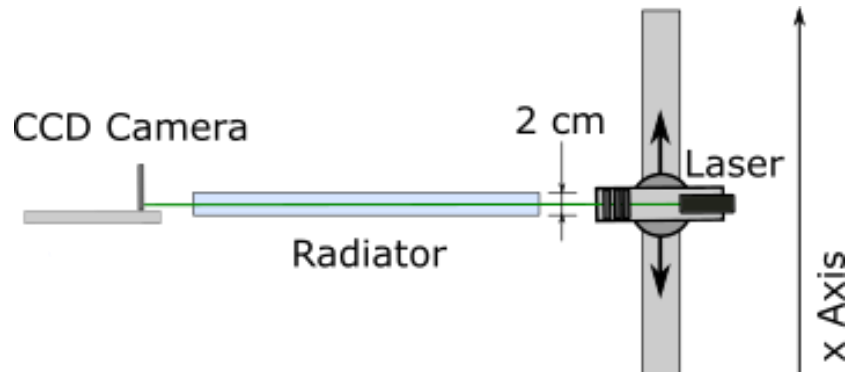
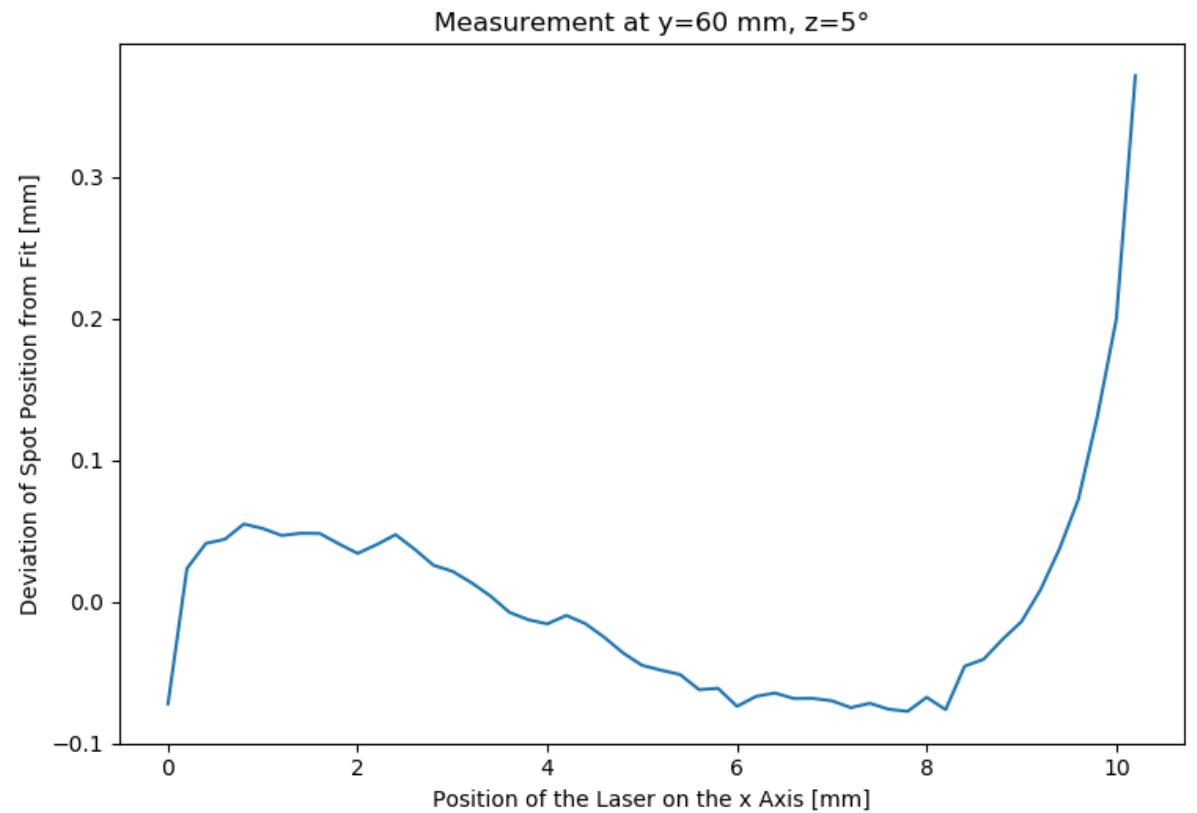
Vertical Scan (x axis)

- Laser is moved on the x axis
- Spot position is measured with the CCD camera
- Deviation of the position from a linear fit is plotted

- Measurements without FELs indicated that light passing through the radiator is slightly deflected
- This effect is most likely caused by irregularities at the sides of the radiators
 - Some defects are visible on the edge
 - The measurements with FELs showed good results
- Even small angles can be separated
- Transmission measurements
 - Will show the effect of defects on photon loss
 - And how well it can be compensated

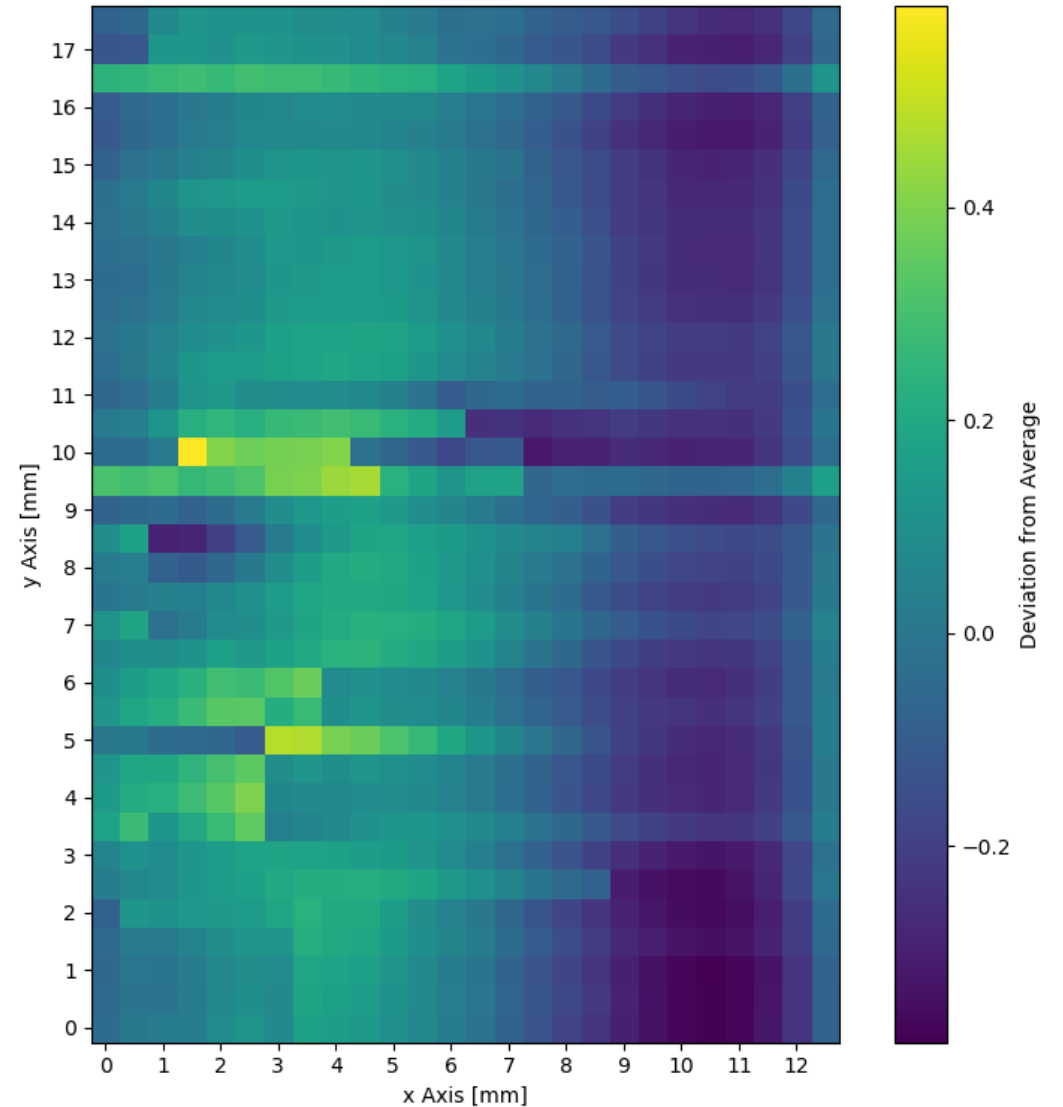
- Several vertical scans are taken
 - After each the laser is moved 0.5 mm on the y axis
- The Heatmap shows the deviation of the spot position from a linear fit

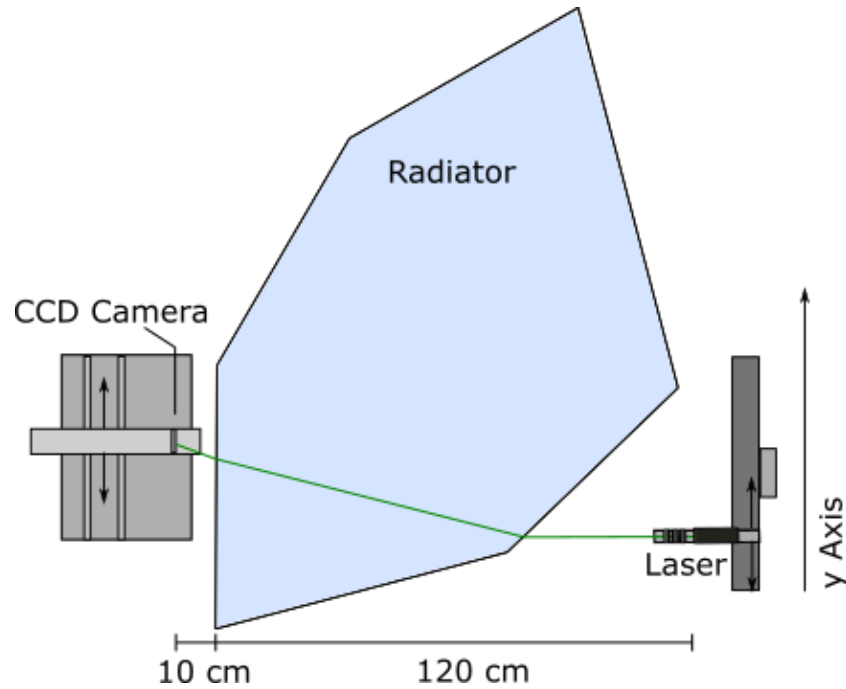
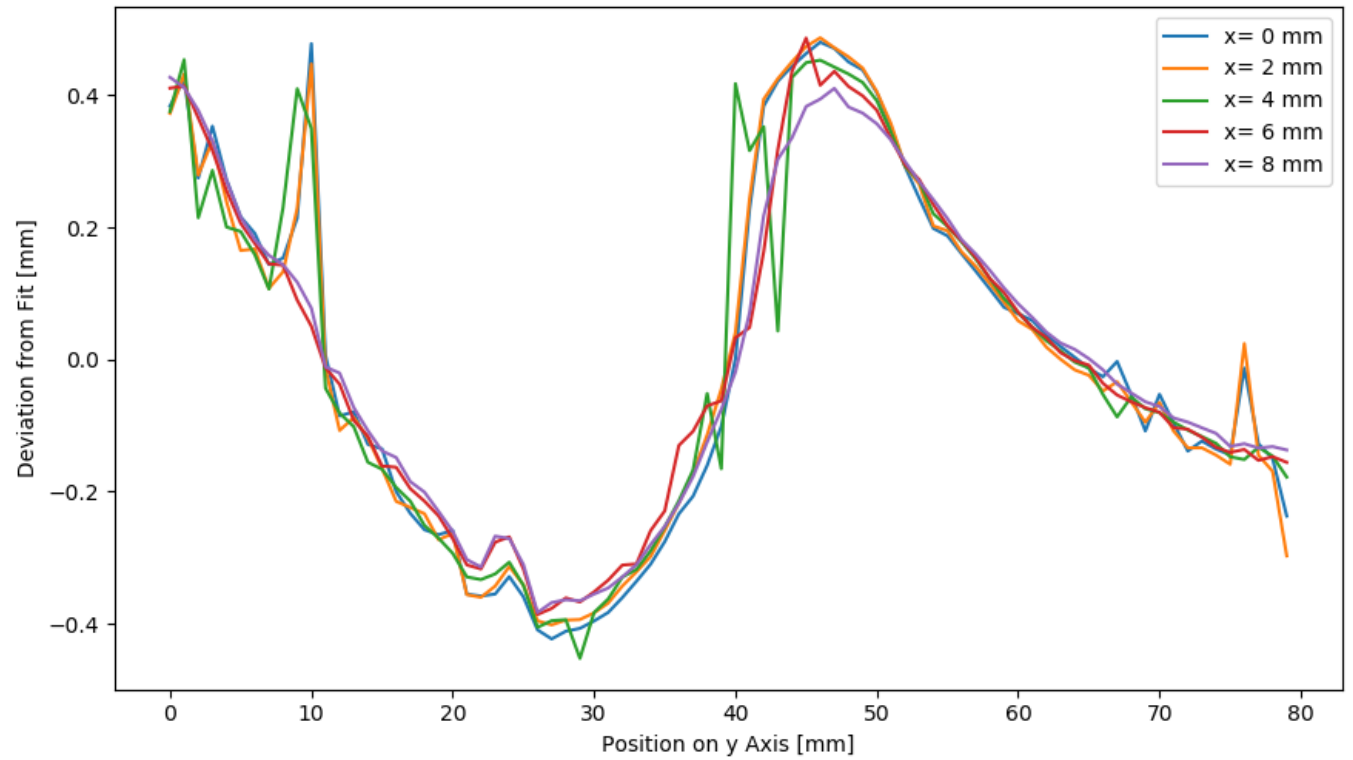
Horizontal Scan (y axis)

- The plot shows the deviation of the spot position from a linear movement

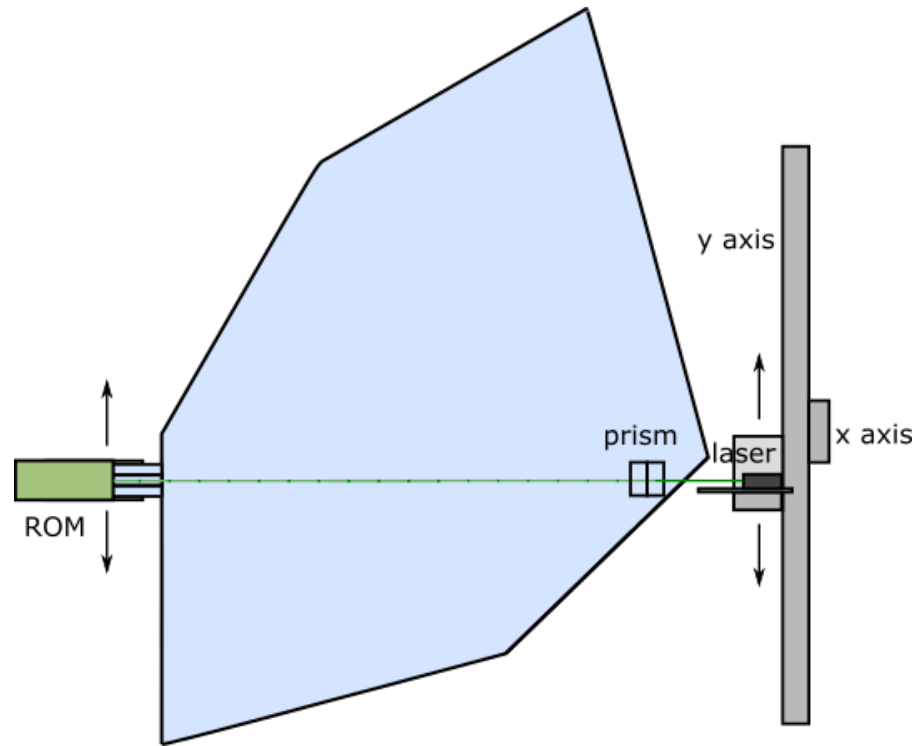
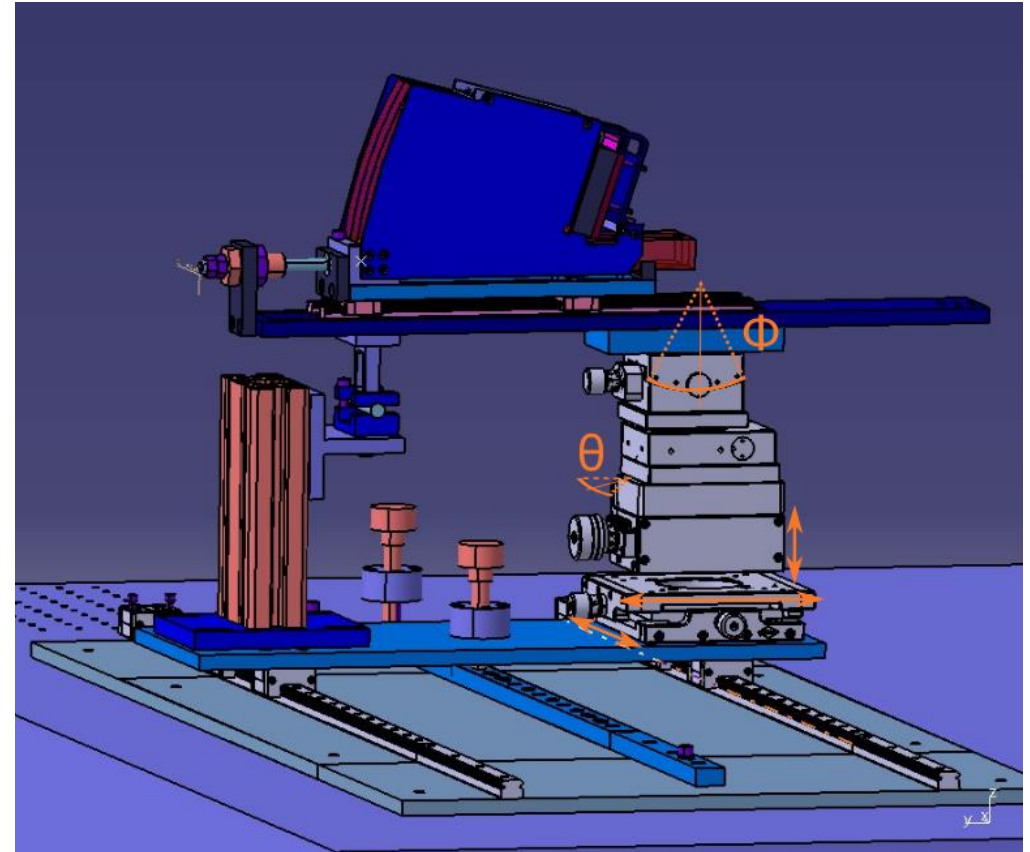
Setup with FELs and Gluing Station

- CCD camera is now mounted in front of the ROM

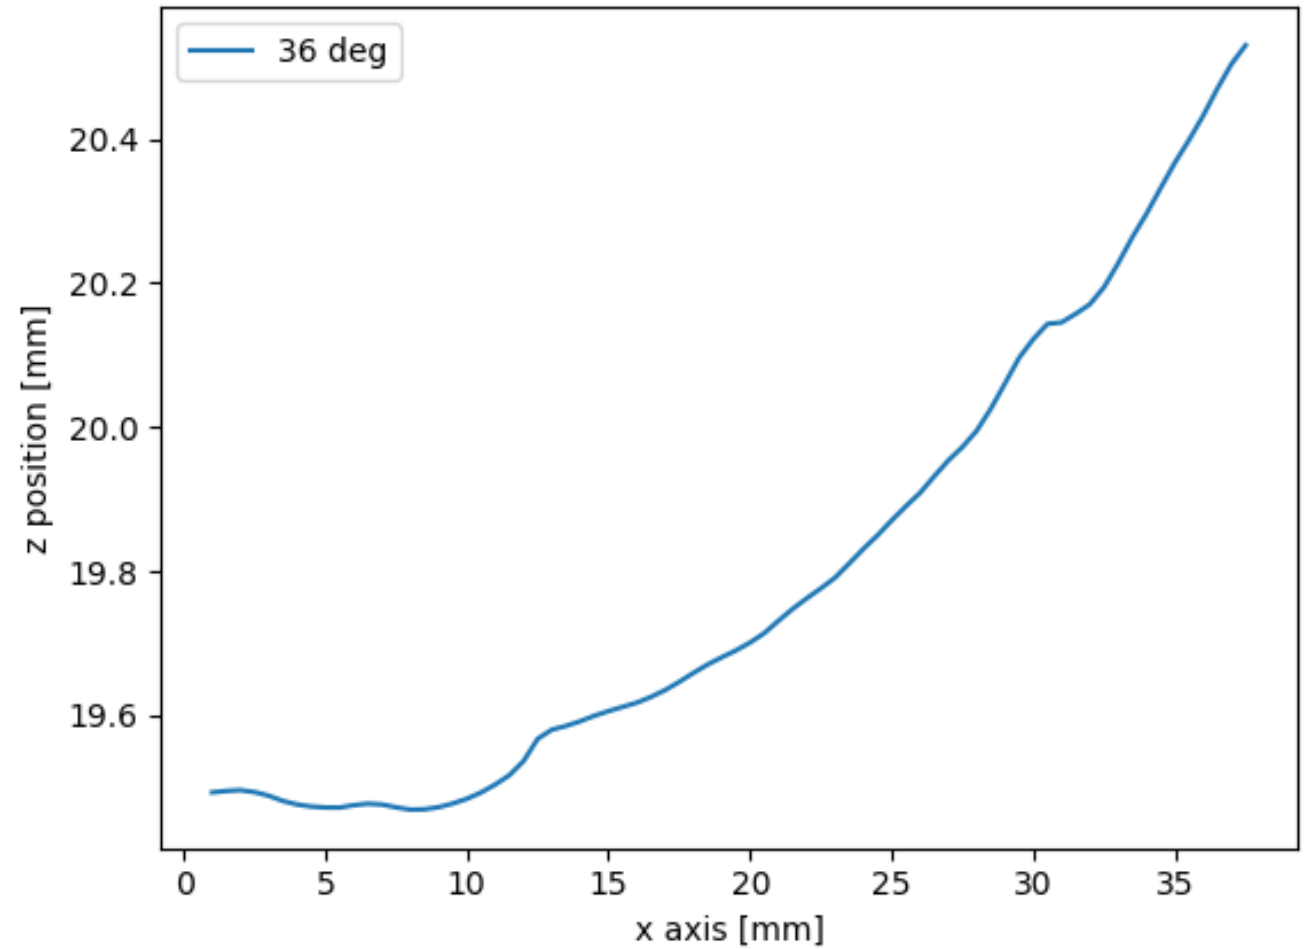
- The spot position on the CCD camera is measured for several angles between $\varphi=21^\circ$ and $\varphi=41^\circ$
- For each angle this results in a parabola
 - Caused by the optical error of the FEL

- An example of a measured parabola

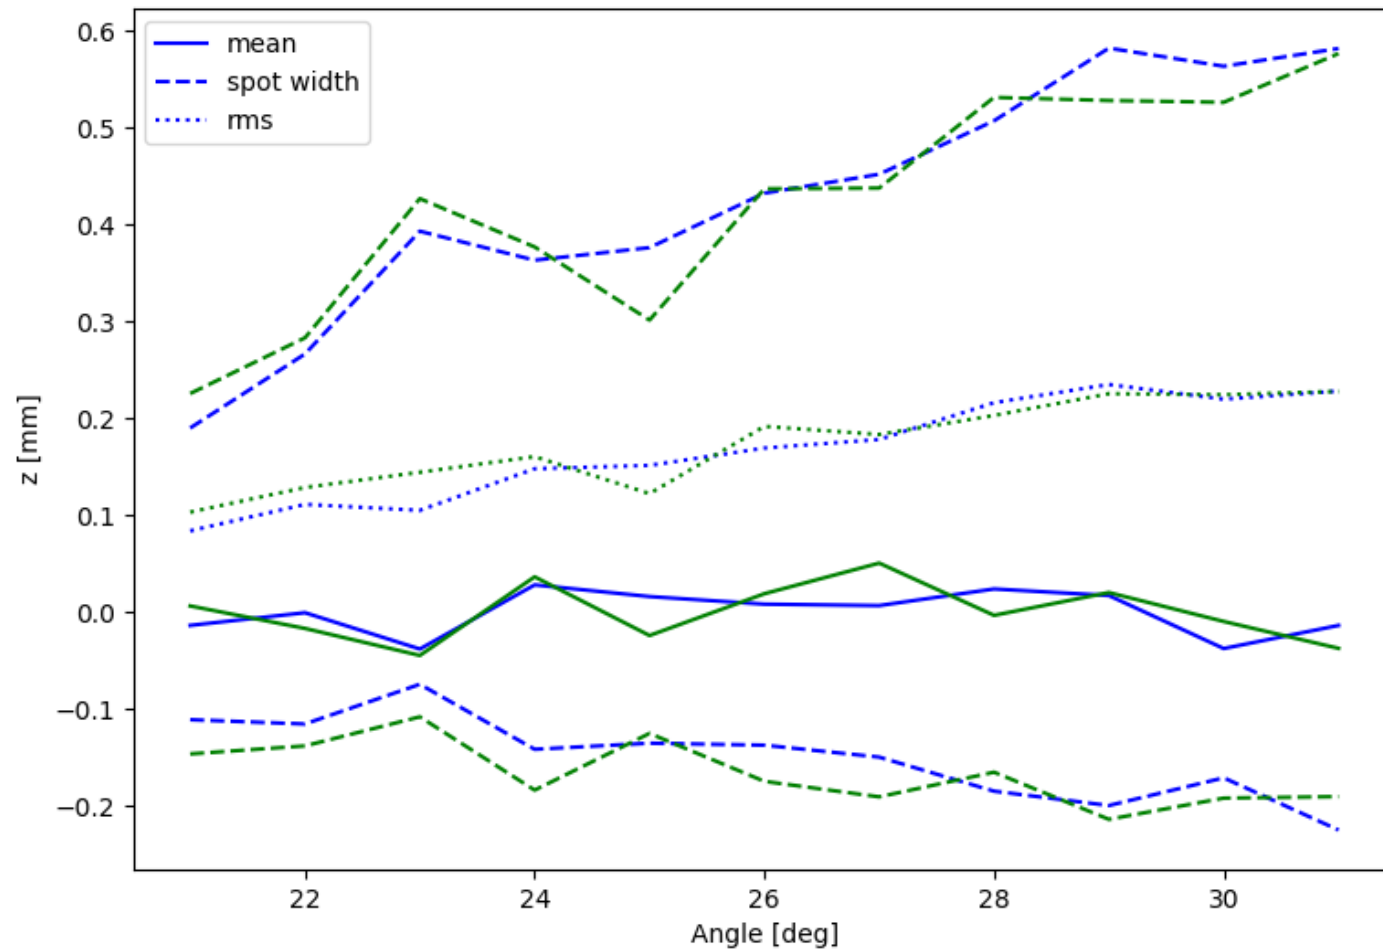
Comparison of measured (green) and simulated (blue) Data

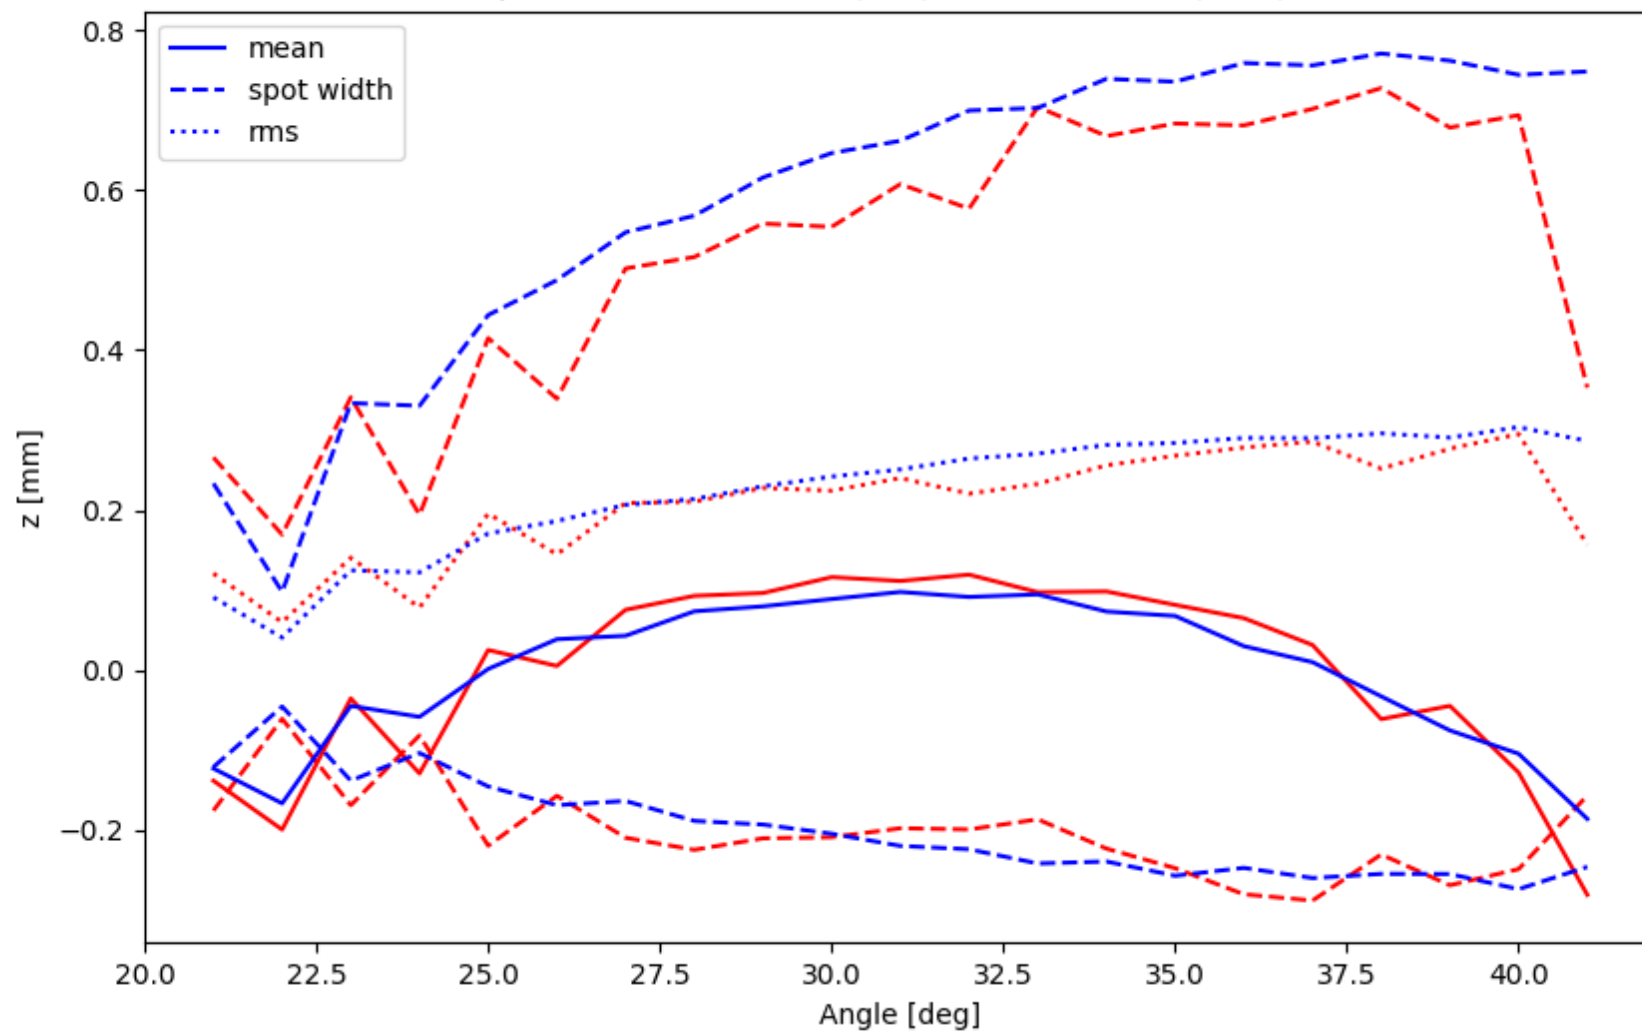
Comparison of measured (red) and simulated (blue) Data

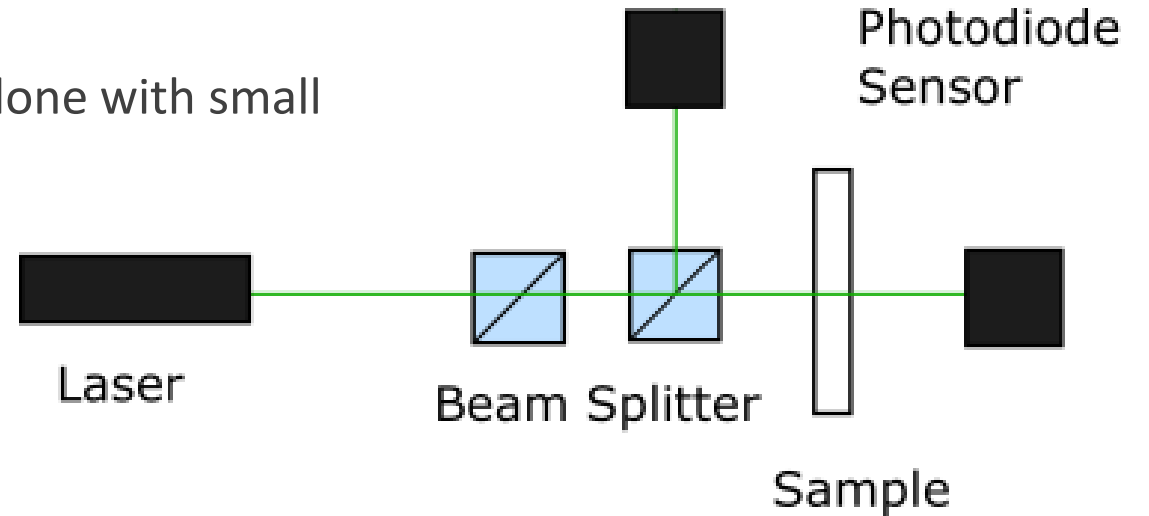
Ongoing Transmission Measurements

- Currently studying the effect of optical grease and glue on the connection
 - Possibly even out scratches
 - Reduce photon loss
- To protect the radiator and FELs the first tests are done with small fused silica plates
