#### EMC Backward Endcap Status report

Panda Collaboration Meeting, EMC session 12. 10. 2022

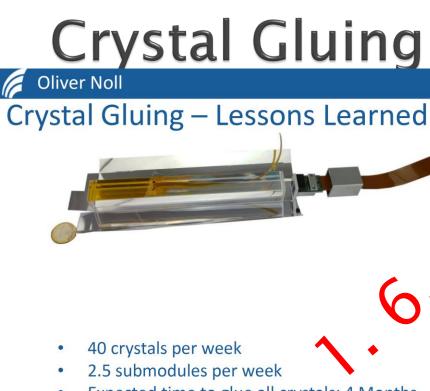
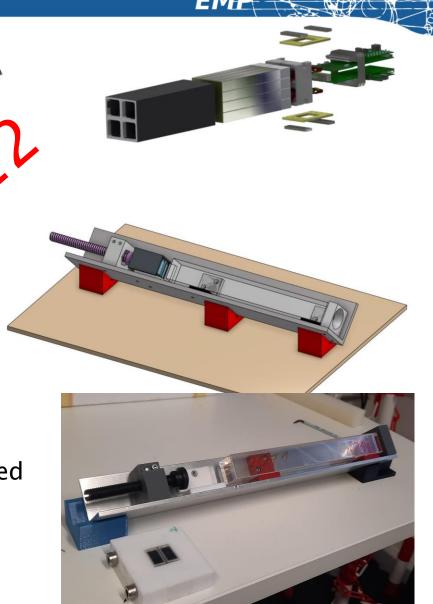
## Crystal Gluing

- Expected time to glue all crystals: 4 Months
- Gießen needs fixtures back
- Design of simplified version
- Prototype is under construction
  - Total crystals glued: 450/640
  - New Gluing station: one produced and in operation

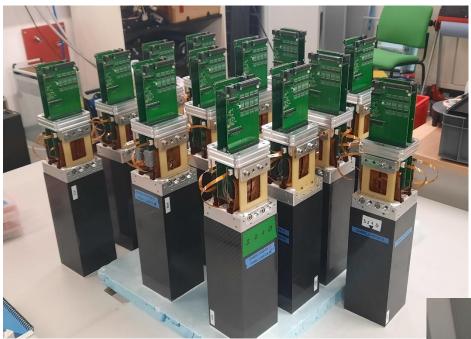
#### Submodule Production

- Submodule assembly (32 full, 16 half submodules):
  - Crystal gluing
  - Mechanical assembly of submodule
  - Electronics pre-check
  - Stopper gluing
  - Final check and calibration in climate chamber

- Production running smoothly
- Total 20 of 32 full subunits completed
- Assembly of all full subunits expected until end of year

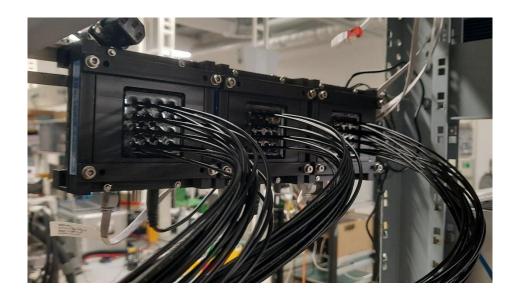
## Submodule Calibration

- Lightpulser system: 3 additional systems built
- 3 Submodules with full readout chain installed in chamber

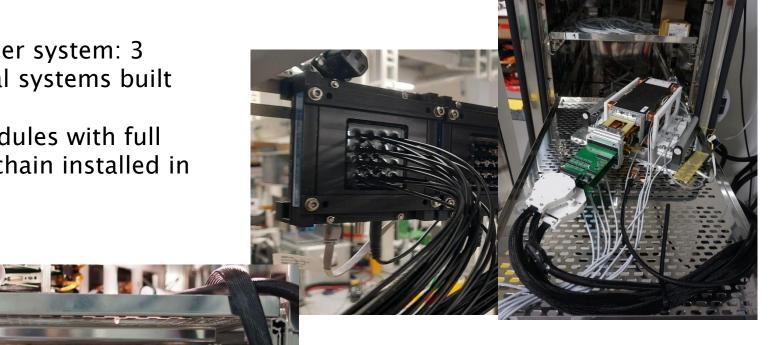
### Submodule Calibration

Lightpulser system: 3 additional systems built

3 Submodules with full readout chain installed in chamber

- Submodule tests at -25° started
- Cosmic ray measurements
- First tests with calibration scripts ongoing
