SIS100 tunnel installation Dipoles and Missing Dipoles

GSI Helmholtzzentrum für Schwerionenforschung GmbH, Darmstadt

Klausurtagung Kloster Eberbach
September 22 - 24, 2025

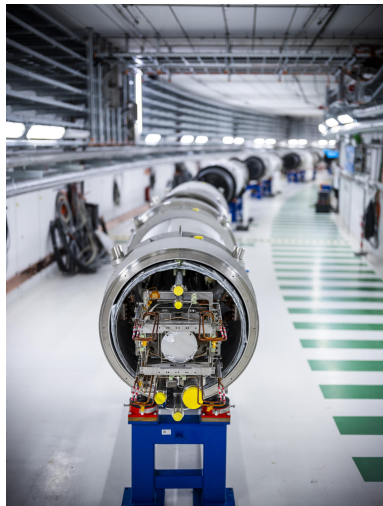
- 88 dipoles and missing dipoles are inside the tunnel (of 130 in total)
 - 80 dipoles (of 108)
 - 8 missing dipoles (of 12)
- missing:
 - sector 5 is still completely empty.
 - sector 4 - cells 8,9,A,B were temporarily skipped to have more space at the labyrinth for other transports
 - cell E in sectors 4 and 6 were skipped because of the fire protection wall

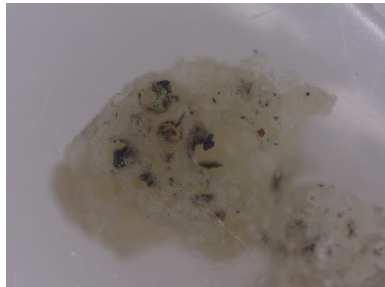
Process lines - cleaning

- Small particles were found in some Helium-pipes
→ creates risks for restrictor and cooling plant
- Analyzation by technology laboratory (see pics)
- Some metal parts probably created by welding team during pipe preparation
→ solved by improved protection
- Other material unclear (epoxy like, brittle, maybe solder flux remains?)

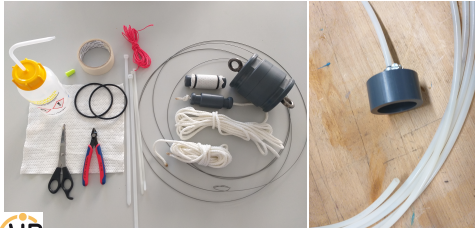
Process lines - cleaning

- Cleaning of all pipes before the welding
- Easy access to pipes 1,3 and 5
- More difficult for return lines (2 and 4) because of recoolers and holder inside, but vacuum cleaning with videoscope is possible
- Final control with videoscope after welding

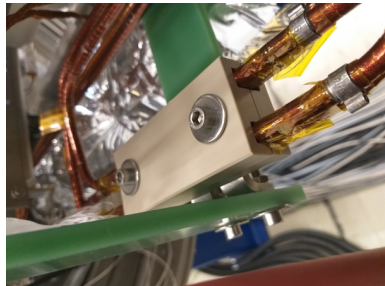
Open tasks: Busbar clamps

- small 220 pieces ordered + delivered for DP-DP connection
- not installed yet to keep space for the welding team

- Pablo Knoblauch is working on this topic
- Two possible concepts:
 - small clamps (like in the right picture)
 - epoxy bandage
- many pros and cons: accessibility, stability, sharp edges etc.
- no final decision yet

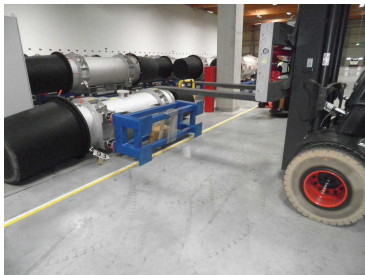
Damaged Dipole 93

- Cryostat, thermal shield, beam chamber scrapped (too much damage).
- New yoke will be build from steel for quadrupoles.
- Delivery of repaired dipol to GSI without beam chamber. After magnetical field measurements beam chamber and CAP will be installed.

Actual picture (last Friday):
half yokes are produced (laser welded
by sub-contractor in Rostock)
